DOT HS 813 524

# **Special Crash Investigations: Remote Move-Over-Law Crash Investigation; Vehicle: 2016 Dodge Charger Pursuit; Location: Nevada; Crash Date: May 2021**

**Special Crash Investigations  
Remote Move-Over-Law Crash Investigation  
Case No. DS21006  
Vehicle: 2016 Dodge Charger Pursuit  
Location: Nevada  
Crash Date: May 2021**

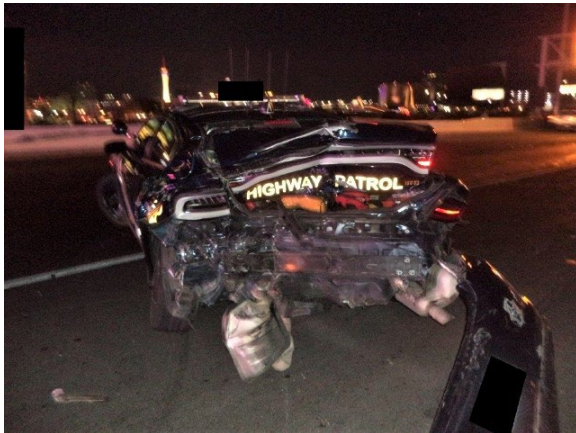
*Figure 1. Struck subject vehicle, 2016 Dodge Charger (police photo)*

The Dodge sustained direct and induced damage to the back plane, and induced damage to the left, right, top, and bottom planes. The SCI team used on-scene police photos to assess the

damage. Direct damage to the back plane appeared to be located laterally in the left and center sections, and vertically from the bumper to the beltline. The back bumper fascia was displaced, the left quarter-panel was crumpled, the trunk lid was crumpled, and the backlight was disintegrated. The left-rear axle, wheel, and tire were displaced forward, shortening the left wheelbase. The estimated collision deformation classification (CDC)<sup>3</sup> for the Dodge in Event 1 was 07BYEW2. A WinSMASH Photo-CDC run calculated a total delta-V in the 25 to 40 kmh (16 to 25 mph) range.

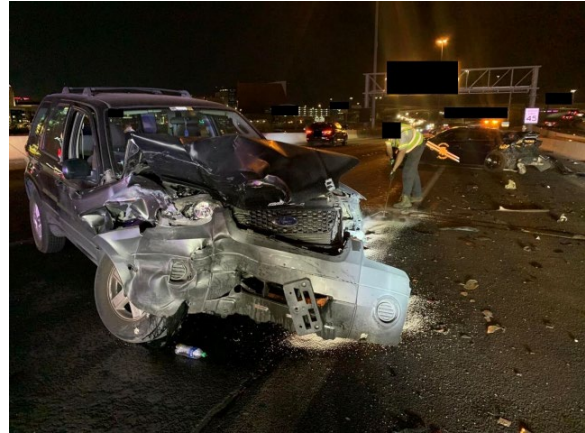
*Figure 2. Striking vehicle, 2006 Ford Escape (police photo)*

The Ford sustained direct and induced damage to the front, left, right, and top planes. The SCI team used on-scene police photos to assess the damage. Direct damage to the front plane appeared to be located laterally in the middle and right sections, and vertically from the bumper to the beltline. The front bumper fascia was displaced at the right aspect, and the left and right quarter-panels and hood were crumpled. The right-front tire appeared to be restricted. The estimated CDC for the Ford in Event 1 was 12FZEW3. A WinSMASH Photo-CDC run calculated a total delta-V in the 40 to 55 kmh (25 to 34 mph) range.

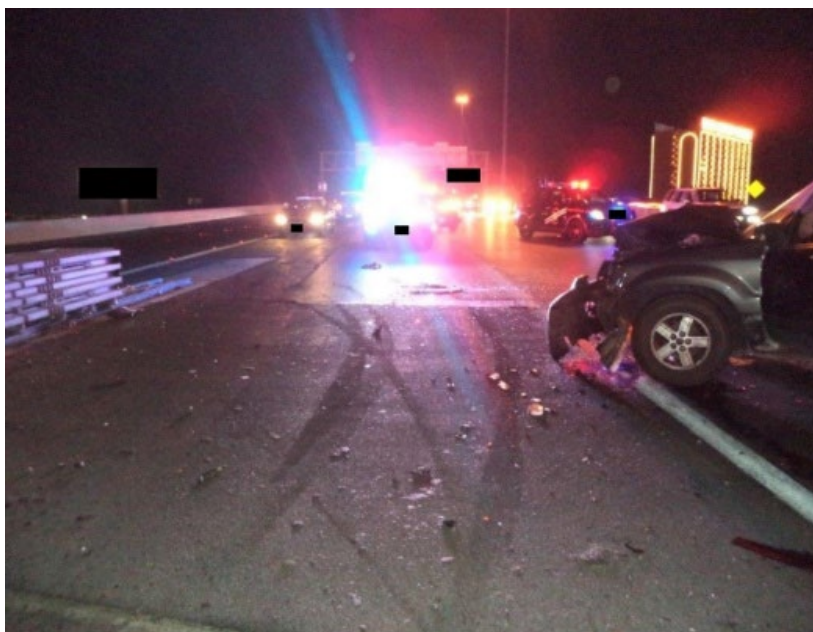
*Figure 3. Lookback view from area of impact, looking east (police photo)*

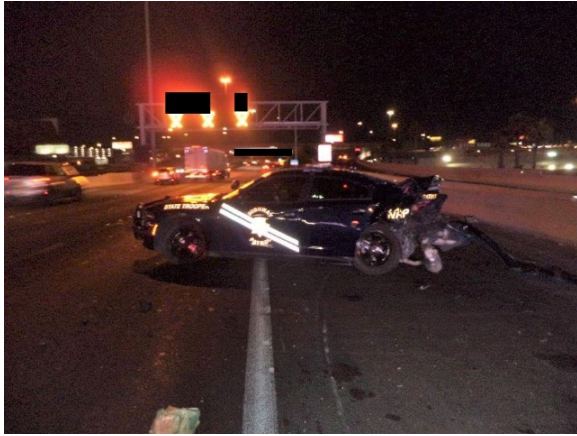
*Figure 4. Final rest location looking west, 2016 Dodge Charger Pursuit (police photo)*

The crash included a single event. After entering the right shoulder, the Ford's front plane struck the Dodge's back plane. Impact forces pushed the Dodge forward in a westbound trajectory and counterclockwise rotation. It came to rest facing south in the right shoulder and first lane from the right (Figure 4). The Ford traveled westbound in a post-impact trajectory while rotating clockwise. It traveled approximately 3 m (10 ft) and came to rest facing north in the first and second lanes from the right (Figure 5).

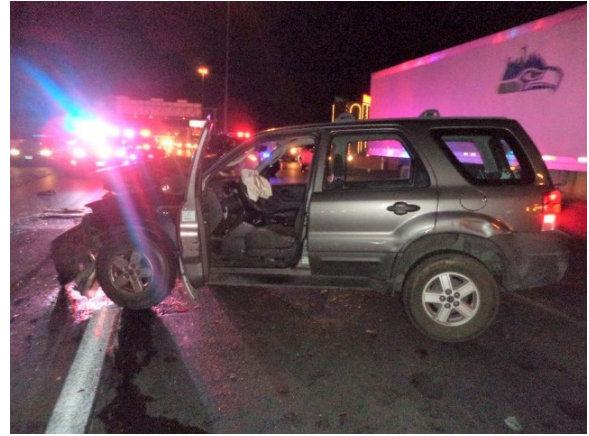
*Figure 5. Final rest position looking east, 2006 Ford Escape (police photo)*
