DOT HS 813 528

# **Special Crash Investigations: Remote Move-Over-Law Crash Investigation; Vehicle: 2021 Ford Explorer; Location: Nevada; Crash Date: July 2021**

**Special Crash Investigations**  
**Remote Move-Over-Law Crash Investigation**  
**Case No. DS21008**  
**Vehicle: 2021 Ford Explorer**  
**Location: Nevada**  
**Crash Date: July 2021**

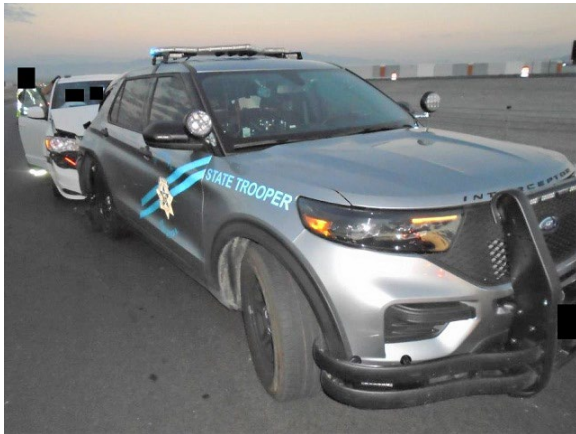
*Figure 1. Struck subject vehicle, 2021 Ford Explorer Police Interceptor (police photo)*

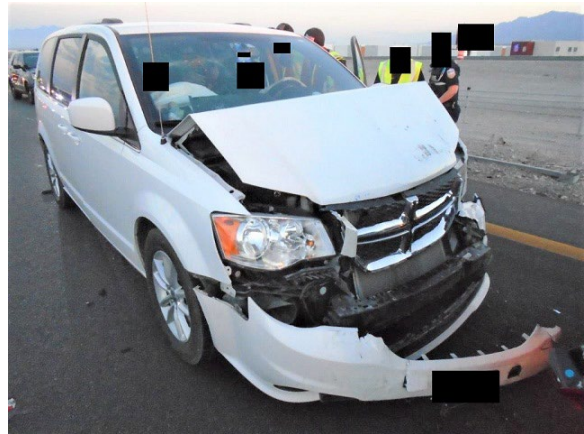
*Figure 2. Striking vehicle, 2018 Dodge Grand Caravan (police photo)*

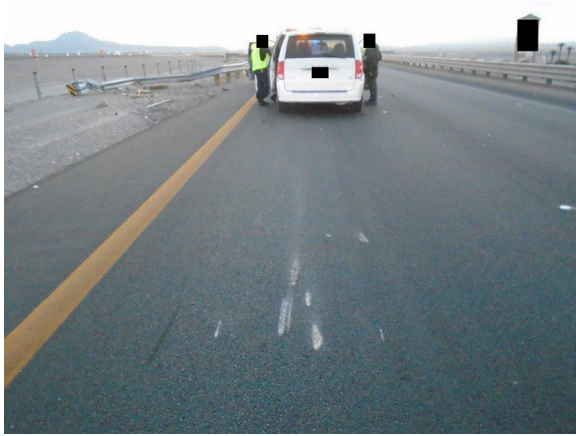
The crash included a single event. The front plane of the Dodge impacted the back plane of the Ford. A group of scrape marks in the left lane pavement identified the POI (Figure 3). Impact forces displaced the Ford forward where it came to rest facing east in the left lane approximately 13.1 m (43 ft) east of the POI (Figure 4). The Dodge traveled eastbound in a post-impact trajectory in the left lane where it came to rest facing east approximately 12.2 m (40 ft) east of the POI.

*Figure 3. View looking east from area of impact to Dodge at final rest (police photo)*

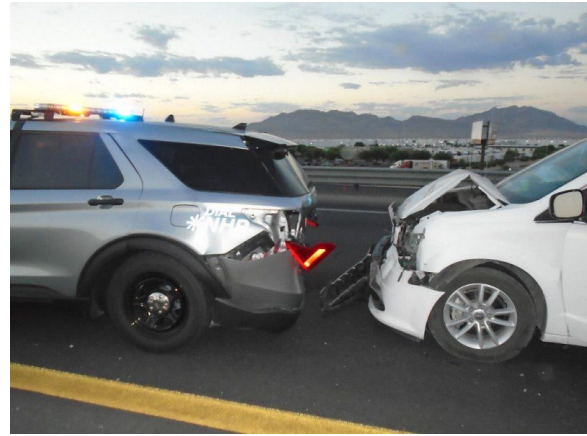
*Figure 4. Final rest positions of Ford with emergency lights activated, and Dodge (police photo)*

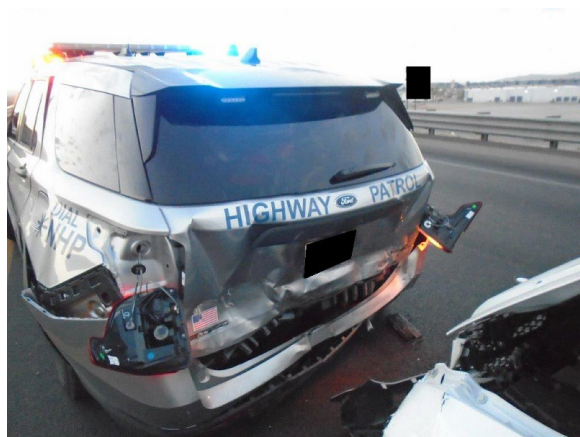
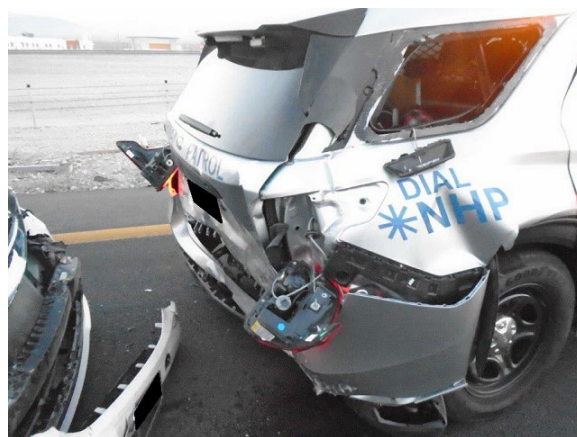
The Ford sustained direct and induced damage to the back plane, and induced damage to the left and right planes (Figures 5 and 6). Direct damage to the back plane appeared to be distributed laterally from bumper corner to bumper corner, and vertically from the bumper to the beltline. The sheet metal of the back liftgate was crushed, the back bumper fascia was displaced, and the tail lamps were displaced and hanging from electrical wiring. Based on views of the Ford shown in on-scene police photos, the tail lamps continued to flash in their post-impact state. The sheet metal of the left and right quarter-panels was crumpled, and the left rear and right rear tires appeared to be restricted. The right-side glazing in the cargo area was disintegrated. The estimated CDC for the Ford in Event 1 was 06BDEW2. A WinSMASH photo-CDC run calculated a total delta-V in the 40–55 km/h (25–34 mph) range.

Figure 5. Back-plane damage, Ford (police photo)

Figure 6. Back-plane damage, Ford (police photo)

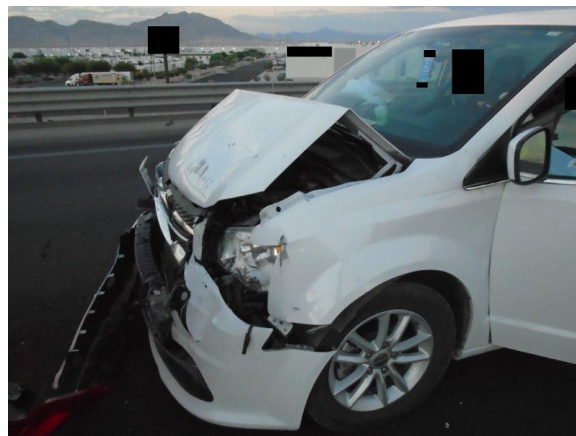
Based on the police report and photos, the Dodge sustained moderately severe damage to the front plane. The front plane had direct and induced damage, and the left and right planes had induced damage. Direct damage to the front plane appeared to be distributed laterally from bumper corner to bumper corner, and vertically from the bumper to the beltline. The front bumper fascia was displaced and the sheet metal of the hood and left front fender was crumpled. The estimated CDC for the Dodge in Event 1 was 12FDEW2 (Figure 7). A WinSMASH photo-CDC run calculated a total delta-V in the 40–55 km/h (25–34 mph) range.

*Figure 7. Front plane damage, Dodge (police photo)*
