DOT HS 813 586

**Special Crash Investigations:
On-Site Air Bag Inflator Rupture
Investigation;
Vehicle: 2012 Mercedes-Benz C250;
Location: Florida;
Crash Date: November 2020**

On-Site Air Bag Inflator Rupture Crash Investigation
Office of Defects Investigation
SCI Case Number: CR20037
Vehicle: 2012 Mercedes-Benz C250
Location: Florida
Crash Date: November 2020

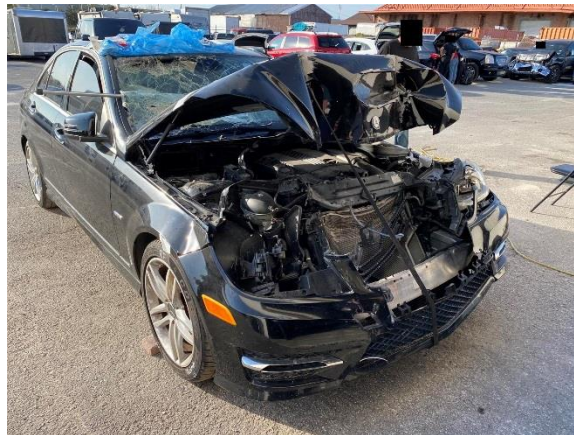
Figure 1. Front right oblique view of the frontal damage to the 2012 Mercedes-Benz

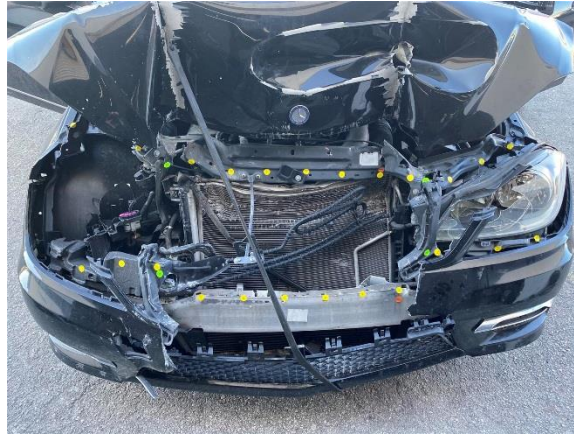
The Mercedes-Benz sustained direct and induced damage extending across the front end-width of the vehicle. The direct contact damage consisted of two vertical creases that extended through the bumper fascia into the bumper beam, through the grille area and into the hood (Figures 4 and 5). Abrasive type scratches were present on the hood face between the vertical creases. The contact damage to the Mercedes-Benz indicated that there was probably an aftermarket fixture that was mounted to the back plane of the Dodge.

Figure 4. Front plane damage to the Mercedes-Benz

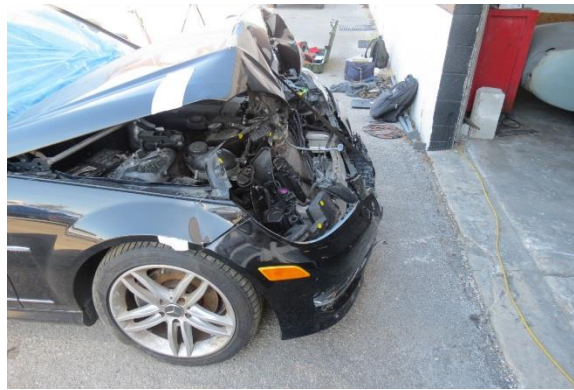
Figure 5. Right lateral view showing the extent of frontal crush

The direct damage started 46 cm (18.1 in) left of the vehicle's centerline and extended right across the front plane 79 cm (31.1 in). Minimal damage occurred to the bumper beam. Based on the NHTSA measurement protocol, the residual crush was documented by total station at two levels, the bumper beam, and the upper radiator support. The Field L was 136 cm (53.5 in). The average crush profile between the bumper beam and radiator support was as follows: C1 = 23 cm (9.1 in), C2 = 15 cm (5.9 in), C3 = 22 cm (8.7 in), C4 = 22 cm (8.7 in), C5 = 21 cm (8.3 in), C6 = 24 cm (9.4 in). The maximum crush was 39 cm (15.3 in) and was located 24 cm (9.4 in) left of the centerline.

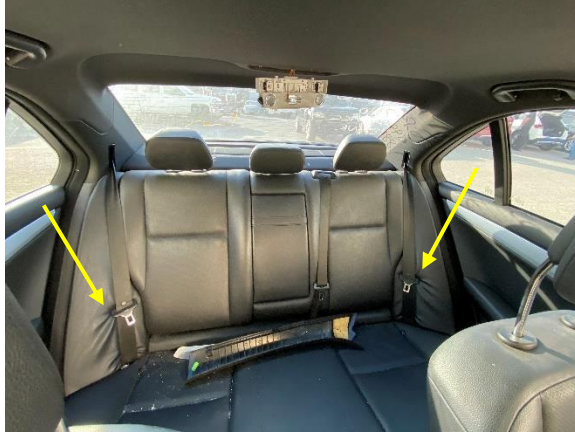
The unoccupied second row left and right pretensioners did actuate, indicated by the yellow arrows in Figure 6, and locked the belt webbing taut against the seatbacks. According to the owner's manual, the second row pretensioners will actuate whether the seat belts are buckled or not.

Figure 6. 2012 Mercedes-Benz second row pretensioner actuation evidence

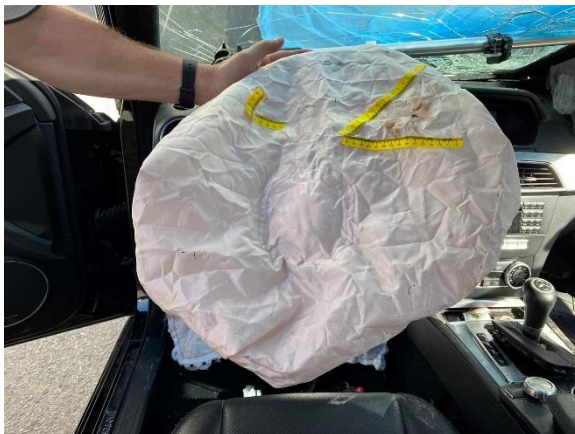
Figure 7. Deployed driver's frontal air bag and blood transfers of the upper right

The deployed driver's frontal air bag was located in the steering wheel hub and the deflated air bag measured 46 cm (18.1 in) in diameter. The air bag module had overall dimensions of 14 cm (5.5 in) vertically and 16 cm (6.3 in) horizontally and the module cover consisted of five flaps that opened at designated tear points. Evidence of blood was found in the upper right quadrant of the driver's air bag.

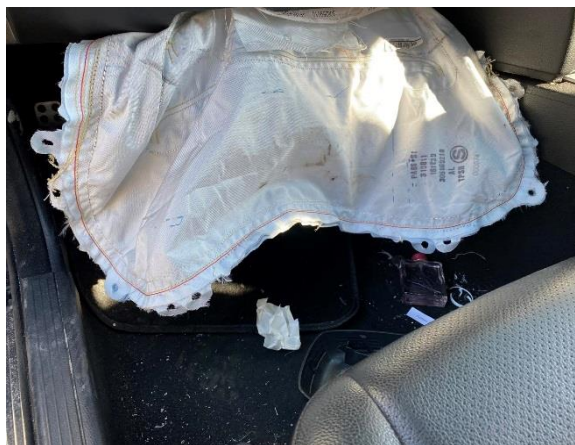
Figure 8. Deployed driver knee air bag

The driver knee air bag deployed from the module located in the lower instrument panel below the steering column. The deployed knee air bag measured 26 x 54 cm (10.2 x 21.3 in). The single cover flap was 9 x 32 cm (3.5 x 12.6 in). No residual contact evidence was found on the driver knee air bag.

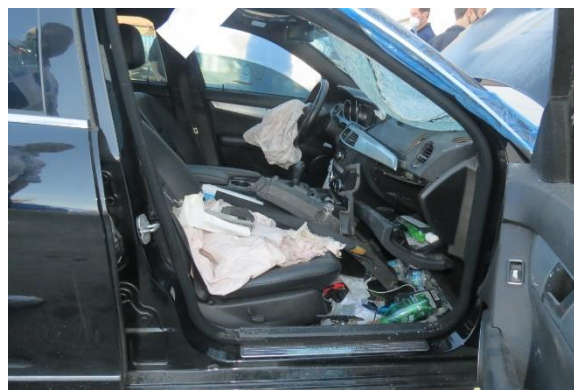
Figure 10. View of passenger's side showing the air bag as found at time of the SCI Inspection

The deployment of the passenger's frontal air bag (Figures 10 & 11) resulted in an apparent over-pressurization in the inflator and caused a total rupture of the inflator and the components in the air bag module. There was also a complete separation of the air bag fabric from the module.

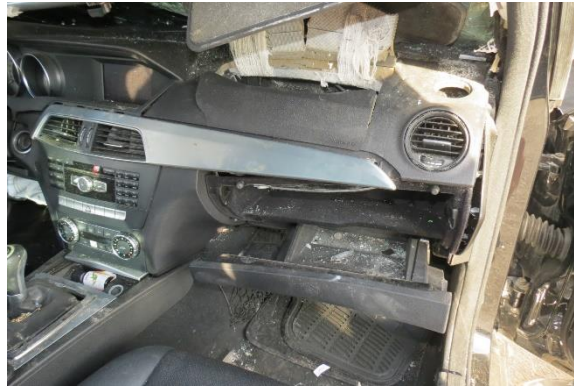
Figure 11. View of the front right instrument panel after removal of air bag and air bag module components during the SCI Inspection

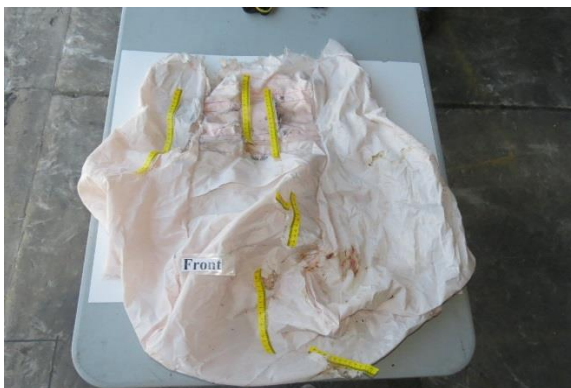
SCI investigators, the attorney, and consultants representing Mercedes-Benz, as well as the attorney and consultants for the front passenger were present to document and inspect the ruptured air bag module. The passenger's frontal air bag fabric was removed from the Mercedes-Benz and placed on an inspection table. The air bag was approximately 71 cm (28 in) by 80 cm (31 in) and was catastrophically damaged with tear points throughout as indicated by the yellow measurements in Figures 12 and 13 identifying the location of the damage. There were several large tears to both sides of the air bag fabric from the air bag inflator and housing components rupturing and projecting through the air bag. Figure 12 shows the damage sustained to the front, and Figure 13 shows the damage sustained to the back of the air bag.

Figure 12. Front view of the passenger's frontal air bag

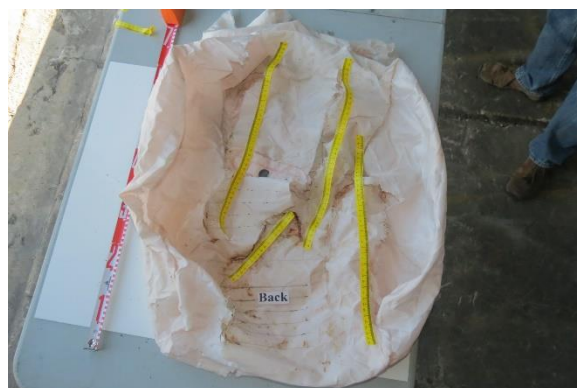
Figure 13. Rear view of the passenger's frontal air bag

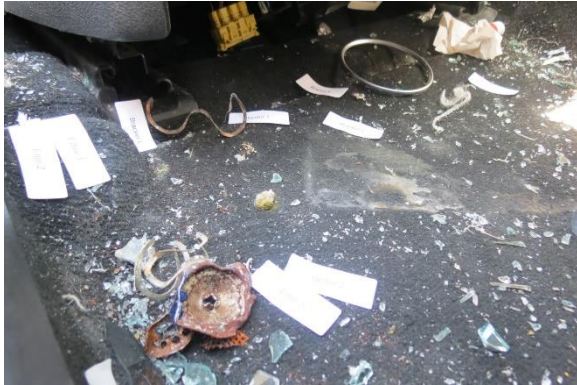
Figure 14. View of passenger floorboard showing air bag module components with labels as found

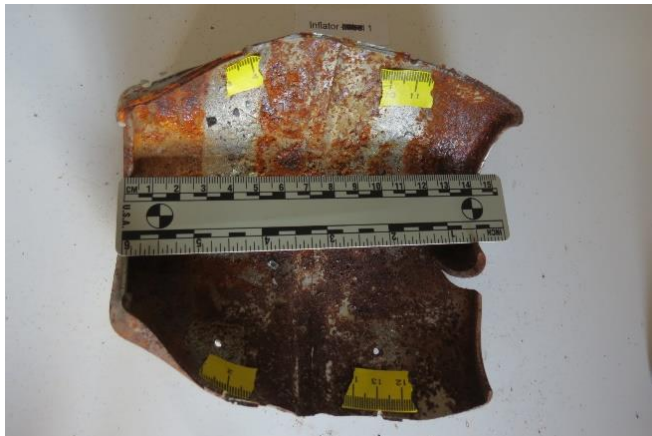
During the inspection, the air bag inflator casing was found to have split lengthwise crossing through the vent holes. Figure 16 shows the casing with the yellow tape indicating the vents where the split occurred. Additionally, a plastic housing for the air bag module was found that had the manufacture label still intact. Based on this label, it was determined that the air bag module was manufactured by Takata in 2011. This label indicated that this air bag module was the original equipment installed in the vehicle and was never replaced as required by the NHTSA recall. Figure 17 highlights this data in the red boxes. On-site Mercedes-Benz representatives would not confirm or deny this label as being accurate to indicating an original Takata air bag at the time of the inspection. It was later confirmed by Mercedes-Benz that this was the original air bag installed in the vehicle at the time of manufacturing.

Figure 16. Image of the split air bag module casing

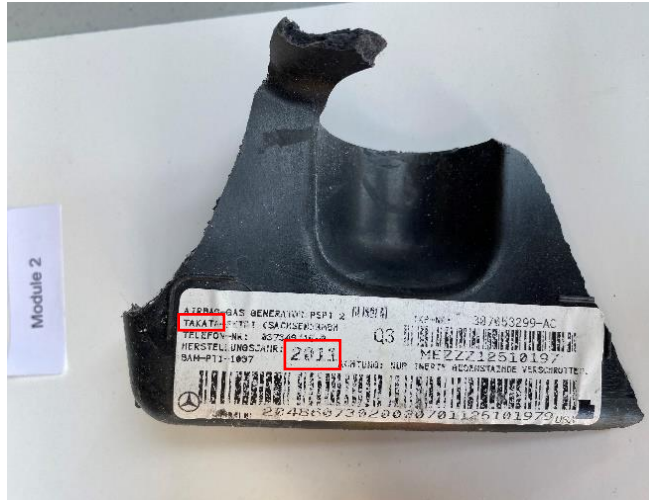
Figure 17. Image of the air bag module manufacture label
