DOT HS 813 602

# **Special Crash Investigations: Remote Move-Over-Law Crash Investigation; Vehicle: 2018 Freightliner M2 Flatbed/Nonmotorist; Location: Washington State; Crash Date: September 2021**

**Special Crash Investigations**  
**Remote Move-Over-Law Crash Investigation**  
**Case No. DS21013**  
**Vehicle: 2018 Freightliner M2 Flatbed/Nonmotorist**  
**Location: Washington State**  
**Crash Date: September 2021**

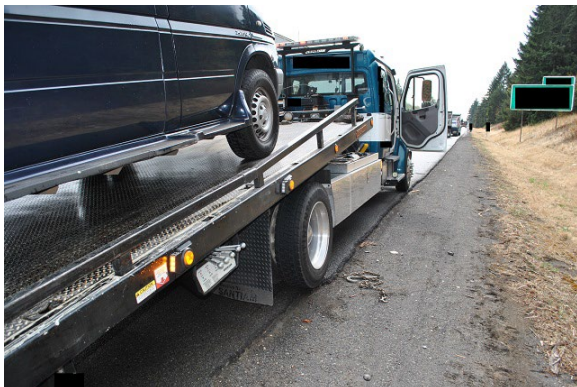
*Figure 1. Struck vehicle, 2018 Freightliner M2 tow truck (police photo)*

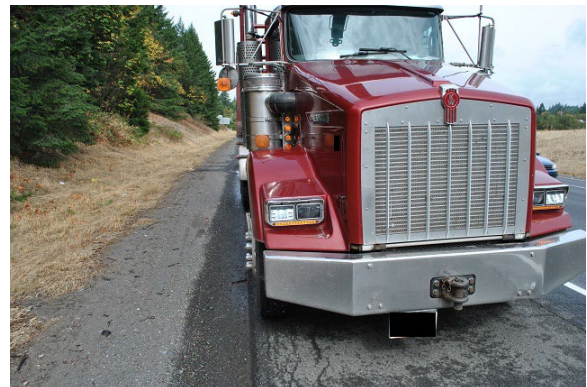
*Figure 2. Striking vehicle, 2007 Kenworth T8 truck-tractor pulling a 1950 Fruehauf log trailer (police photo)*

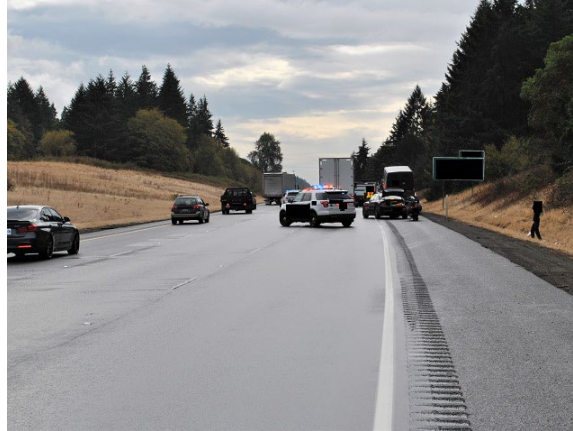
The crash occurred in the southbound lanes of the physically divided north/south interstate highway (Figure 3). The roadway had three southbound asphalt lanes each measuring approximately 3.6 m (11.8 ft) wide. The lanes were separated by dashed white painted stripes and raised reflective markers located on the dashes and within the spaces between the dashes. The left roadway edge had a solid yellow painted fog line and an asphalt shoulder with a milled-in type rumble strip. The right roadway edge had a solid white painted fog line and an asphalt shoulder measuring approximately 4.5 m (14.8 ft) wide with a milled-in type rumble strip. Traveling southbound, the roadway was level with a slight left curve radius measuring approximately 1,814 m (5,951 ft) at the right fog line. Based on police photos, the pavement, markings, and reflectors were in good condition. The right roadside had a drainage ditch, ascending grass embankment, and tree line, oriented roughly parallel to the roadway. The posted speed limit was 96 kmh (60 mph). Conditions at the time of the crash were daylight, raining, and wet. The Kenworth driver told police his visibility was affected by road spray coming off other vehicles. Aside from the Freightliners emergency lighting, no supplemental warning devices were in use at the site prior to the crash.

*Figure 3. Crash site, looking south (police photo)*

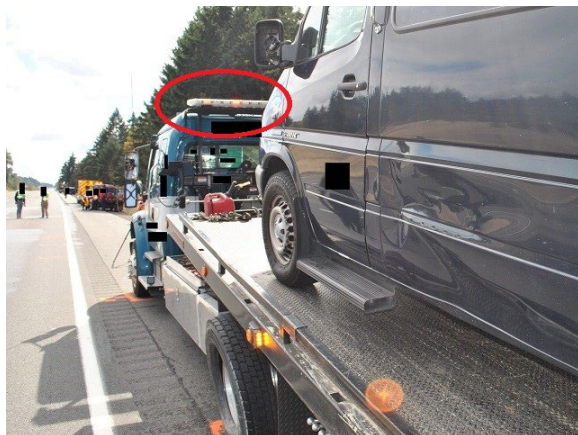
The leading end of the carrier had a rear-facing LED light bar with amber lights that were activated (Figure 4). The left and right sides of the carrier deck had five round amber-colored lamps extending its length that were activated. The back edge of the carrier had red and white reflective tape. Due to the high roof profile of the Sprinter when loaded on the flatbed, it may have obscured the Kenworth driver's view of the tow truck's light bar.

*Figure 4. 2018 Freightliner M2, LED light bar is activated (police photo)*

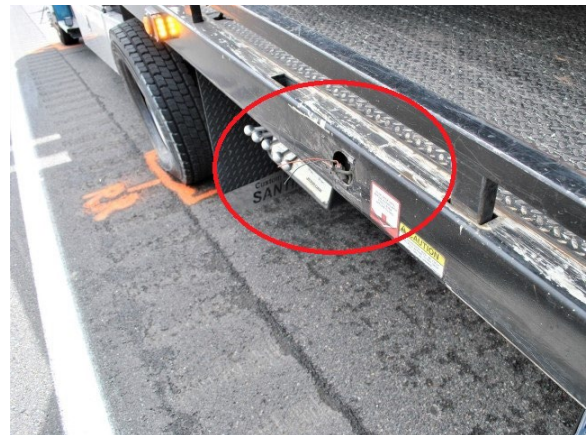
Based on the police report and photos, the Freightliner sustained minor damage to the left plane. Damage to the carrier included scrape marks and a displaced running light. The left-rear wheel was bent, and the tire was de-beaded. No other damage was noted by police or visible in police photos. The estimated truck deformation classification (TDC) for the Freightliner in Event 1 was 06LBES1 (Figure 5).

*Figure 5. Left plane damage, 2018 Freightliner M2 (police photo)*

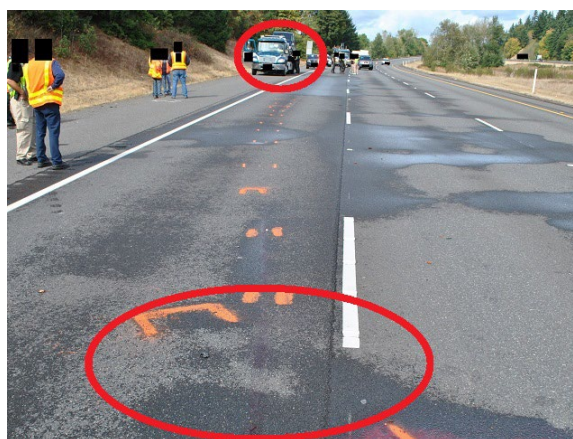
The tow truck driver was standing on the right southbound shoulder between the left plane of the Freightliner's carrier deck and the first travel lane from the right. He was facing west and retrieving chains to secure the van. The tow truck driver was struck and dragged by the right plane of the trailer, and impact forces likely displaced him forward causing him to contact the carrier deck of his vehicle. Police and the witness suggested he was likely contacted by the trailer tires. He was dragged along the edge of the tow truck before being pitched into the air. After landing on the roadway, the tow truck driver slid to final rest. His more severe injuries included fractures to the vault skull, mandible, cervical spine, left clavicle, right scapula, right radius, and right ulna; these were attributed to being compressed between the two vehicles. He sustained abrasions and contusions to the face, chest, arms, hips, and legs; these were attributed to contact with the ground. He came to rest face down in the first and second lanes from the right, approximately 50 m (164 ft) south of the point of impact (Figure 6). He remained there until removed by emergency responders.

*Figure 6. Lookback view looking north from tow truck driver's location at final rest to area of impact (police photo)*

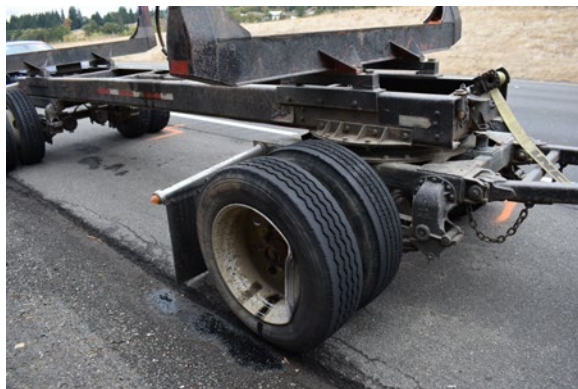
The Kenworth was not struck or damaged. In Event 1, the right plane of the Fruehauf trailer struck the left plane of the Freightliner. Damage to the trailer included a bent right-front wheel and de-beaded tire (Figure 7). The estimated TDC for the trailer in Event 1 was 12RTFSA. In Event 2, the right plane of the Fruehauf trailer struck the tow truck driver. Police photos did not document any deformation to the trailer for this event. It appears likely that one or more right-side tires, and one or both upright standards (Figure 8), struck the tow truck driver. The estimated TDC for the Kenworth in Event 2 was 12RTFUA.

*Figure 7. 1950 Fruehauf log trailer (police photo)*

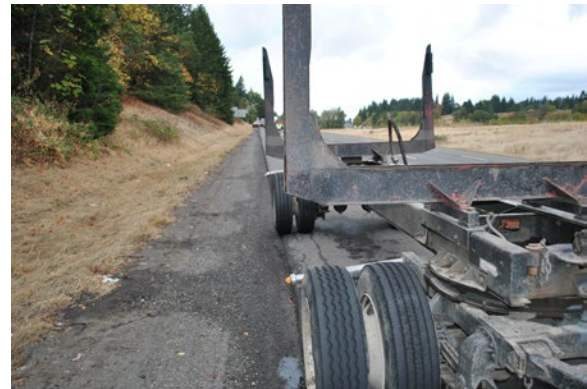
*Figure 8. Upright stations, 1950 Fruehauf log trailer (police photo)*

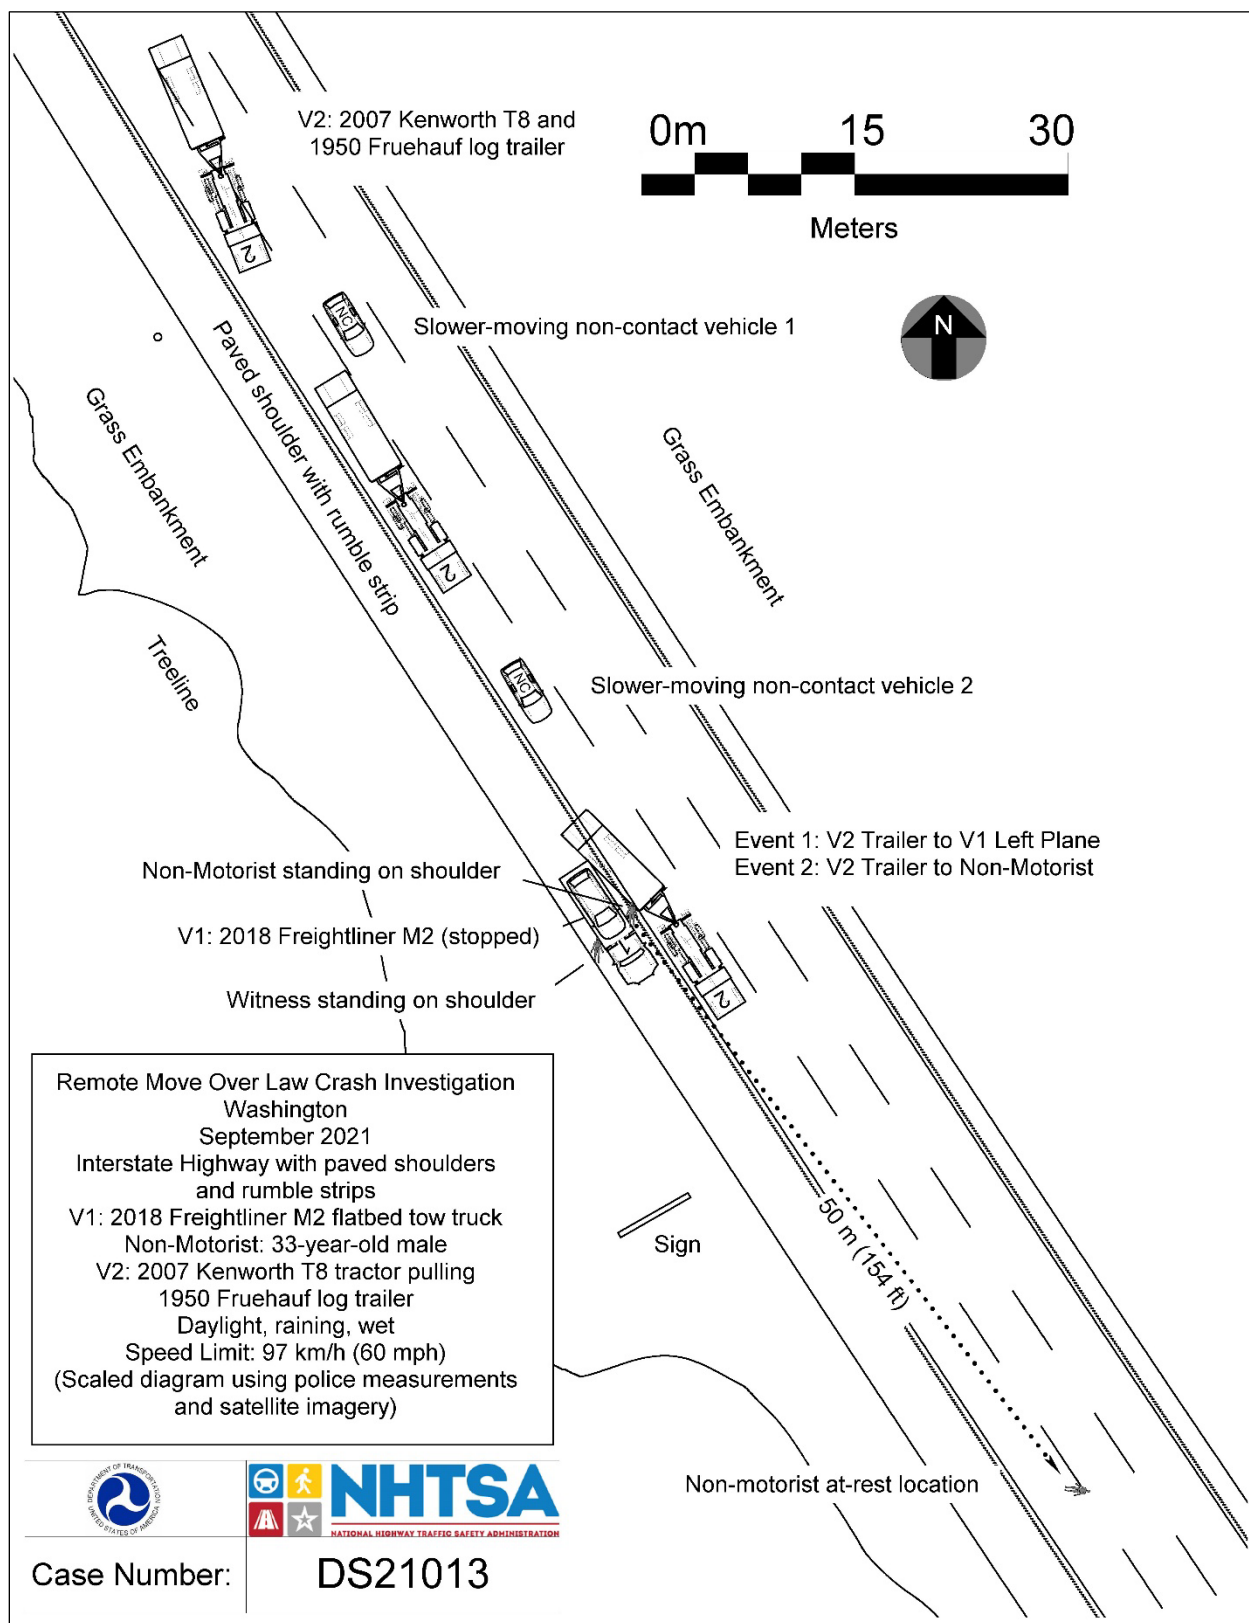
# Crash Diagram

The Fruehauf's right-front wheel struck the Freightliner's left-rear wheel and its right upright standards struck the left edge of the Freightliner's carrier deck (Event 1). The trailer continued forward and its right-side tires and upright standards probably struck the tow truck driver (Event 2). The damage patterns to the vehicles suggested a swiping type of contact. According to the witness, he felt the Freightliner lunge at impact. Based on police photos and witness statements, the Freightliner appeared to remain in its original position on the shoulder. The witness saw the tow truck driver pitched into the air an unknown distance before landing on the roadway and sliding an estimated 17 m (55 ft). The tow truck driver came to rest approximately 50 m (164 ft) south of the area of impact in the first and second lanes from the right.
