DOT HS 813 677

Special Crash Investigations: On-Site Ambulance Crash Investigation; Vehicle: 2011 Ford F-450, Type I Ambulance; Location: Kentucky; Crash Date: October 2022

Special Crash Investigations On-Site Ambulance Crash Investigation SCI Case No: CR22016 Vehicle: 2011 Ford F-450 Type I Ambulance Location: Kentucky Crash Date: October 2022

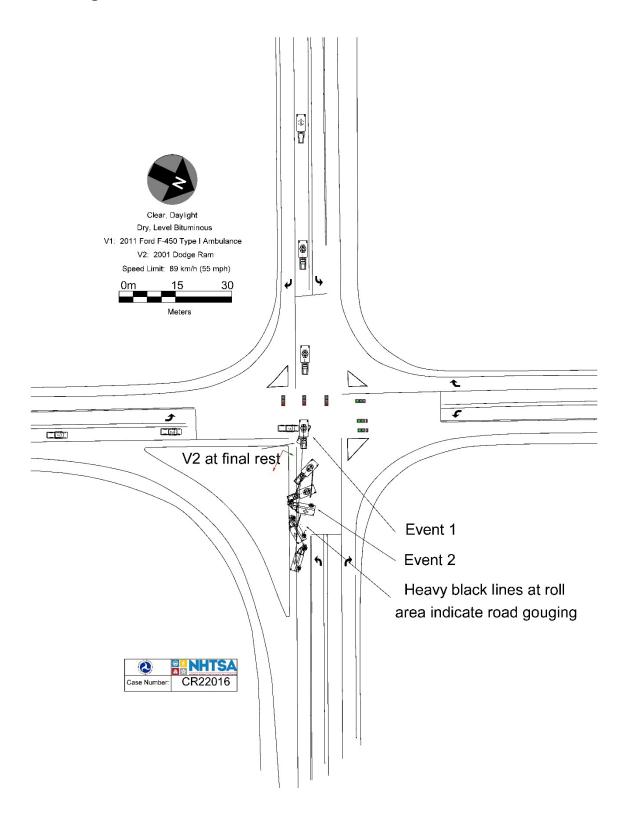
Crash Diagram

The Dodge's front plane struck the right side of the ambulance's patient compartment at the rear axle (Event 1). The impact induced the ambulance into a clockwise rotation where it tripped and rolled over one-quarter turn onto its left side (Event 2), coming to final rest approximately 34 m (112 ft) east of the impact point, facing west. The impact also induced the Dodge into a clockwise rotation of approximately 90°, based on media photography. It came to its final rest in the southeast corner of the intersection, facing east.

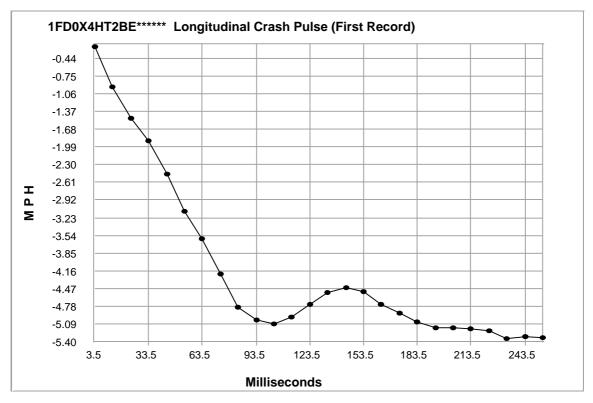
Longitudinal Crash Pulse (First Record)

Deployment Data (First Record): The maximum longitudinal and lateral delta Vs were reported as -9.01 km/h (-5.60 mph) and -5.11 km/h (-3.18 mph). These occurred at 300 msec and 60 after AE. Both side curtain air bags deployed and the seat belt pretensioners actuated at 1,269.5 msec after AE. The maximum roll angle was 112.51 degrees to the left consistent with one-quarter turn.
