DOT HS 813 684

**Special Crash Investigations:
On-Site Rollover Crash
Investigation;
Vehicle: 2021 Porsche Macan;
Location: California;
Crash Date: June 2022**

Special Crash Investigations
On-Site Rollover Crash Investigation
Case No. DS22018
Vehicle: 2021 Porsche Macan
Location: California
Crash Date: June 2022

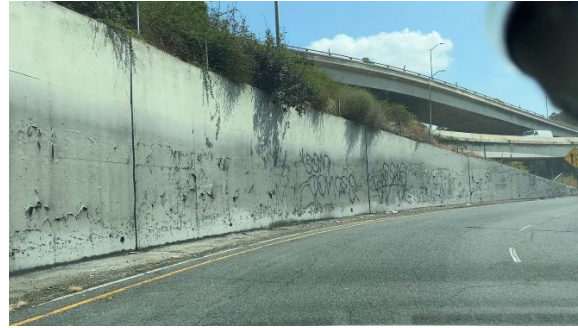
Figure 4. Ramp transition to southbound roadway, looking southeast

The Porsche was initially traveling westbound as it entered the on-ramp to transition to a southbound roadway (Figure 4) at a driver-reported speed of 80 km/h (50 mph) through the right curve. The driver said he did not see, hear, or feel anything that indicated activation of any avoidance features.

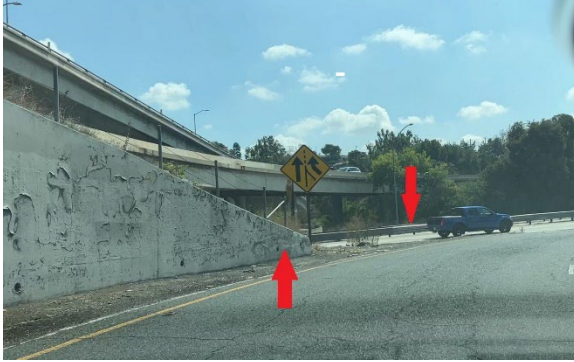
Figure 5. Event 1 (wall), Event 2 (guardrail, looking southeast)

As the Porsche continued in the curve, the driver lost control and the vehicle departed the roadway to the left. The driver said he was avoiding an object in the roadway, but the police report did not support this. The left plane of the vehicle struck the wall (Event 1) in a

sideswiping type collision (Figure 5). The Porsche crossed the gore between the two roadways and entered the southbound travel lanes. It appears to have been in a clockwise yaw crossing the travel lanes, striking the guardrail with its front plane (Event 2). The WinSMASH program calculated a barrier equivalent speed of 20 km/h (12 mph). The Porsche penetrated the guardrail and began a left-side-leading rollover (Event 3). It continued into the median area, rolling two-quarter turns and struck the back side of the northbound roadway guardrail with its right plane (Event 4), where it came to rest (Figure 6).

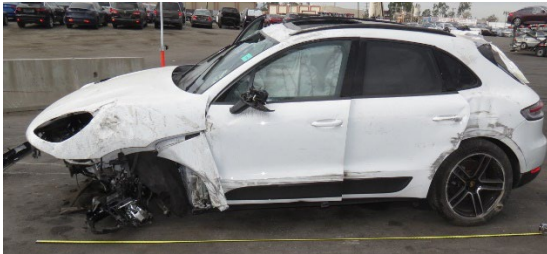
Figure 7. Left plane damage, 2021 Porsche

The Porsche had direct and induced damage to the front, left, right, and top planes. For Event 1 wall impact, direct damage to the Porsche's left plane began 50 cm (19.6 in) aft of the left rear axle and extended 396 cm (155.9 in) forward (Figure 7). The damage near the front left bumper corner was masked by the damage from the guardrail impact. The collision deformation classification (CDC) was 12LDES1.

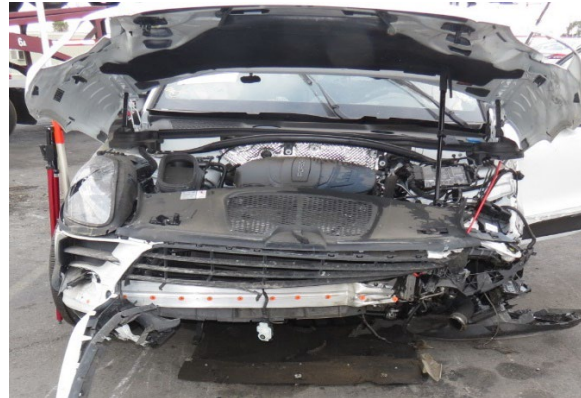
Figure 8. Front plane damage, 2021 Porsche Macan

For Event 2 guard rail impact, direct damage began at the front left bumper corner and extended to the front right bumper corner (Figure 8). Eleven measurements were taken at bumper level using the Nikon total station and the AutoCrush program calculated 6 crush measurements as follows: C1 = 15 cm (5.9 in), C2 = 14 cm (5.5 in), C3 = 12 cm (4.7 in), C4 = 8 cm (3.1 in), C5 = 3 cm (1.1 in), C6 = 1 cm (0.4 in). Maximum crush measured 15 cm (5.9 in) at C1 and the CDC for the Porsche in Event 2 was 11FDEW1.

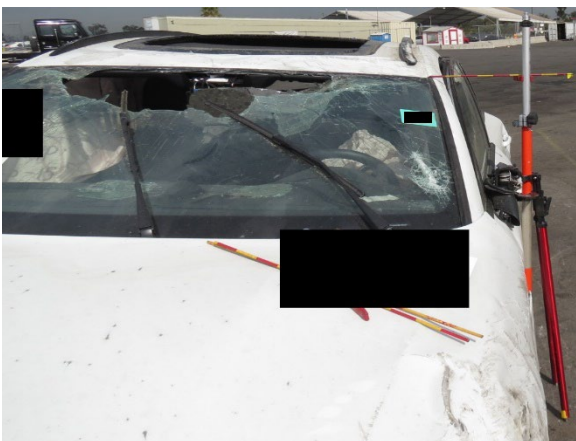
Figure 9. Roof crush, 2021 Porsche Macan

For Event 3 rollover, direct damage extended from the front of the hood to the mid-point of the roof and measured 249 cm (98.0 in). Direct damage extended from roof side rail to roof side rail and measured 110 cm (43.3 in) from side to side (Figure 9). The maximum vertical crush was located the top of the left A-pillar and measured 2 cm (0.8 in). The CDC for the rollover was 00TYDO2.

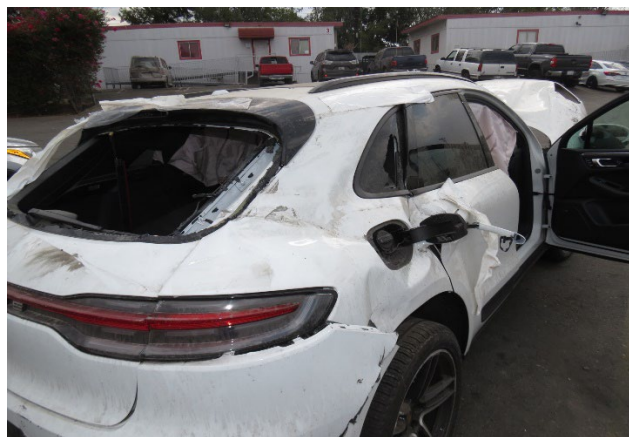
Figure 10. Right plane damage, 2021 Porsche

The Porsche was on its roof when it struck the second guardrail with its right plane during Event 4. The direct damage began aft of C-pillar and extended to the right front fender (Figure 10). The CDC for this impact was 00RDMW2.

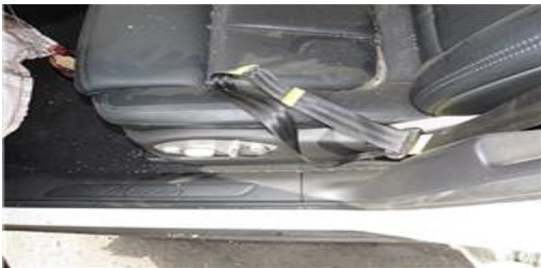
Figure 11. Driver's seat belt, 2021 Porsche

The Porsche had lap and shoulder seat belts for all seat positions. Based on evidence obtained during the vehicle inspection, the Porsche driver was belted. His seat belt webbing and buckle were scuffed when loaded by the driver during the crash (Figure 11). The belt retractor pretensioner actuated, locking the belt in the used, unspooled position (Figure 12).
