DOT HS 813 711

# **Special Crash Investigations: On-Site Rollover Crash Investigation; Vehicle: 2017 Nissan Altima; Location: California; Crash Date: August 2022**

**Special Crash Investigations**  
**On-Site Rollover Crash Investigation**  
**Case No. DS22019**  
**Vehicle: 2017 Nissan Altima**  
**Location: California**  
**Crash Date: August 2022**

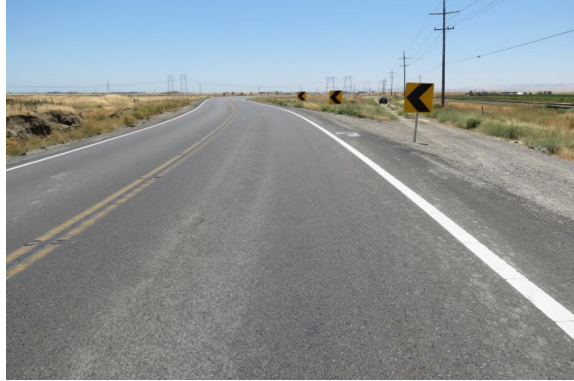
The crash occurred on an east/west, undivided, two-lane county road with a posted speed limit of 80 km/h (50 mph) and an advisory speed of 72 km/h (45 mph) at the crash site. The eastbound lane was initially straight and level before changing to an S-curve that began with a left curve and changed to a right curve. The roadway was paved with asphalt and the lanes were separated by a double solid yellow stripe with a milled-in rumble strip and raised yellow reflectors. The pavement was in a traveled, polished, and worn condition. The centerline paint was worn and faded with breaks in the paint, and around the curve many of the yellow reflectors were missing. Four rows of raised white ceramic Botts' dots had been placed across the eastbound lane to alert traffic of the curve ahead, but most of the dots were missing. The roadway was bordered on the left and right by solid white painted fog lines and gravel shoulders. The fog lines were bright and sharply defined and appeared newer than the centerline. The lanes measured 3.7 m (12.0 ft) to the fog lines and 5.0 m (16.0 ft) to the edge of pavement. The right shoulder had a slope measuring -17 percent. The roadside was uneven ground covered with grass. The Nissan's point of departure was in a left curve having a radius of 347 m (1,138 ft).<sup>1</sup> The superelevation at this location was level. Five traffic warning signs were posted on the right shoulder parallel with the curve (Figure 2). Each sign had a black chevron pointing left on a yellow background. They had a prismatic finish and stood approximately 1.9 m (6 ft) in height. The signposts were break-away type square steel tubing. The signs were spaced 14.3 m (46.9 ft) apart and were 1.0 m (3.0 ft) right of the pavement edge. Conditions were dark in an area without streetlights, clear, and dry. A crash diagram is included at the end of this report.

*Figure 2. Crash site, looking east to area of roadway departure and showing chevron sign*

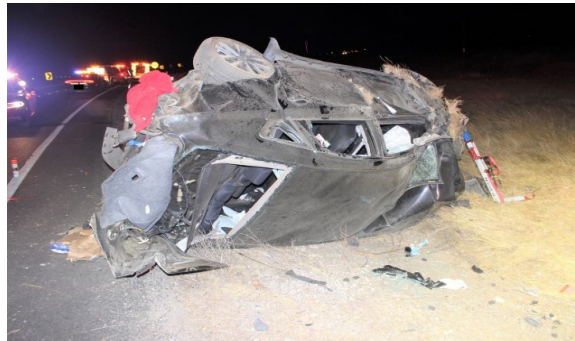
trip rollover (Event 3 – EDR Event Record 2). The EDR roll angle data reported negative values (right to left rotation) beginning with  $-10^{\circ}$  at 0.2 seconds and ending with  $-560^{\circ}$  at 5.0 seconds. This event triggered the deployment of the driver's outboard seat-mounted side-impact air bag and the left IC air bag. Vehicle damage suggests the left, top, right, back planes, and possibly the front plane, contacted the ground during the rollover. The Nissan rolled an estimated seven quarter turns and came to rest on its right plane, facing south on the roadside (Figure 3). The estimated roll distance was 57 m (187 ft).

*Figure 3. 2017 Nissan Altima at rest  
looking east (police photo)*

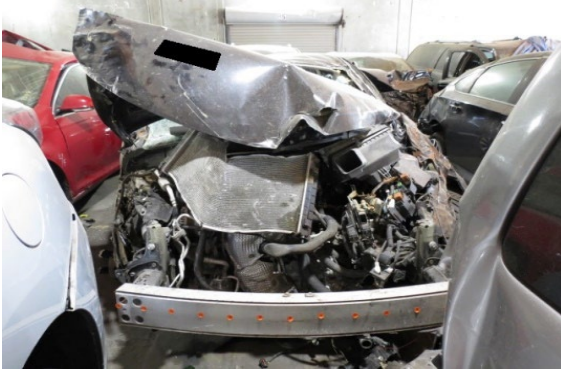
Events 1 and 2 were frontal impacts to breakaway steel signposts that likely caused overlapping damage. Additional front-end contact with the ground was likely during a subsequent event. The headlamp assemblies, grille, and front trim components were missing; the radiator was detached. The front bumper fascia and the energy absorbing device were detached from the vehicle during the rollover and were not present at the vehicle inspection. The front bumper reinforcement bar was used to measure crush damage to the front plane. Thirteen measurements were taken at bumper level using the Nikon total station and the AutoCrush program calculated six crush measurements as follows.  $C_1 = 7$  cm (2.8 in),  $C_2 = 6$  cm (2.4 in),  $C_3 = 5$  cm (2.0 in),  $C_4 = 6$  cm (2.4 in),  $C_5 = 9$  cm (3.5 in), and  $C_6 = 12$  cm (4.7 in). Maximum crush measured 12 cm (4.7 in) and was located 64 cm (25.2 in) right of center and the collision deformation classification (CDC) for Event 1 was 12FLEN1 (Figure 4). The CDC for Event 2 was 12F9EN99.

*Figure 4. Front plane damage, 2017 Nissan Altima*

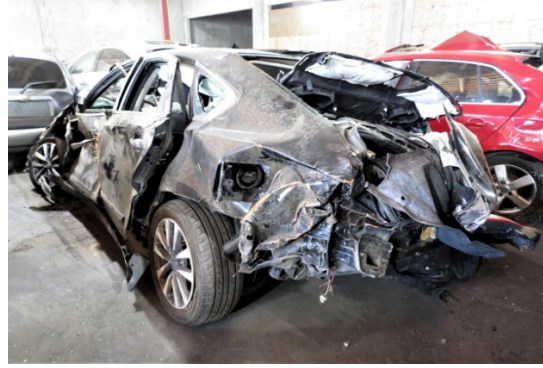
Event 3 was a rollover that caused direct and induced damage to the left, top, right, and back planes (Figures 5 and 6). The left front and right rear tires were de-beaded, and the right front wheel was fractured and missing. Police indicated the right front tire had separated from the rim during the rollover. All four doors were jammed shut. The hood was crushed and buckled; the trunk lid was crushed and displaced from its hinges. The left and right planes had direct damage distributed from bumper corner to bumper corner and from sill to roof side rail. Both side view mirrors were fractured and missing. The greenhouse exhibited damage to all sides. Direct damage to the roof extended laterally from roof side rail to roof side rail, and longitudinally from windshield header to backlight header. Maximum lateral greenhouse crush was located at the top of the left C-pillar and measured 10 cm (3.9 in). Maximum vertical greenhouse crush was located on the upper aspect of the left A-pillar and measured 8 cm (3.1 in). The CDC for Event 3 was 00LDAO3.

*Figure 5. Left and back plane damage, 2017 Nissan Altima*

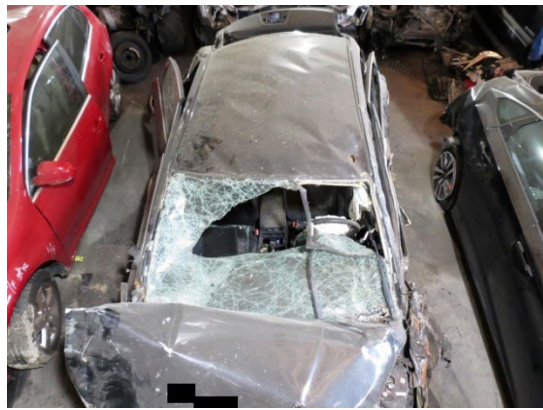
*Figure 6. Top plane damage, 2017 Nissan Altima*

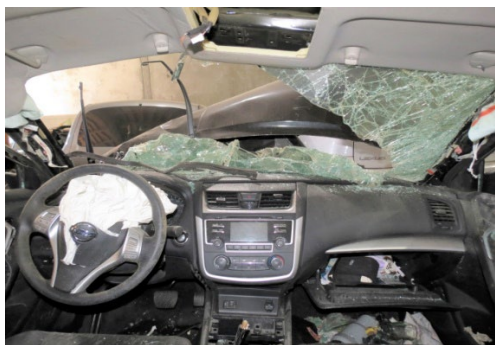
The Nissan had interior damage caused by impact forces, integrity loss, air bag deployments and occupant contacts (Figure 7). The windshield was fractured and holed, and the backlight and side glass were disintegrated; only the second-row right-side glass was intact. All four doors were jammed shut. Four of six available air bags were deployed, and the front-row seat belt pretensioners were actuated. The seat belt was scuffed and stretched, the center console was deformed, the gear shift lever was fractured, the driver's seat back was bent to the right, the front passenger seat head restraint was bent forward, and the roof header was gouged and scuffed. The front-row space was reduced by lateral intrusion of the forward upper quadrant of the left door panel (5 cm [2.0 in]) and the left A-pillar (7 cm [2.8 in]). It was reduced by vertical intrusion of the left windshield header (11 cm [4.3 in]) and left roof (4 cm [1.6 in]). The second-row space was reduced by vertical intrusion of the right backlight header (10 cm [3.9 in]).

*Figure 7. Front row damage, 2017 Nissan Altima*

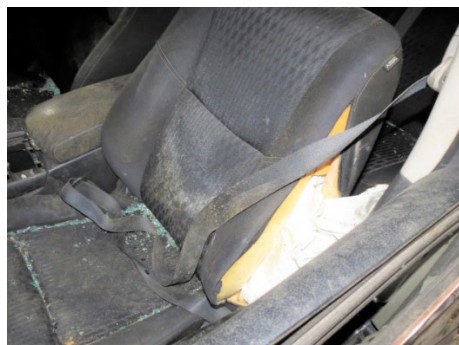
The Nissan had continuous loop lap and shoulder seat belts with sliding latch plates for all seat positions. Emergency responders found the driver's pretensioned seat belt extended and buckled (Figure 8). The SCI investigation found evidence of occupant loading on the belt and latch plate. The plastic trim on the latch plate was scuffed, and the belt was stretched at the D-ring and scuffed at 60 cm (23.6 in) above the stop button where it engaged the latch plate. The EDR reported the driver's belt as "On (fastened)." The evidence suggests the driver was using the lap and shoulder belt but their positions prior to the crash were unknown. How the driver was displaced from his belted position was undetermined. The driver's domestic partner who was interviewed stated the driver typically wore his seat belt in a proper manner. The PCR reported the driver's belt usage as unknown.

*Figure 8. Driver's seat belt, 2017 Nissan Altima*

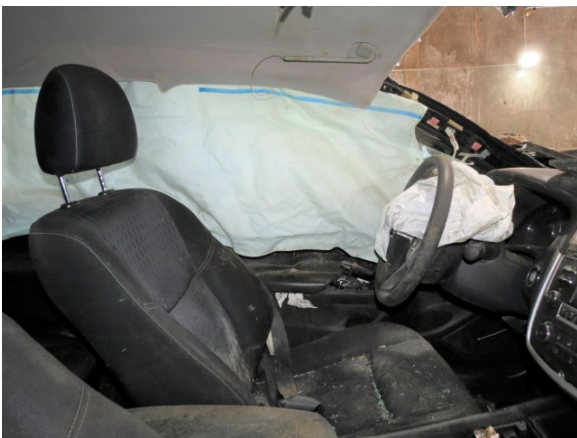
The Nissan had driver's and passenger's frontal air bags, front row outboard seat-mounted side-impact air bags, combination side-impact/roll-sensing IC air bags for both rows (Figures 9 and 10), and front row seat belt retractor pretensioners. Per the EDR report, the driver's frontal air bag, the right IC air bag, and both pretensioners deployed during Event Record 1. The driver's outboard seat-mounted side air bag and the left IC air bag deployed during Event Record 2 (rollover event). Both IC air bags deployed at 250 ms after AE, but during separate events. All deployed air bags appeared to have deployed normally and none appeared damaged. During his movement within the vehicle and while being ejected, it appears likely the driver contacted one or more air bags, but no physical evidence of loading or contact was visually present. The driver was fully ejected and came to rest on the ground, partially underneath the vehicle. The evidence, including occupant contacts to the roof and a disintegrated backlight, suggests he was ejected through the backlight.

*Figure 9. Left IC air bag, 2017 Nissan Altima*

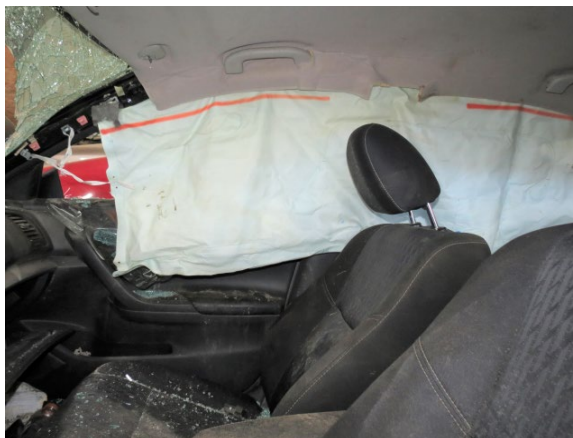
*Figure 10. Right IC air bag, 2017 Nissan Altima*

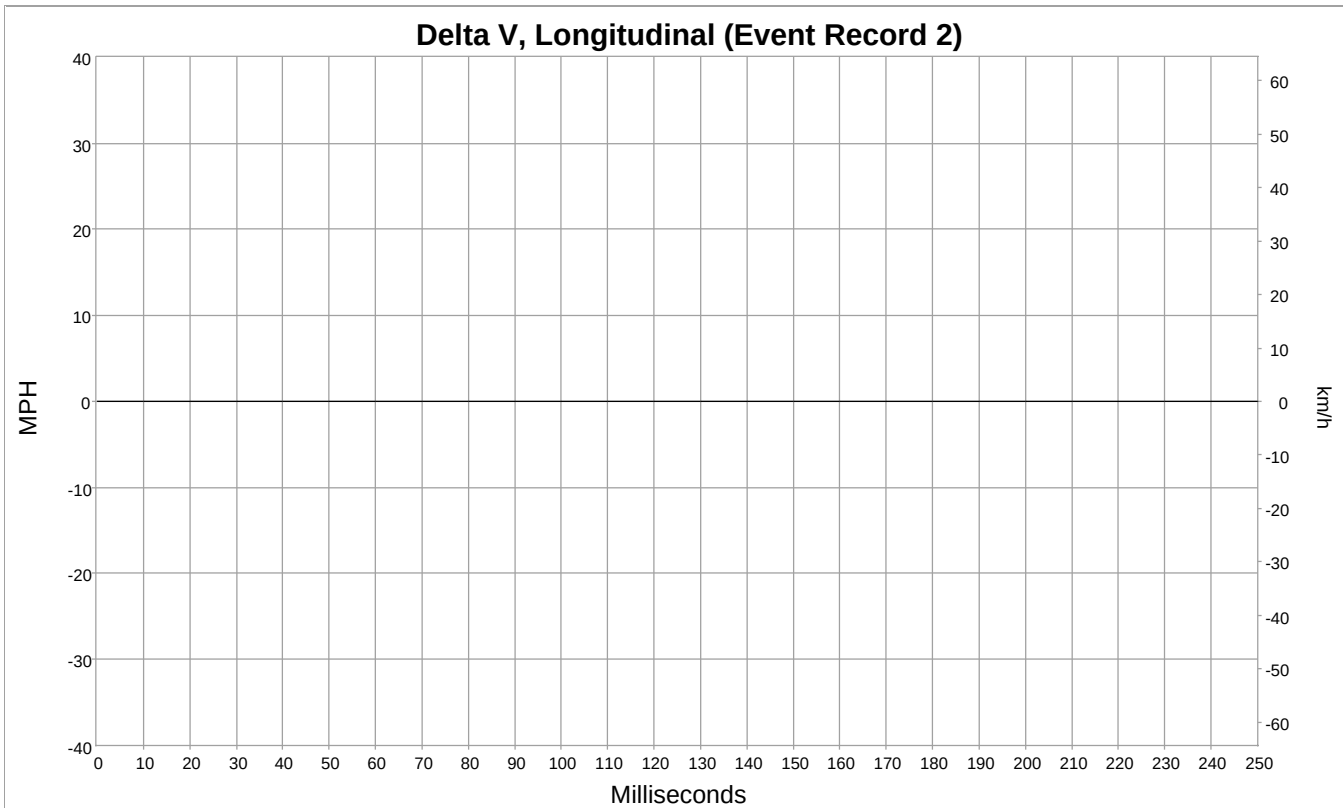
**Longitudinal Delta V (Event Record 2)**

Event 3 caused damage to multiple planes. EDR Event Record 2 reported a maximum longitudinal delta V of 0 km/h and maximum lateral delta V of 0 km/h. The delta V values for this event appear to be invalid and the cause is undetermined.
