U.S. Department
of Transportation

**National Highway
Traffic Safety
Administration**

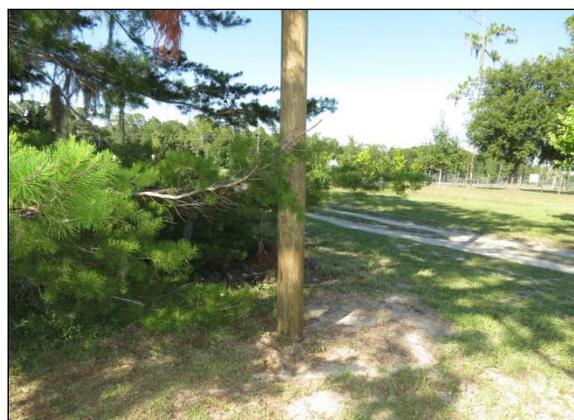
Figure 5: Northeast-facing view of the wooden utility pole (replaced) and driveway of the private residence.

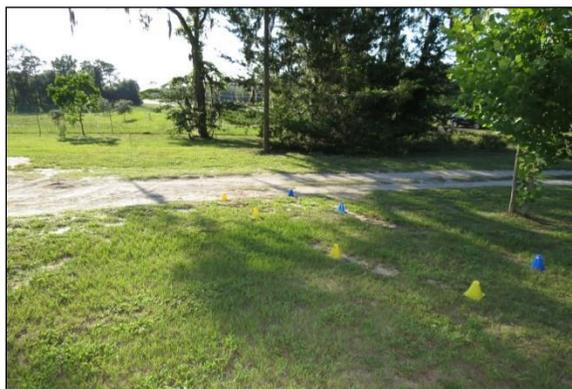
Figure 6: West-facing view of the Tesla's yawing tire marks through the lawn of the residence and the location of the impacted utility pole (replaced). The intersection is visible in the distance in the upper left corner.

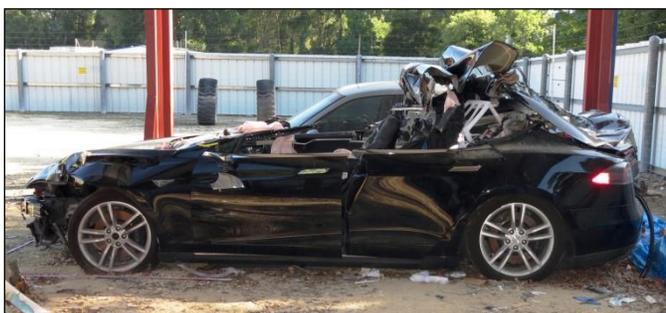
Figure 7: Left plane view of the 2015 Tesla Model S 70D sedan.

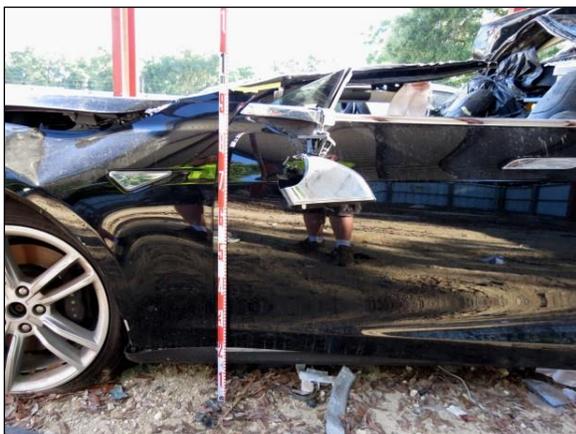
Figure 8: Height of the damage pattern as viewed from the left plane Tesla.

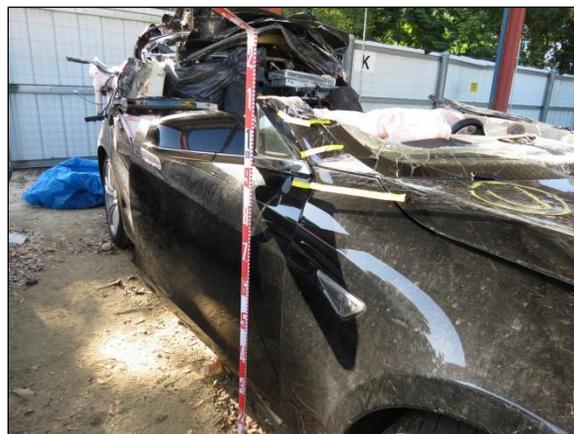
Figure 9: Height of the damage patterns to the Tesla's right A-pillar.

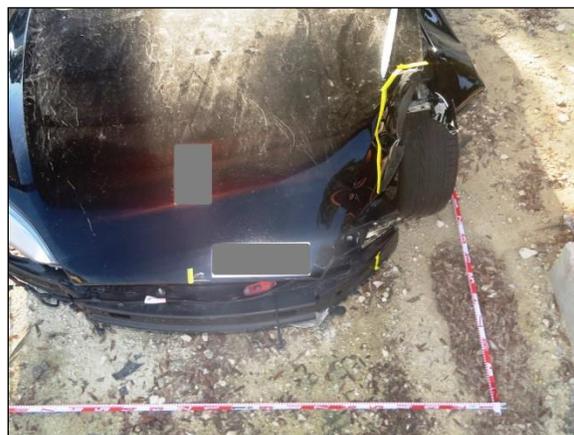
Figure 10: Overhead view of the Event 4 damage profile to the Tesla.

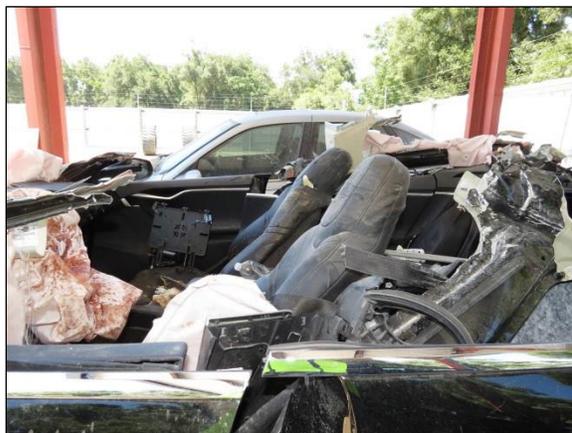
Figure 11: View of the Tesla and the sheared greenhouse, with rearward deformation to both front seats.

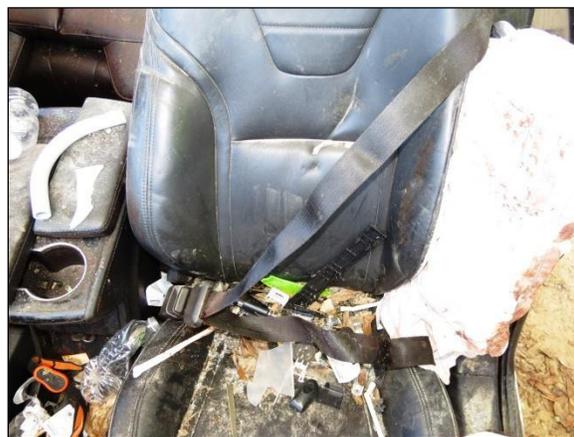
Figure 12: The Tesla driver's 3-point lap and shoulder safety belt system.

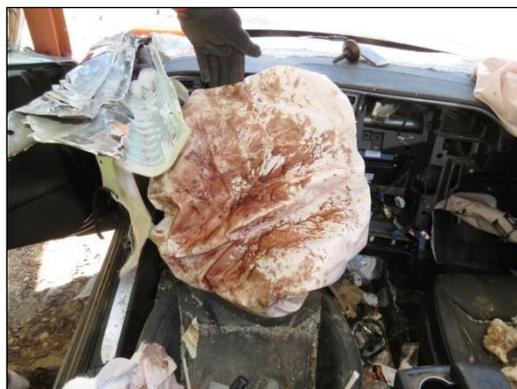
Figure 13: Deployed driver's frontal air bag covered in blood evidence within the Tesla.

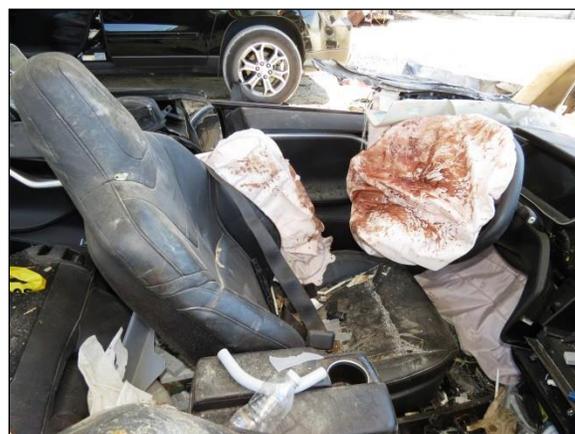
Figure 15: Deployed driver's seat-mounted side impact, frontal, and knee air bags within the Tesla.

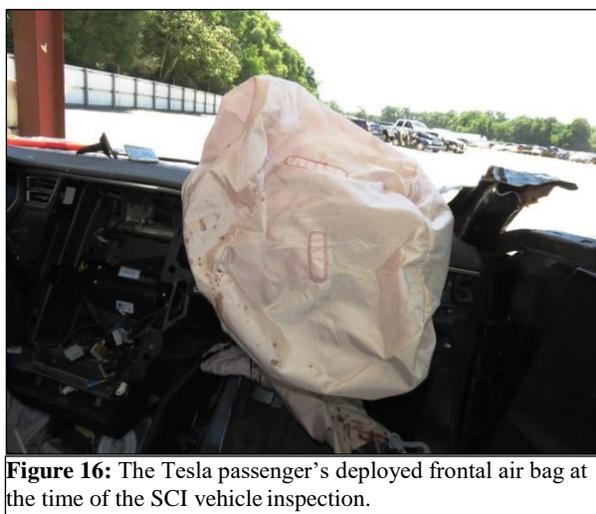
Figure 16: The Tesla passenger's deployed frontal air bag at the time of the SCI vehicle inspection.

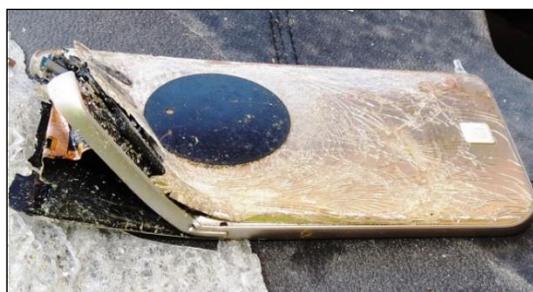
Figure 18: View of the backside of the cellular telephone and the deformed top left corner.

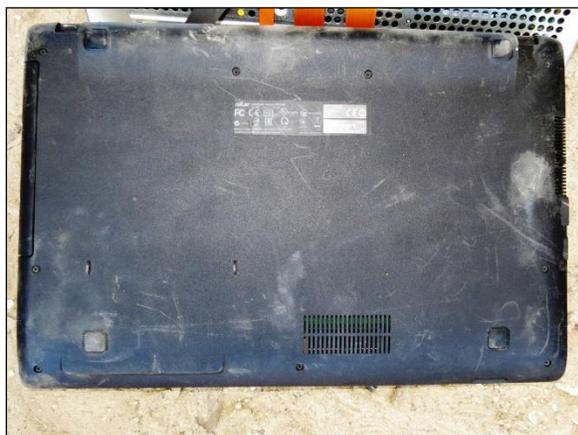
Figure 19: The Asus X551MAV-EB01-B(S) personal laptop computer found within the Tesla.

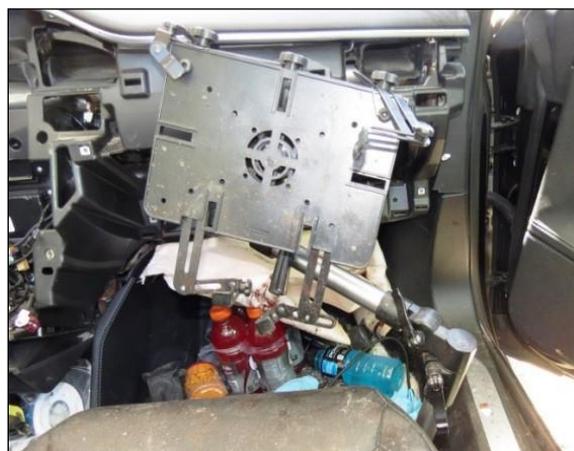
Figure 20: The Mobotron MS-526 stand/holder installed within the Tesla.

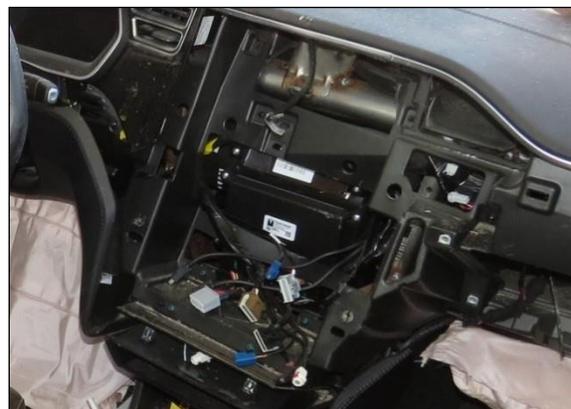
Figure 21: View of the Tesla's center instrument panel at the time of the SCI inspection.

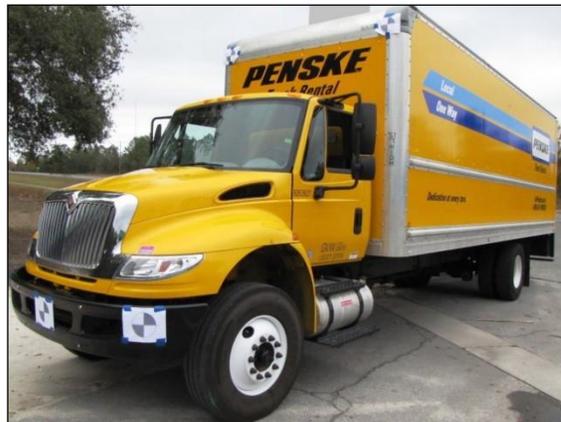
Figure 23: Front left oblique view of the 2015 International 4300 single-unit straight truck.

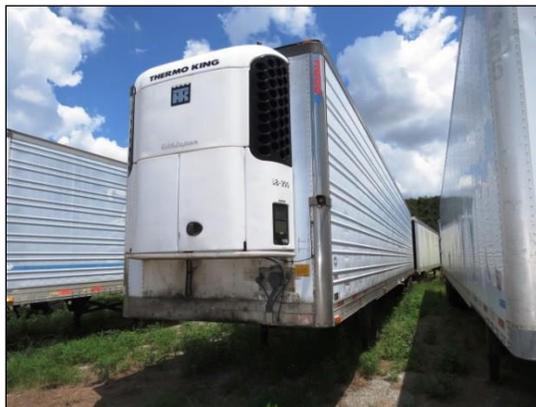
Figure 26: Left front oblique view of the 2003 Utility Trailers Incorporated refrigerated semi-trailer.

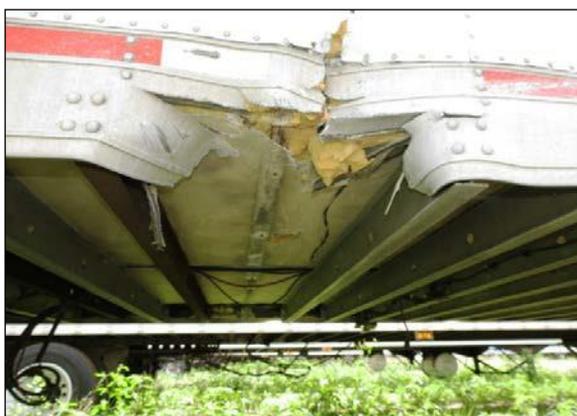
Figure 28: Undercarriage damage to UTI semi-trailer and missing I-beam from engagement with the Tesla.

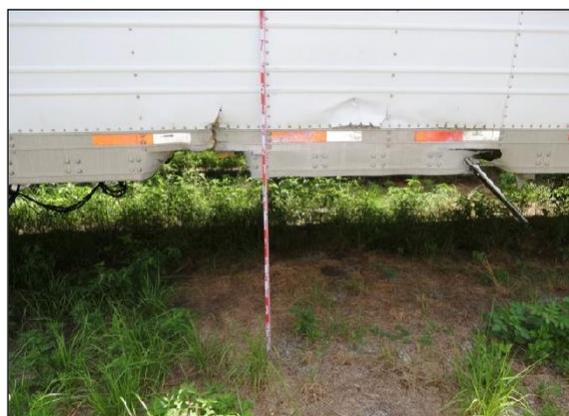
Figure 27: Damage to the right plane of the UTI semi-trailer from impact by the Tesla.
