DOT HS 812 532

**Special Crash  
Investigation:  
Remote Non-Traffic  
Surveillance Hyperthermia  
Investigation  
Vehicle: 2006 Volkswagen  
Passat  
Location: Ohio  
Incident: July 2016**

**INDIANA UNIVERSITY**  
**TRANSPORTATION RESEARCH CENTER REMOTE NON-TRAFFIC**  
**SURVEILLANCE HYPERTHERMIA INVESTIGATION**  
CASE NUMBER - IN16028    LOCATION - OHIO  
VEHICLE - 2006 VOLKSWAGEN PASSAT    INCIDENT DATE - July 2016

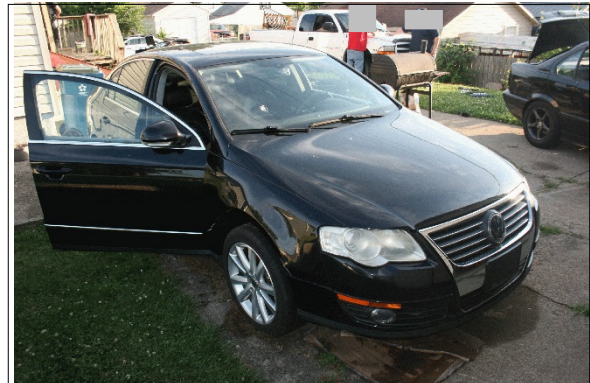
**Figure 1:**Police photo of the 2006 Volkswagen Passat at the incident scene, view northeast

This incident occurred in a suburban, residential neighborhood in the driveway of a single-family residence. The Volkswagen was inoperative, unlocked, with the windows closed, and parked in the driveway near the back door of the residence. An unknown year and model BMW was also parked in the driveway near the Volkswagen. The victim and his extended family gathered at the residence between 1220 and 1500 hours. During the course of the afternoon it was reported that there was much activity at the residence including errands being run by the victim's father regarding reported maintenance for the BMW and the father's brother and stepbrother performing maintenance on their vehicles. The victim, his brother, and cousin were initially supervised in the residence by the victim's grandmother. Supervision of the children later passed to the victim's father and the father's stepbrother, then back to the grandmother. At some point after approximately 1700 hours but prior to approximately 1840 hours the victim exited the residence, probably through the back door, and entered the Volkswagen through the right front door and could not exit the vehicle. At approximately 1840 hours it was discovered that the victim was missing and a search for him ensued. A 9-1-1 call was placed at 1901 hours. Shortly after arrival of emergency responders (arrival time unknown) a relative found the victim on the right front floorboard of the Volkswagen. The victim was transported by ambulance to a hospital and subsequently transferred to a children's hospital where life support was eventually ceased and he was pronounced deceased two days following the incident.

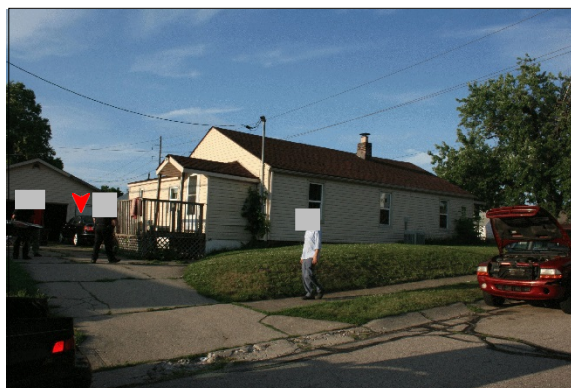
driveway was located at the back of the residence. An inoperative Volkswagen was located an estimated 8 m (26 ft) due north of the west-facing back entrance to the house. An unknown year and model BMW was also parked in the driveway located approximately 3 m (10 ft) west of the Volkswagen and an unknown year Dodge Durango was parked at the curb near the driveway. The BMW and Dodge were related to the incident since activities related to maintenance on the vehicles was taking place during the time that the incident occurred. The BMW and Volkswagen were parked in front of a two-car garage. No shade trees were located near the Volkswagen; however, shade from the garage fell on the vehicle in the later afternoon hours. The Incident Diagram is included at the end of this report. The Non-Traffic Surveillance data forms are attached to the end of this report as Attachment A.

**Figure 2:** Police photo showing residence and location of Volkswagen (arrow), view northeast

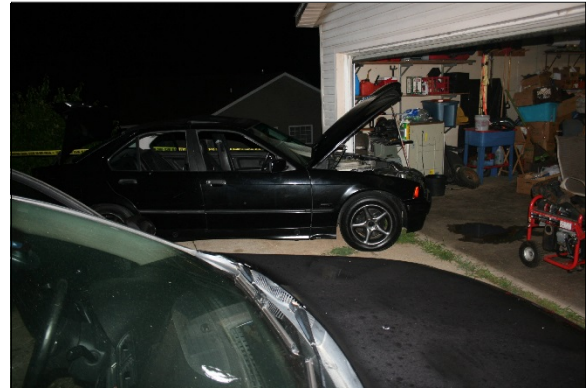
**Figure 3:** Police photo showing the BMW (background), photo from right side of Volkswagen, view west

shop he parked the BMW next to the Volkswagen. The father probably spent some time working on the vehicle since the hood was shown to be up in the police on-scene photographs (**Figure 3**). The father and stepbrother were also seen by the grandmother working on the Dodge that was parked at the curb near the driveway. It was during this time period (after 1700 hours but before 1840 hours) that the victim exited the residence unseen by the grandmother and entered the Volkswagen. At approximately 1840 hours the grandmother discovered that the victim was missing and a search for the child ensued. A 9-1-1 call was placed at 1901 hours.

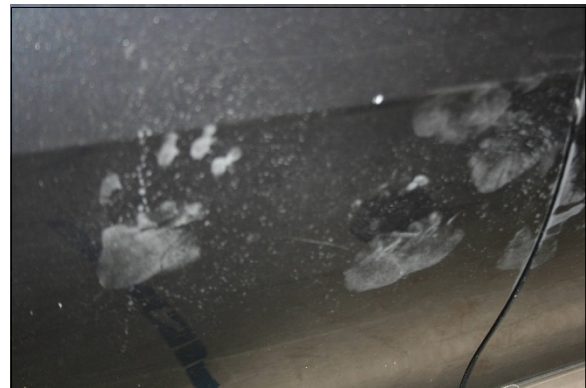
**Figure 4:** Police photo showing child hand prints on right rear door leading to right front door handle

Once the victim exited the residence, he would have to traverse a short distance across the porch, then down three steps to a deck and then one step off the deck to reach the driveway. The Volkswagen was located an estimated 8 m (26 ft) straight north of the west-facing back door of the residence. The police photographs of the Volkswagen documented child size hand prints on the exterior surface of the vehicle's right rear and right front door near the right front door handle (**Figures 4 and 5**) indicating that the victim entered the vehicle through the right front door. Child-size hand prints and fingerprints on the interior of the right front door and a smear of body oil, possibly from the victim's forehead, on the right front glazing indicated the victim probably attempted to exit the vehicle or summon help. A pair of children's sandals were found on the front left floor indicating the victim had likely gone to the

driver's side as well. There were also some perspiration marks on the driver's door and a smear of possible body oil was on the driver's door window. The status of the rear door child safety locks was not addressed in the police incident report. The evidence suggested that the victim never entered the second row.

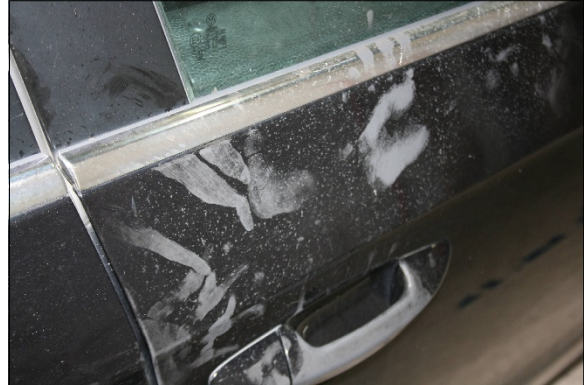
**Figure 5:** Police photo showing hand and finger prints near right front door handle and hand print on door handle
