DOT HS 812 534

**Special Crash Investigations  
Non-Traffic Surveillance  
Remote Hyperthermia Fatality  
Investigation  
Vehicle: 2003 Mitsubishi  
Galant  
Location: South Carolina  
Incident Date: July 2014**

**NON-TRAFFIC SURVEILLANCE  
SPECIAL CRASH INVESTIGATIONS  
CASE NO. CR16036  
REMOTE HYPERTHERMIA FATALITY INVESTIGATION  
VEHICLE: 2003 MITSUBISHI GALANT  
LOCATION: SOUTH CAROLINA  
INCIDENT DATE: JULY 2014**

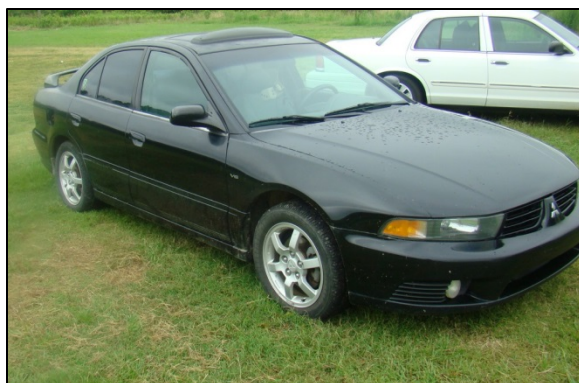
The interest in this remote investigation involve the circumstances surrounding the hyperthermia-related fatality of a 3-year-old male who was found inside a 2003 Mitsubishi Galant (**Figure 1**) that was parked on the lawn area of his home.

**Figure 1: Image of the 2003 Mitsubishi Galant on the lawn area of the incident. (Image obtained from the investigating police department.)**

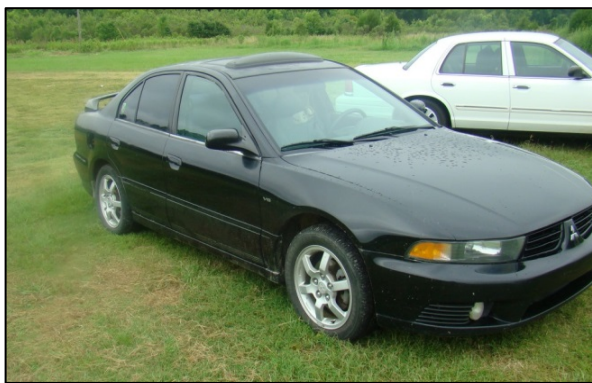
**Figure 3: Front right exterior view of the 2003 Mitsubishi Galant. (Image obtained from the investigating police department.)**

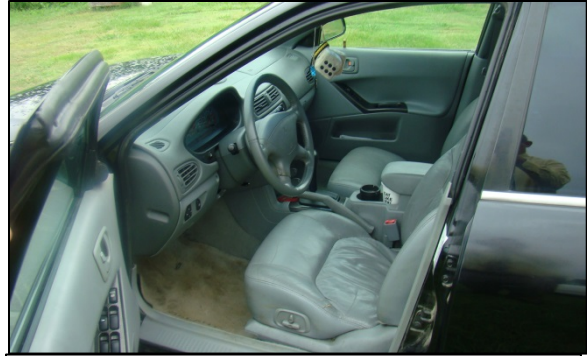
**Figure 4: Front row interior of the 2003 Mitsubishi Galant. (Image provided by the investigating police department.)**

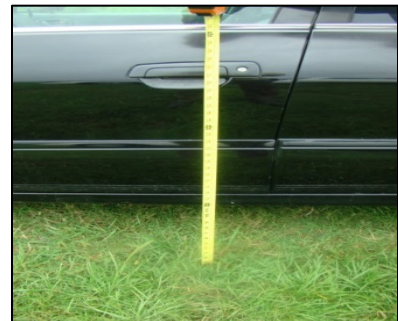
The four exterior door handles on the Mitsubishi were hinged at the top edge and rotated in an upward direction to release the door latch (**Figure 5**). The bottom edge of the driver's door latch was measured by the investigating officer at 78 cm (30.75 in) above the ground. The SCI team documented an exemplar Mitsubishi Galant and recorded the same measurement for the front handles. Fully rotated (lifted), the front door latches measured 81 cm (31.75 in) above the ground. The rear door handles on the exemplar vehicle measured 82 cm (32.25 in) and 85 cm (33.5 in) respectively. Keyed lock cylinders were incorporated into both front door handle assemblies.

**Figure 5: Exterior driver's door handle of the Mitsubishi. (Image provided by the investigating police department.)**

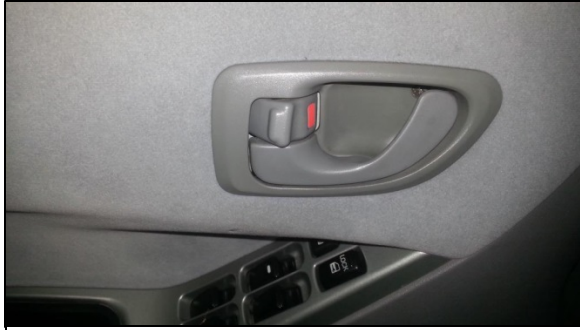
The interior door release levers on the Mitsubishi were located in the upper-forward aspect of the door panels and consisted of an L-shaped lever requiring a horizontal pull to open the doors. The levers were 10 cm (3.75 in) in length, inclusive of the hinge point. The levers were flush-mounted to the door panel. **Figures 6 and 7** are exemplar views of the interior door release levers.

**Figure 6:** View of the exemplar driver's door interior release lever.

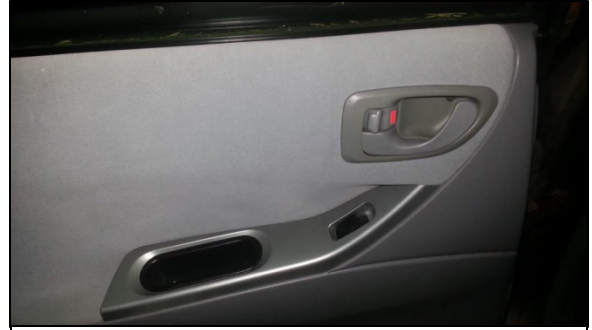
**Figure 7:** View of the exemplar second row left door interior release lever.

With the doors locked either by key fob, utilizing the interior power locking switches, or manually locking all four doors independently, the front door release levers would override the lock for the specific door. The rear door locks would not unlock when the release lever was pulled. The rotating locking knob had to be manually rotated rearward to unlock the specific second row door.

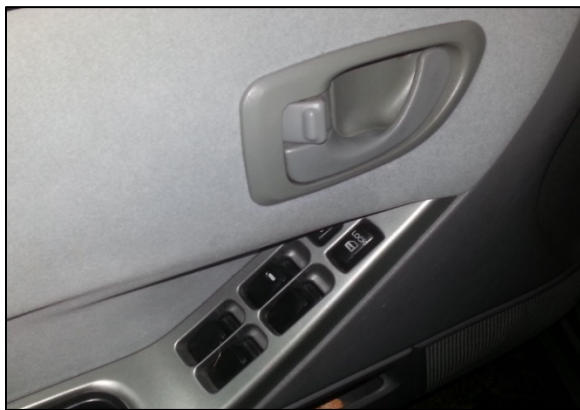
The interior-mounted power locking system consisted of rocker-type switches that were mounted on the up-sloped forward edge of the integrated armrest on both front door panels. The leading edge (forward) of the switch provided the locking function while the aft edge was the unlock mode. The rear doors were not equipped with power lock switches. **Figures 8 and 9** are exemplar views of the front row power locking rocker switches.

**Figure 8:** View of the exemplar driver's power locking switch.

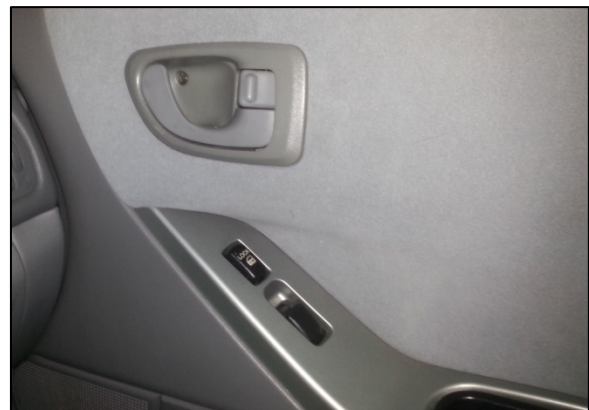
**Figure 9:** View of the exemplar front row right power locking rocker switch.

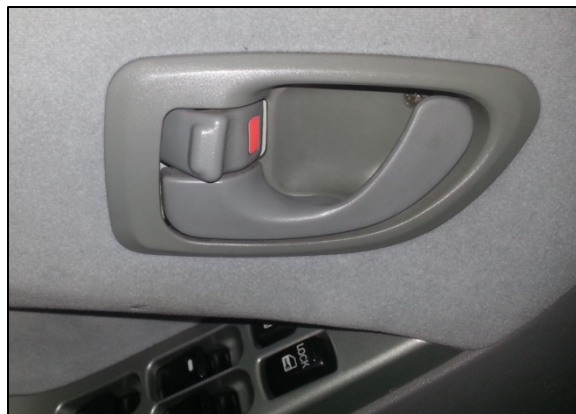
The interior manual locking system consisted of rotating lock knob located directly above the interior door release lever (**Figure 10**) at each door. The color coordinated lock knobs matched the release levers. The leading edges of the knobs were marked with a high visibility orange stripe, visible only in the unlocked position. With the rotating knob pushed forward and flush with the release lever, the door would lock. Rotating the knob rearward unlocked the doors.

**Figure 10: Exemplar interior manual locking knob in unlocked position.**
