U.S. Department
of Transportation
**National Highway
Traffic Safety
Administration**

DOT HS 812 553

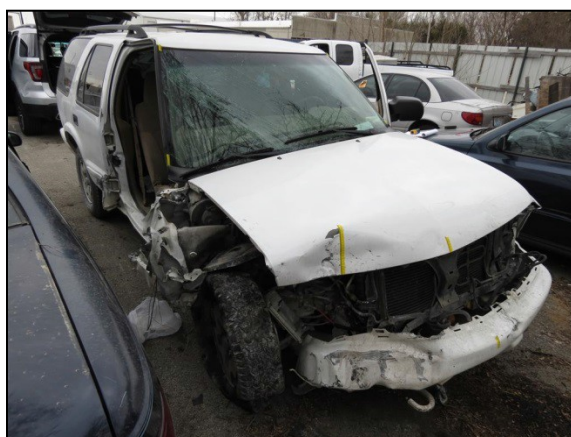
Figure 1: Front right oblique view of the Chevrolet Blazer depicting the vehicle deformation.

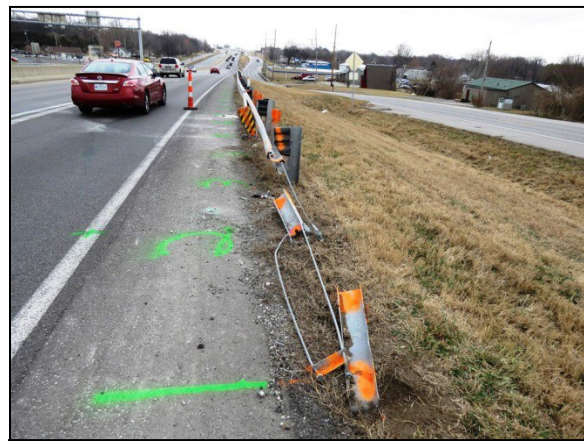
Figure 4: East-looking image depicting the crash site and the X-Lite guardrail end terminal damage.

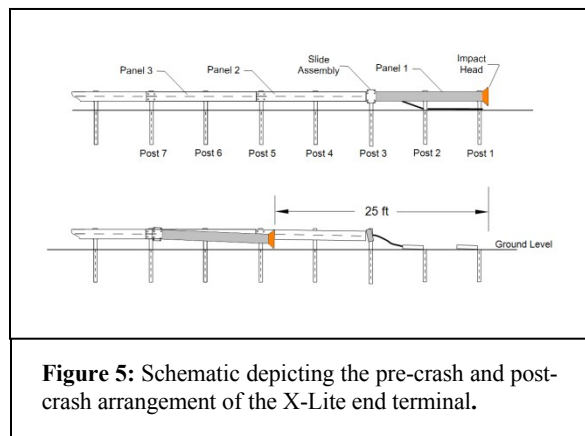
The impact-face measured 33 x 61 cm (13 x 24 in), width x height, and was attached to the leading edge of the W-beam. W-beam Panel-1 spanned Posts 1 through 3 and was bolted to slots in Post-1 and -2. No block-outs were required at Post-1 and -2. A slider assembly that was attached to the end of Panel-1 was bolted to Post-3 through a block-out and a slotted connection in the slider. The slots allowed the panel to separate from the posts during an impact and the panel telescoped down the guardrail via the slider assembly. Tensioned ground struts connected Post-1 and -2 with a tensioned cable between Post-2 and -3. Post-1 was weakened by slots cut into the flanges of the I-beam. The impact force fractured the beam 5 cm (2 in) below ground level through the weakened section. Post-2 also fractured at ground level during the impact.

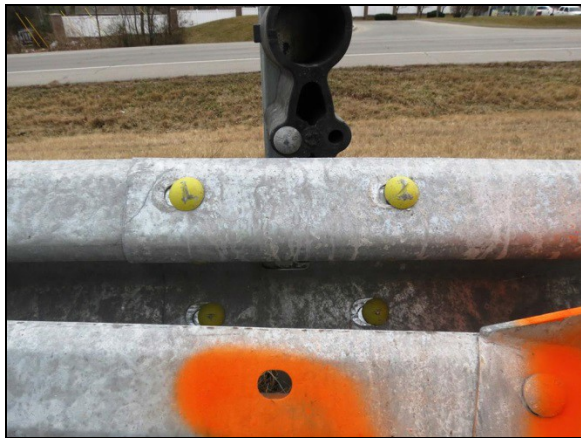
Figure 6: South-looking image of the displaced Panel-1 at Post-5 and the shear bolt connection between Panel 2 and 3.

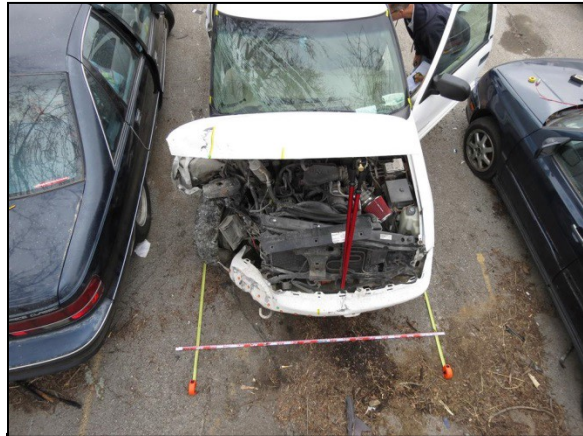
Figure 8: Overhead view of the Chevrolet depicting the frontal damage.

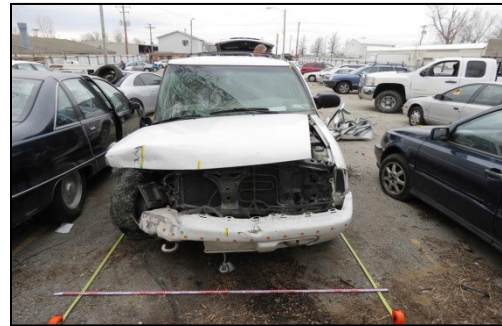
Figure 9: Front image of the Chevrolet depicting the deformation.

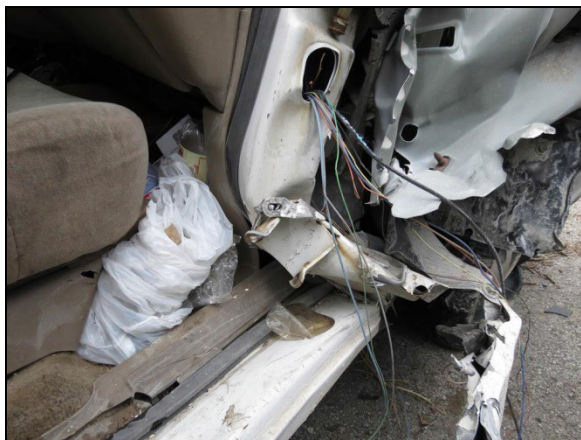
Figure 10: Right view depicting the deformation at the Chevrolet's right hinge pillar

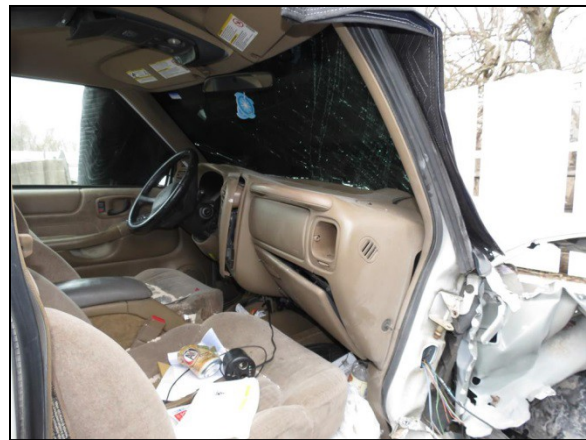
Figure 12: Right interior view of the Chevrolet.
