**Special Crash Investigations
On-Site Guardrail End
Treatment Impact
Investigation
Vehicle: 2008 Mercury
Mariner
Location: Pennsylvania
Crash Date: November 2016**

CASE NO.: CR16028

ON-SITE GUARDRAIL END TREATMENT IMPACT INVESTIGATION

VEHICLE: 2008 MERCURY MARINER

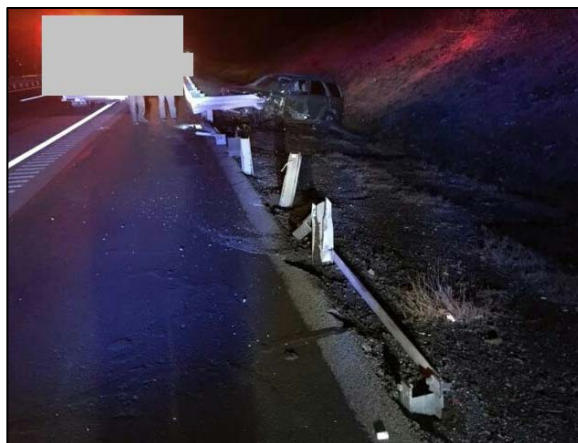
Figure 1: On-scene image of the Mercury and crash site. Image supplied by the PTC.

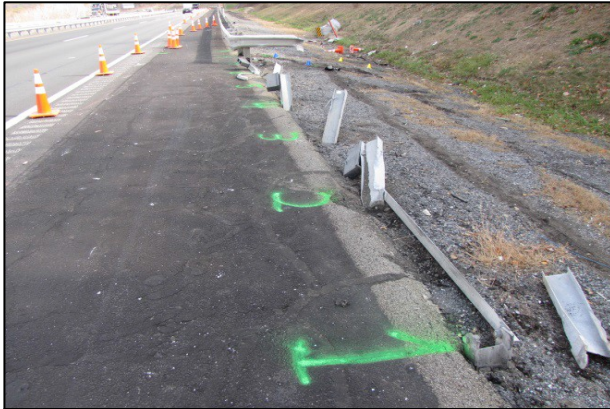
The front right corner of the Mercury impacted the end terminal located at Post 1 (Event 1, **Figure 4**) and began to displace it to the east. The frontal air bags within the Mercury deployed. The force of the impact accelerated the end terminal along the guardrail, and 3.7 m (12.0 ft) of W-beam was extruded from the impact head. The right bias of the crash force caused the Mercury to initiate a clockwise rotation. As the displaced end terminal detached the W-beam from Post 3, the end terminal separated from its contact with the Mercury and the vehicle's front plane began to engage the face of the guardrail between Post 3 and 4. This separated the bumper fascia from the vehicle.

Figure 4: East-looking image depicting the point of impact.

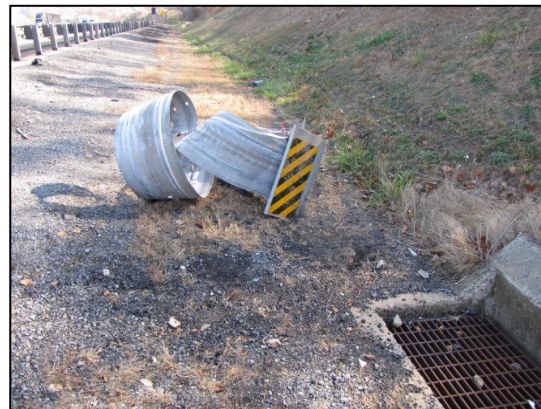
Figure 5: East-looking image depicting the final rest position of the displaced end terminal and extruded rail.

The Mercury continued along its errant trajectory and began to deflect the guardrail system toward the field side. A kink formed at Post 4 as the combined mass of the end terminal and extruded rail was accelerated to the southeast (thrown forward ahead of the vehicle). The W-beam deformed into a U-pattern and sheared as it separated from Post 4. The combined mass of the end terminal and extruded rail were displaced onto the road side 29.8 m (97.8 ft) from Post 1, in the vicinity of Post 16 (**Figure 5**). This section of damaged guardrail measured 5.9 m (19.5 ft) in length.

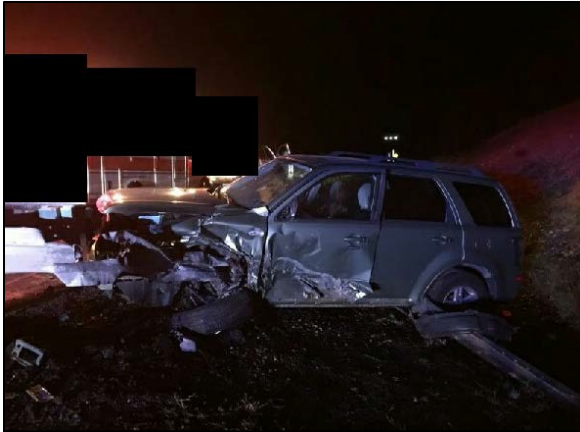
The vehicle progressed beyond the plane of the guardrail system into the roadside, but the exposed W-beam remained penetrated into the vehicle. This bent the W-beam around Post 7 as the vehicle came to rest. At final rest, the Mercury (**Figure 6**) was facing the northwest, 13.6 m (44.6 ft) from Post 1 of the end treatment. **Figure 7** is an image of the vehicle's final rest position (represented by the small yellow and blue evidence marking cones) taken during the SCI site inspection.

Figure 6: On-scene east-facing image of the Mercury at final rest. Image supplied by PTC.

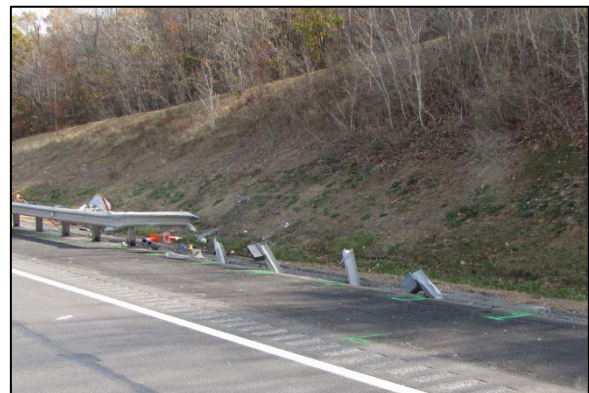
Inspection of the installation determined that the crash resulted in an approximate overall damage length of 13.4 m (44.0 ft) which extended to the area of Post 8. **Figure 9** provides an overall oblique view of the damaged guardrail system. The HBA-Post 1 separated from its foundation on impact. The post was displaced to the southeast coming to rest within the swale adjacent to Post 11. SYT-Post 2 was deformed 70 degrees to the east, bending at ground level. The I-beam was partially torn through the weakening holes on its field side. A block-out was used with the carriage bolt at this post to support the W-beam. SYT Posts 3 to 6 were deformed approximately 50 to 80 degrees in the vehicle's direction of travel, bending at ground level. Composite block-outs and carriage bolts were used at each post.

Figure 9: Oblique view of the crash site looking to the southeast.

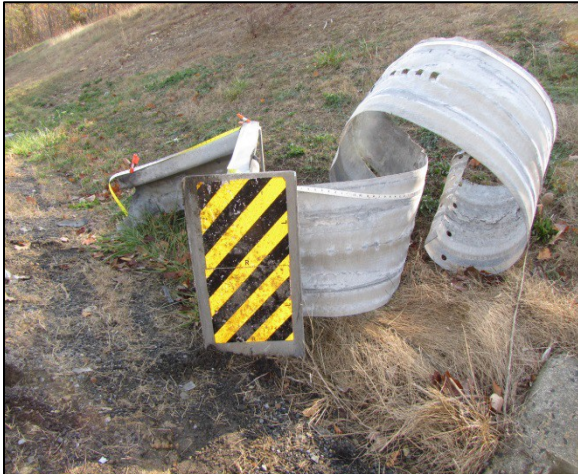
Figure 10: Southeast-facing image depicting the ET-Plus 10 cm (4 in) end terminal and the extruded guardrail.

During the crash sequence, the Mercury departed the right road edge and the right corner of the vehicle struck the face of the end terminal. The impact face measured 38x71 cm (15x28 in) width by height and was abraded at its upper left corner. The force of the impact displaced the end terminal to the east extruding the W-beam. The length of the extruded rail measured 3.7 m (12.0 ft). The end terminal separated from the Mercury and was accelerated forward as the front plane of the vehicle engaged the face of the W-beam between Posts 3 and 4. The W-beam kinked at Post 4 and tore adjacent to post. The end terminal and a 5.9 m (19.3 ft) section

of the W-beam was then projected to the east, coming to rest on the road side (**Figure 10**).

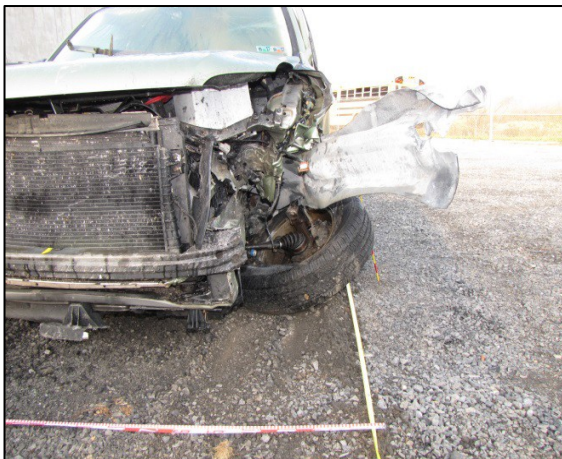
The torn end of the W-beam then engaged the left corner of the Mercury (**Figure 11**). The eastward momentum of the vehicle directed the exposed end of the W-beam through the open space between the left frame and left front wheel assembly. The guardrail pierced the toe pan, entered the driver's floor space and intruded to the second row (**Figure 12**). In total, 229 cm (80 in) of guardrail entered the vehicle as the Mercury rotated counterclockwise to its final rest position.

Figure 11: Image of the left aspect of the Mercury's front plane and intruded guardrail.

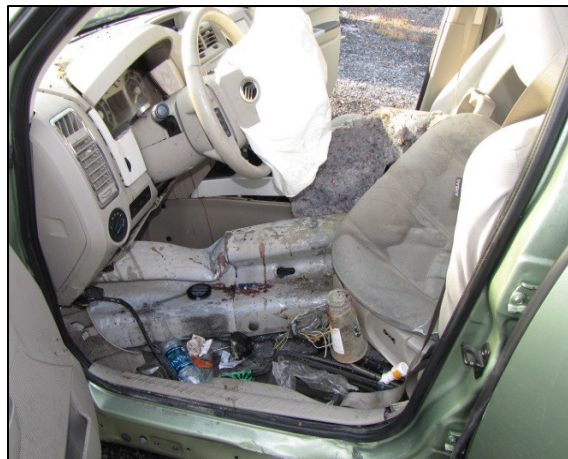
Figure 12: Interior image of the Mercury depicting the intruded guardrail.

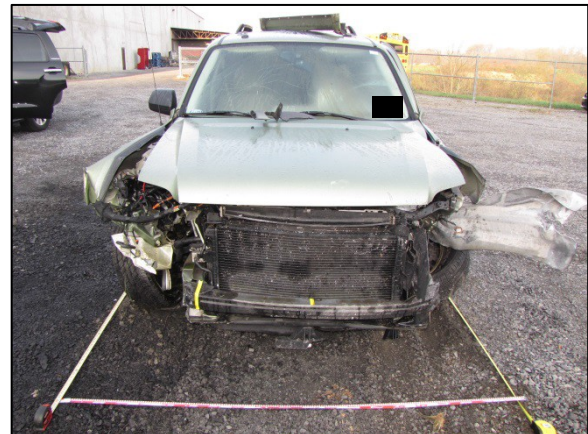
The front corners of the vehicle exhibited impact damage as a result of the road-departure impact. The Mercury (**Figure 14**) impacted the end terminal with its front plane (Event 1). The direct contact damage began 48 cm (19.0 in) right of centerline and extended 30 cm (12.0 in) to the right corner. The crush of the unsupported end of the front bumper reinforcement measured 3 cm (1.0 in). There was no deformation of the right frame rail. The right fender crushed 30 cm (12.0 in) rearward and deformed 28 cm (11.0 in) outward. The right front tire was displaced into the hinge pillar of the front door and was debedded from the rim. The right wheel base was shortened 13 cm (5.1 in). The Collision Deformation Classification representing this damage pattern was 12FREE3. The corner impact and yielding properties of the guardrail were outside the scope of the WinSMASH program for analysis.

Figure 14: Front view of the Mercury depicting the two regions of damage.

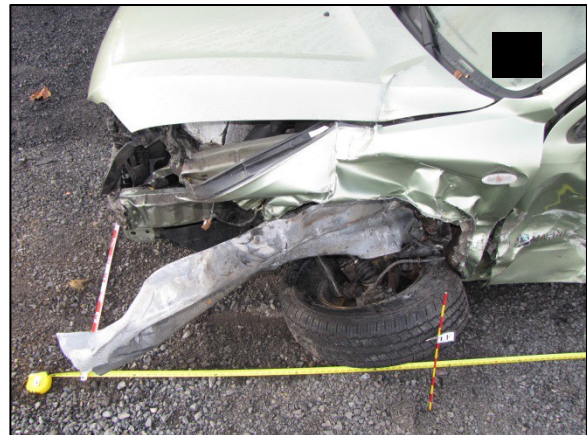
During the prolonged engagement with the guardrail and its deformation, the front bumper fascia separated from the vehicle. The deformed guardrail engaged the left corner of the Mercury and speared the vehicle (Event 2). This engagement occurred in the open space between the left frame rail and the inner aspect of the left front tire (**Figure 15**). The end of the left frame rail was deformed approximately 3 cm (1 in). The guardrail pierced the driver toe pan and entered the occupant compartment. The side wall of the left front tire was cut, the suspension fractured and the wheel assembly was displaced rearward 25 cm (9.8 in). Contact with the guardrail support posts extended rearward to the mid aspect of the left front door. All four doors and the rear lift gate remained closed during the crash and were operational at the time of the SCI inspection. The CDC assigned to this damage pattern was 12FLEE8. A reconstruction analysis of this impact was beyond the scope of the WinSMASH program.

Figure 15: Left view of the Mercury at the left front axle.

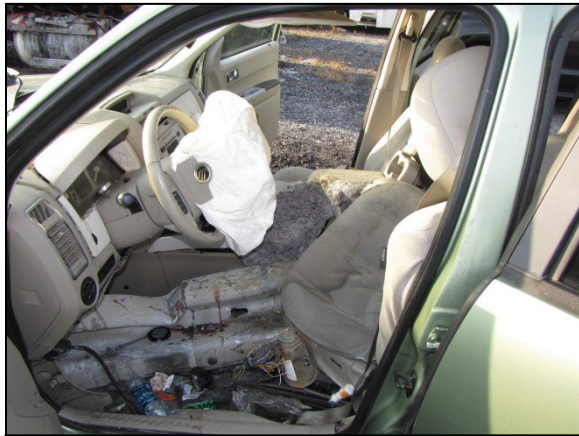
The interior damage to the Mercury consisted of the intrusion of the W-beam guardrail with associated deformation of the driver seat, fracture of the windshield, and deployment of the frontal air bags. The guardrail entered the occupant compartment through the left aspect of the driver's toe pan. The hole in the toe pan measured 43 cm x 30 cm (13.0 in x 12.0 in) width by height. The guardrail traveled along the floor pan and under the right aspect of the driver seat (**Figure 16**). The guardrail contacted and forced the driver seat vertically from the seat track and rotated the seat approximately 60 degrees CW. The driver seatback angle was near vertical and in contact with the left B-pillar. The guardrail deformed the center console to the right and entered the interior second row at its mid-point (**Figure 17**). The intrusion measured 229 cm (80.0 in) from the toe pan. The front row right seat was in a full-rear track position. The seatback was reclined 30-degrees.

Figure 16: Left interior view of the Mercury depicting the intruded W-beam guardrail.

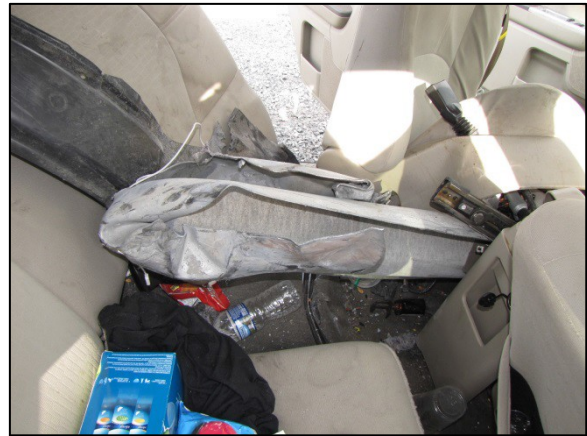
Figure 17: Right interior view of the Mercury's second row and the intruded guardrail.

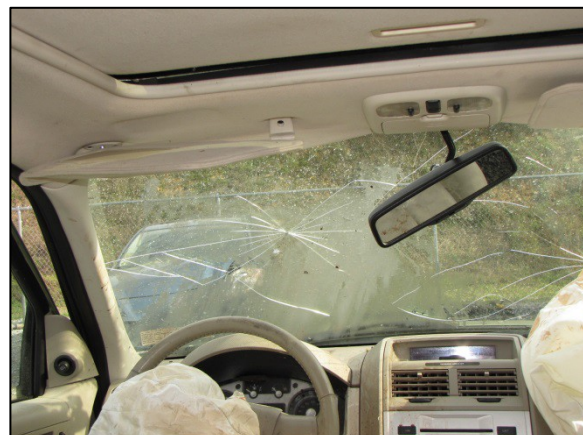
Figure 18: Image depicting the fluid spill patterns and fracture site to the left aspect of the Mercury's windshield.

The associated spill pattern from the drink measured 23 cm x 36 cm (9.0 in x 14.0 in). It began at the fracture site and extended toward the left A-pillar. The location of the fracture site and spill pattern was consistent with the driver holding the drink container in her left hand.

A second fluid spill pattern was observed on the left half of the windshield. This second fluid was darker in color and was presumed to be coffee-based. This pattern began at the fracture site and extended to the right measuring 25 cm x 54 cm (10.0 in x 23.0 in) width by height. The fabric of the deployed air bags was also stained by the fluid. Chocolate chips were observed within the spill on the windshield and on the top of the instrument panel forward of the driver position. The fluid spill was present on the center aspect of the instrument panel running down onto the right aspect of the driver's lower instrument panel and knee bolster. A brand name plastic drink container was found on the floor forward of the driver seat.

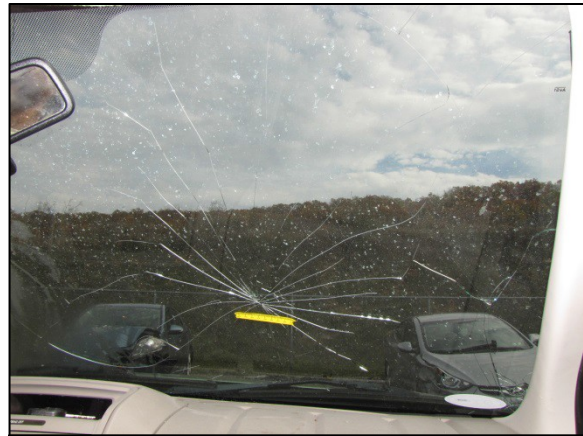
Figure 19: Interior view of the Mercury depicting the fracture site at the right aspect of the windshield.

The location of the spill was consistent with the front right occupant holding the drink in her left hand. The right half of the windshield was fractured directly forward of the front right seat position (**Figure 19**). This fracture site was located 40 cm (15.8 in) left of the right A-pillar and 46 cm (18.0 in) below the windshield header. The fracture was attributed to probable contact from the unbelted front row right occupant as she loaded through the deployed air bag.

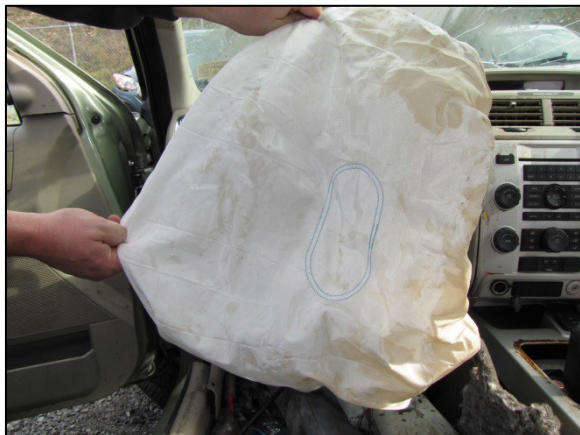
The driver's frontal air bag deployed from an I-configuration module mounted within the center hub of the steering wheel. The symmetrical I-configuration cover flaps were 12 cm (4.7 in) in height and 13 cm (5.3 in) in width. The driver air bag (**Figure 20**) was 61 cm (24.0 in) in diameter in its deflated state and was vented by two 3 cm (1.2 in) diameter ports located at the 11 and 1 o'clock sectors on the back side of the air bag. Internal tethering was sewn to the face of the air bag with an oval-shaped stitch pattern that measured 14 cm (5.5 in) in height and 8 cm (3.0 in) in width. The following nomenclature was stamped onto the air bag at the top aspect of the module assembly: 607930300CC02 FORD U377 EWPU2FOHGS1. There was no residual evidence of occupant contact to the deployed air bag. The right and top aspects of the air bag fabric were stained a brown color from the presumed coffee-based beverage associated to the front row right occupant.

Figure 20: View of the deployed driver's frontal air bag within the Mercury.

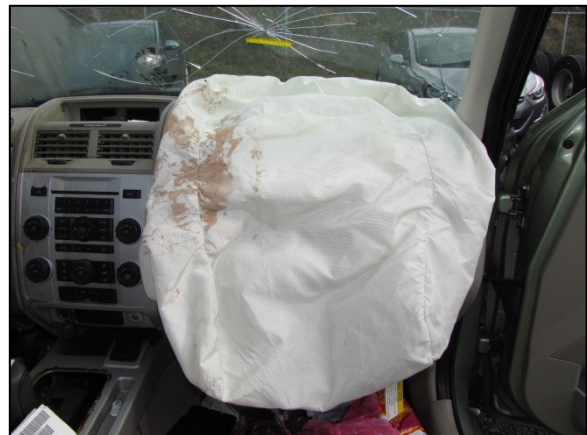
Figure 21: View of the deployed passenger's frontal air bag within the Mercury.

The passenger's frontal air bag (**Figure 21**) deployed from a mid-mount module through H-configuration cover flaps. In its deflated state, the air bag measured 41 cm (16.0 in) in width and 61 cm (24.0 in) in height with 58 cm (23.0 in) of rearward excursion. The air bag was not tethered. Venting was achieved via two 6 cm (2.5 in) diameter ports located on the lateral aspects of the air bag. A barcode label identified the air bag as 08454800 AA 02 F2TTYNSDA/V.

The unbelted front row right occupant engaged the deployed air bag during her forward trajectory. There was no direct evidence associated with occupant contact; however, a large, brown-colored fluid stain was present on the left aspect of the air bag consistent with the presumed coffee-based beverage.
