DOT HS 812 562

# **Special Crash Investigations On-Site Side Impact Crash Investigation**

**Vehicle: 2016 Chevrolet  
Malibu**

**Crash Date: October 2016**

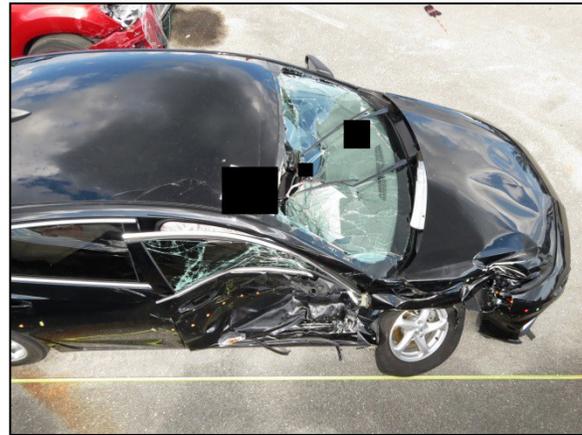
The Malibu sustained impact damage to its right plane, consistent with the right plane impact and subsequent side-slap (crash events #1 and #2). Direct contact damage from the first impact from the Tahoe's front plane was located at the forward aspect of the Malibu's right plane. It began at the right front bumper corner and extended 233 cm (91.7 in) rearward along the right front fender, right front door, and onto the right rear door (**Figure 7**). The direct contact ended 12 cm (4.7 in) rearward of the rear edge of the right front door. Noteworthy characteristics of the damage included a distinct area of vertically oriented deformation immediately forward of the Malibu's right front tire/wheel, as well as a similar impression at the right A-pillar. This damage matched the profile of the aftermarket bumper guard affixed to the Tahoe's front plane. An additional characteristic of note was the arching rubber transfer at the forward aspect of the right rear door, attributable to the left front tire of the Tahoe. This evidenced the alignment, rotation, and side-slap of the vehicles during the crash.

**Figure 7:** Overhead view of the Event 1 damage pattern to the right plane of the Malibu.

A residual crush profile was documented by the SCI investigator using a Nikon Nivo 5.M+ total station. The crush at mid-door level was measured using a Field-L length of 233 cm (91.7 in), beginning at the right front bumper corner and extending rearward. The results were as follows: C1 = 0 cm (0 in), C2 = 19 cm (7.5 in), C3 = 21 cm (8.3 in), C4 = 22 cm (8.7 in), C5 = 23 cm (9.1 in), C6 = 14 cm (5.5 in). Maximum crush measured 30 cm (11.8 in) to the right front door, between the C2 and C3 measurement locations.

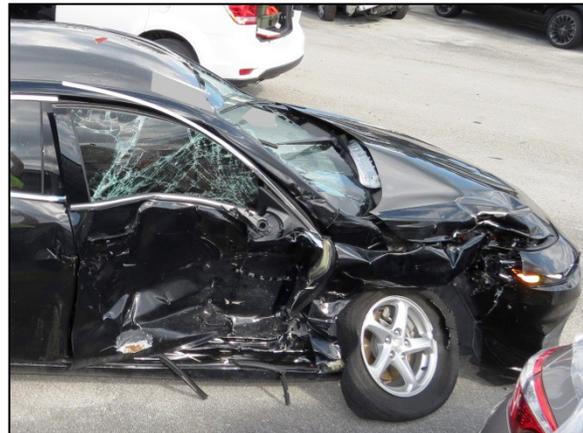
The Collision Deformation Classification (CDC) assigned to the Malibu's damage pattern (**Figure 8**) related to the Event 1 impact was 02RYEW3. Using the documented measurements, the "Missing Vehicle" algorithm of the WinSMASH model was used to calculate the vehicle velocity change for the crash event. The total calculated delta-V was 24 km/h (14.9 mph), which appeared reasonable. Longitudinal and lateral components of the calculated delta-V were -12 km/h (-7.5 mph) and -21 km/h (-13.0 mph), respectively.

**Figure 8:** Event 1 damage to the Malibu from impact with the Tahoe's front plane.

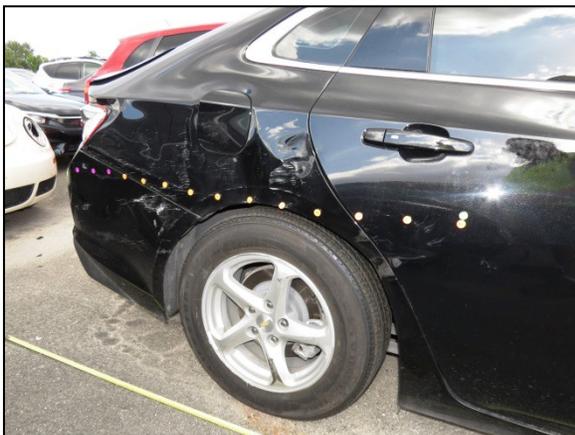
**Figure 9:** View of the Event 2 damage pattern to the right plane of the Malibu.

Damage from the Event #2 side-slap was located on the rear aspect of the Malibu's right plane. Direct contact began 50 cm (19.7 in) forward of the right rear axle position and extended 141 cm (55.5 in) rearward to the right rear bumper corner (**Figure 9**). In the damage pattern was minor lateral crush and deformation to surrounding components. A residual crush profile was also documented by the SCI investigator using the total. The crush at mid-door level was measured using a Field-L length of 141 cm (55.5 in), which matched the location and width of the direct contact damage.

Resultant crush measurements were: C1 = 8 cm (3.2 in), C2 = 7 cm (2.8 in), C3 = 5 cm (2.0 in), C4 = 4 cm (1.6 in), C5 = 1 cm (0.4 in), C6 = 0 cm (0 in). Maximum crush was the C1 measurement. The CDC assigned to the Event 2 side-slap damage was 03RBEW1. Based on the measurements, the damage algorithm of the WinSMASH model was used to calculate the vehicle velocity change (delta-V) for the crash event. The total calculated delta-V was 13 km/h (8.1 mph). Longitudinal and lateral components of the calculated delta-V were 0 km/h (0 mph) and -13 km/h (-8.1 mph), respectively. These results were reasonable.

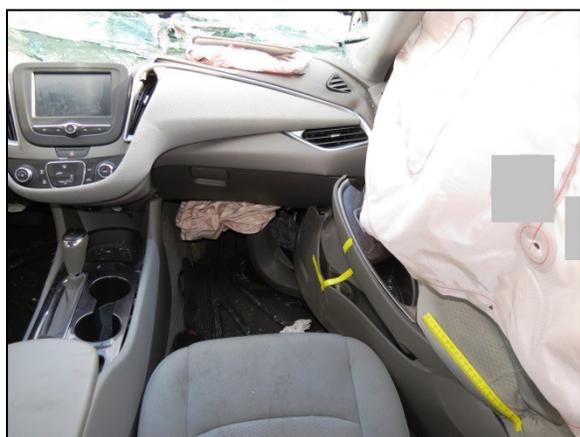
**Figure 10:** Intrusion of the right front door in the Malibu as viewed from above the front row right seat position.

Occupant compartment intrusion was limited to the intrusion of the right front door due to its direct involvement in the impact and the corresponding deformation. The maximum intrusion measured 17 cm (6.7 in), located at the forward lower quadrant of the door. The forward aspect of the intruded door was also engaged against, and had induced deformation to, the right aspect of the instrument panel. Despite the intrusion of its forward aspect, the rear aspect of the right front door was minimally intruded (**Figure 10**). The use of the manual restraint system by the Malibu's occupants and the deployment of the multiple air bag systems reduced the likelihood of their interaction with interior components during the crash.

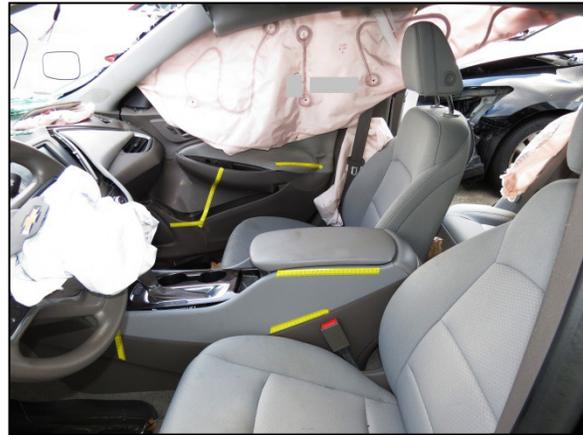
The only discernable evidence of occupant contact included slight rightward deformation of the center console and evidence of occupant loading to the right front door panel. The console deformation resulted from driver loading by her right thigh and right flank in response to the lateral component of the crash forces. Similarly, the occupant loading of the right front door panel resulted from contact by right flank of the front row right occupant in response to the lateral component of the crash forces. **Figure 11** depicts the aforementioned occupant contact in the Malibu, highlighted by yellow evidence marking tape.

**Figure 11:** Occupant contact from the driver and front row right occupant in the Malibu.

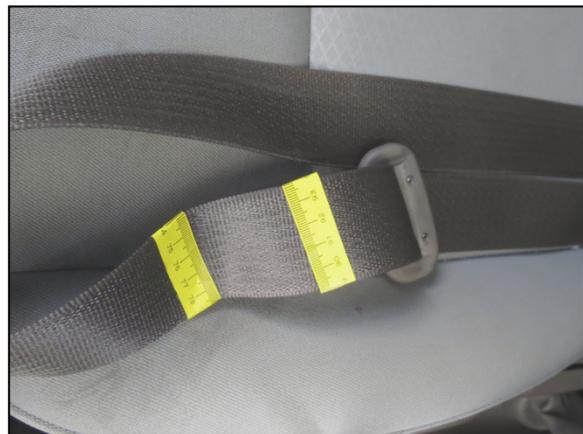
Inspection of the driver's seat belt found the webbing loosely retracted. Once extended, a distinct area of loading from the latch plate on the webbing was visible from 56 to 61 cm (22.0 to 24.0 in) above the lower anchor (**Figure 12**). There was also distinct loading from the D-ring, located 57-61 cm (22.4-24.0 in) above the latch plate loading. Based on the status of the driver's seat belt system and the imaged EDR data, the SCI investigator determined that the driver was belted at the time of the crash.

**Figure 12:** Latch plate loading on the Malibu driver's seat belt webbing.

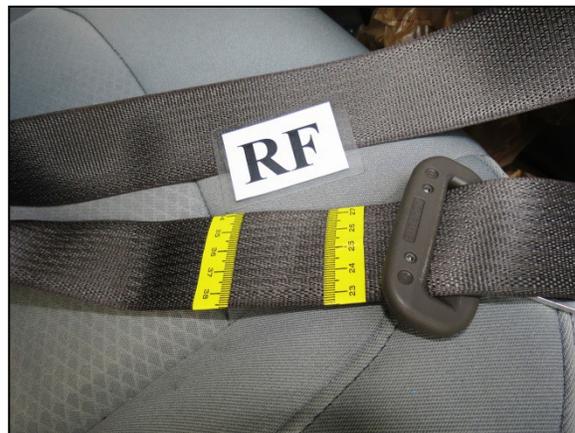
The front row right seat belt was also loosely retracted against the B-pillar. Like the driver's there were two distinct areas of loading from the latch plate and D-ring. These were located 58 to 62 cm (22.8 to 24.4 in) and 121 to 127 cm (47.6 to 50.0 in) above the lower anchor, respectively. **Figure 13** depicts the latch plate and corresponding loading evidence on the webbing. Based on the status of the front row right seat belt and a review of the Malibu's imaged EDR data, the SCI investigator determined that the front row right occupant was belted at the time of the crash.

**Figure 13:** Latch plate and loading evidence on the webbing of the front row right seat belt system in the Malibu.

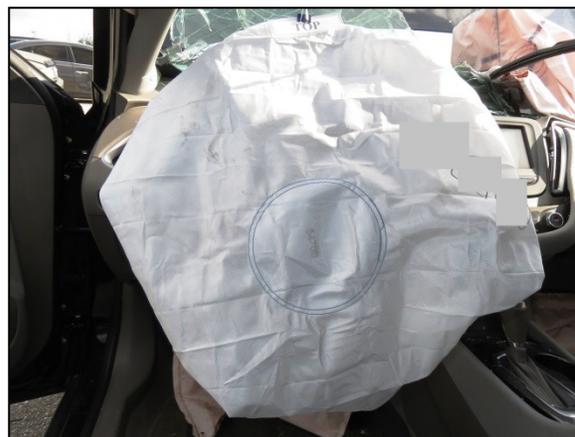
The driver's frontal air bag (**Figure 14**) deployed from the steering wheel hub-mounted module without damage or occupant contact to the module cover flaps. In its deflated state, the air bag measured 68 cm (26.8 in) in overall diameter. There was a 16 cm (6.3 in) diameter center stitch pattern, to which internal tethers were affixed. Small 3 cm (1.2 in) diameter vents were located on the rear of the air bag. Nomenclature included "5469B" on the backside and "5470B" on the face. There was no discernable occupant contact or crash-related damage to the driver's CAC frontal air bag.

**Figure 14:** Deployed driver's frontal air bag in the Malibu.

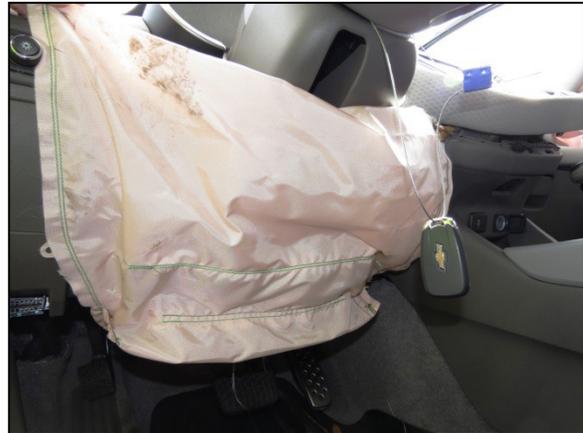
The driver's knee air bag (**Figure 15**) deployed from the bottom of the left lower instrument panel without damage. In its deflated state, the air bag measured approximately 52 cm (20.5 in) wide and was 33 cm (13.0 in) tall. The air bag was not vented. The knee air bag was designed to deploy out and upward along the contour of the lower instrument panel. No discernable contact evidence was visible to the face of the driver's knee air bag, and no crash-related damage was observed. There were some post-crash stains on the fabric of the air bag from an undetermined source.

**Figure 15:** Deployed driver's knee air bag in the Malibu.

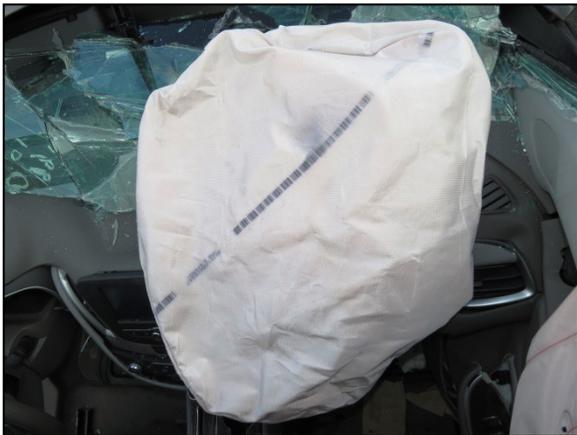
**Figure 16:** Deployed passenger's frontal air bag in the Malibu.

The passenger's frontal air bag (**Figure 16**) deployed from the top instrument panel-mounted module through the 28 cm (11.0 in) wide by 11 cm (4.3 in) tall cover flaps without damage or occupant contact to the module cover flaps. In its deflated state, the air bag measured 68 cm (26.8 in) tall and 52 cm (20.5 in) wide. There were two vents on each side of the air bag, including a 6 cm (2.4 in) diameter upper vent and a 1 cm (0.4 in) diameter lower vent. Overall, the air bag's face was clean, and there was no discernable occupant contact or crash-related damage to the passenger's

frontal air bag. However, there were multiple punctures to the fabric of the air bag from post-crash contact with the fractured windshield glazing.

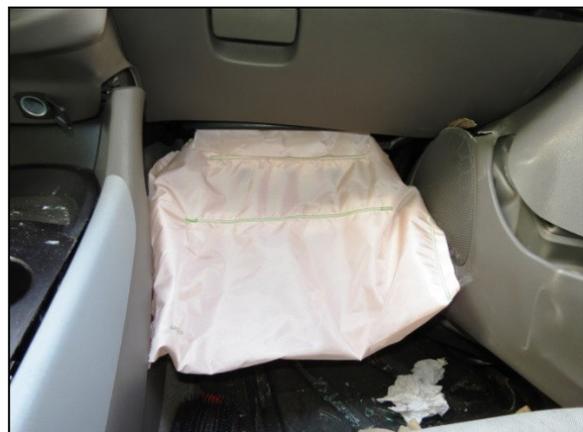
The front right passenger's knee air bag (**Figure 17**) deployed from the bottom of the right lower instrument panel without damage. Like the driver's knee air bag, it measured approximately 52 cm (20.5 in) wide and 33 cm (13.0 in) tall. The air bag was not vented. It was similar in design to the driver's knee air bag. No discernable contact evidence was visible to the face of the front right passenger's knee air bag, and no crash-related damage was observed.

**Figure 17:** Deployed front right passenger's knee air bag in the Malibu.

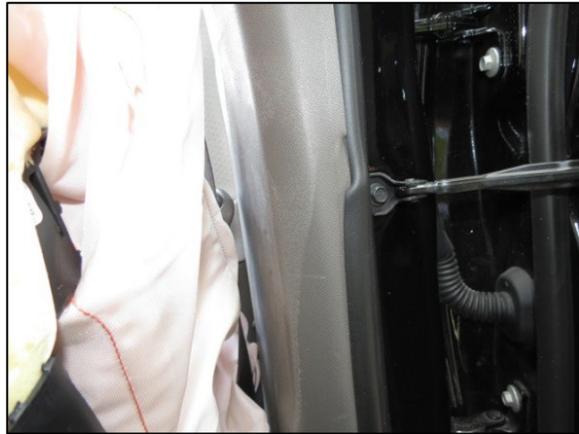
The front right passenger's seat-mounted side impact air bag deployed from the outboard aspect of the seatback. In its deflated state, the air bag measured 58 cm (22.8 in) tall by 28 cm (11.0 in) wide. There was a 4 cm (1.6 in) vent on the outboard aspect of the air bag. Nomenclature included "Nov 18 15." Although there was no discernible occupant contact visible to the air bag, it was likely contacted by the front row right occupant during the crash. Of note, the outboard aspect of the air bag contacted the fascia of the right B-pillar during deployment, resulting in abrasions to the fascia and polymer transfer on the outboard aspect of the air bag. **Figure 18** depicts this contact, with the air bag visible, as viewed from the second row facing forward.

**Figure 18:** Deployed front right passenger's seat-mounted air bag and B-pillar contact in the Malibu.

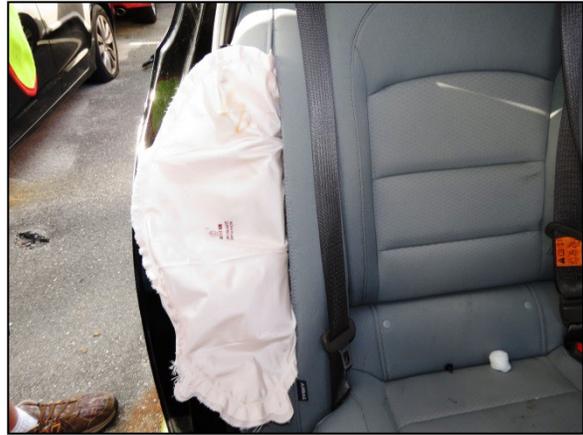
The second row right seat-mounted side impact air bag deployed from the outboard aspect of the seatback through 48 cm (18.9 in) of stitching. In its deflated state, the air bag measured 52 cm (20.5 in) tall by 23 cm (9.1 in) wide. Nomenclature included "Nov 23 2015." No occupant was in proximity to this air bag when it was deployed; therefore, there was no occupant contact to the second row right seat-mounted air bag. There also was no crash-related damage. **Figure 19** depicts the deployed second row right seat-mounted side impact air bag.

**Figure 19:** Deployed second row right seat-mounted air bag in the Malibu.

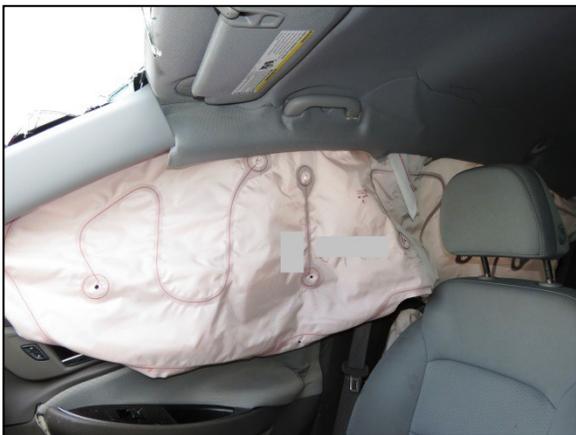
**Figure 20:** Deployed right IC air bag in the Malibu.

The left and right IC air bags deployed from the roof side rails through the headliner. In their deflated states, both air bags measured approximately 190 cm (74.8 in) in overall length. There was 50 cm (19.7 in) of vertical coverage at the front row positions, 40 cm (15.7 in) at the B-pillars, and 40 cm (15.7 in) at the second row positions. When deflated, the IC air bags extended approximately 15 cm (5.9 in) below the beltline of the vehicle. There was no discernible occupant contact to either of the IC air bags. **Figure 20** depicts the deployed right IC air bag.

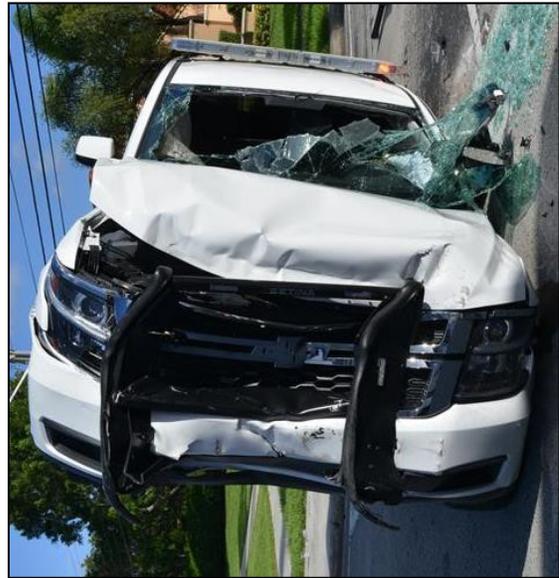
**Figure 21:** View of the Tahoe's front plane damage (on-scene image obtained from the investigating law enforcement agency).

The Tahoe sustained front and left plane damage associative to the multiple event crash. Frontal damage spanned the entire width, and included deformation to the bumper beam, aftermarket bumper guard, grille, hood, and surrounding fascia/trim. It appeared that the bumper guard absorbed significant force during the crash. Based on the damage to the Malibu and Tahoe, it was evident that the right front wheel/tire of the Malibu was aligned with the Tahoe's centerline at the onset of the Event 1 impact. This was evidenced by the deformation from the bumper guard in the Malibu's damage pattern, along with black rubber transfer on the white bumper fascia of the Tahoe. The estimated CDC assigned to the Tahoe for the Event 1 impact with the Malibu was 11FDEW2.

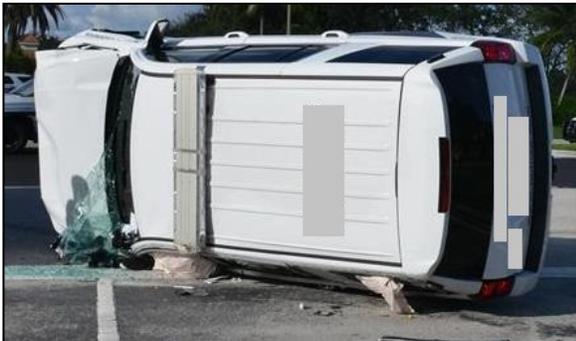
**Figure 22:** View of the overturned Tahoe at final rest depicting undamaged planes (on-scene image obtained from the investigating law enforcement agency).

Due to the positioning of the Tahoe on its left plane in all of the available images of the vehicle, the specific location and severity of the Event 2 side-slap event damage remains unknown. The CDC assigned for the side-slap was 09L99999. The CDC assigned for the one quarter-turn rollover was 00LDAO99. **Figure 22** depicts the overturned Tahoe at final rest, where it is evident that the top, back, and right planes did not sustain damage during the crash.
