DOT HS 812 588

Special Crash Investigations On-Site Rollover Crash Investigation

Vehicle: 2015 Ford Explorer

Crash Date: September 2016

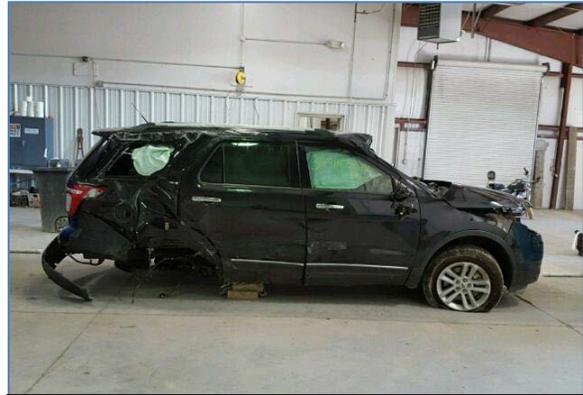
This report documents the-site investigation of a two-vehicle intersection/rollover crash of a 2015 Ford Explorer (**Figure 1**) and the deployment of its right front seat-mounted side impact and both inflatable curtain (IC) air bags. The IC air bags were determined to comply with Federal Motor Vehicle Safety Standard (FMVSS) No. 226, which established requirements for ejection mitigation systems to reduce the likelihood of complete or partial ejection of vehicle occupants through side windows during rollovers or side impact events.

Figure 1: Right side view of the 2015 Ford Explorer

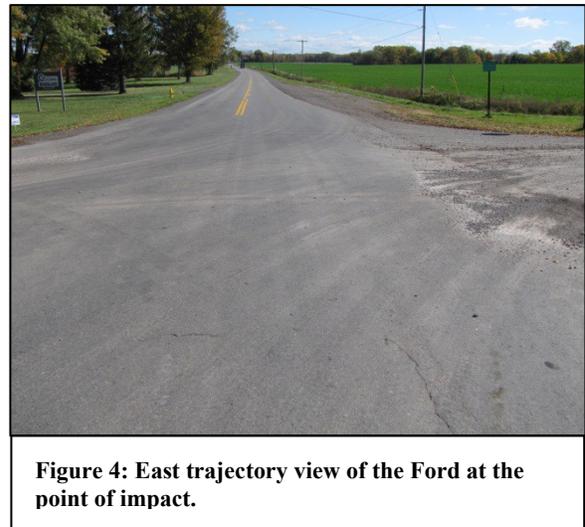
The front plane of the Oldsmobile struck the right plane of the Ford (Event 1) as the vehicles passed through the center of the intersection (**Figure 4**). There was no physical evidence at the scene to identify the specific point of impact. The direct contact damage on the Ford began at the mid-point of the right front door and extended rearward to the right rear corner. The directions of force for this event were in the 2 o'clock sector for the Ford and 11 o'clock sector for the Oldsmobile. The force of the impact caused the Ford's front seat belt pretensioners and front row right seat-mounted side-impact and both IC air bags to actuate. The crash fractured the right rear suspension of the Ford, which resulted in the complete separation of the right rear wheel assembly and drive axle.

Figure 4: East trajectory view of the Ford at the point of impact.

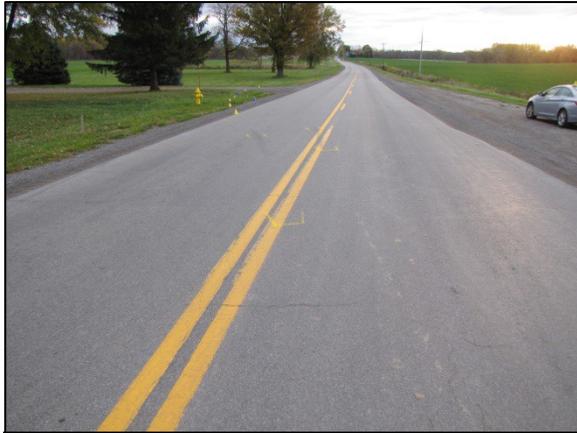
Figure 5 depicts the tire marks in the area of the Ford's approximate 150-degree rotation. The Ford then departed the road and entered the north roadside 33.6 m (110.2 ft) from the intersection impact. It continued to rotate clockwise evidenced an arcing furrow mark attributed to the right front tire. The tire mark on the roadside measured 17.5 m (57.4 ft) in length.

Figure 5: East-northeast-looking view of the tire marks along the Ford's post-crash trajectory.

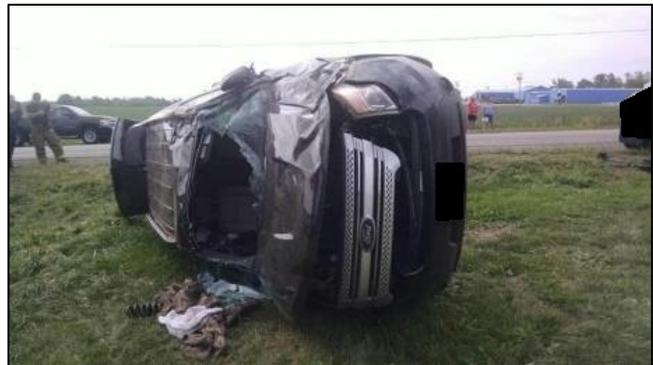
As the Ford reached approximately 245 degrees of rotation, in a near broadside attitude at the edge of a gravel driveway (**Figure 6**), the vehicle overturned due to its instability into a right side leading (Event 2). The Ford rolled about its longitudinal axis for nine quarter-turns over an uninterrupted distance of 29.6 m (97.1 ft) coming to rest in the grassy open field located east of the driveway. At rest, the vehicle was located approximately 8.8 m (28.9 ft) north of the road edge (**Figures 7 and 8**)

Figure 8: South-looking on-scene image of the Ford at final rest. Image supplied by an Internet news source.

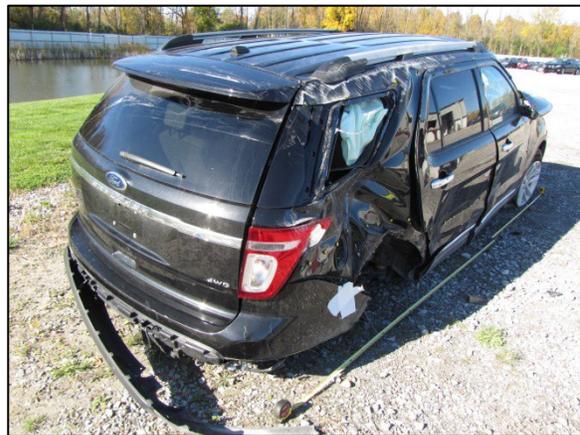
The 2015 Ford Explorer XLT was a 4-door sport utility vehicle (SUV) manufactured in October 2014 and identified by the Vehicle Identification Number 1FM5K8D85FGxxxxxx (**Figure 9**). The vehicle was configured on a 287 cm (113.0 in) wheelbase. Powered by a 3.5-liter V-6 flex-fuel gasoline engine, the 6-speed automatic transmission transferred power to the all-wheel drive platform. Standard equipment included Ford's post-collision safety system, electronic stability control, a tire pressure monitoring system (TPMS), and traction control.

Figure 9: Right rear oblique view of the Ford.

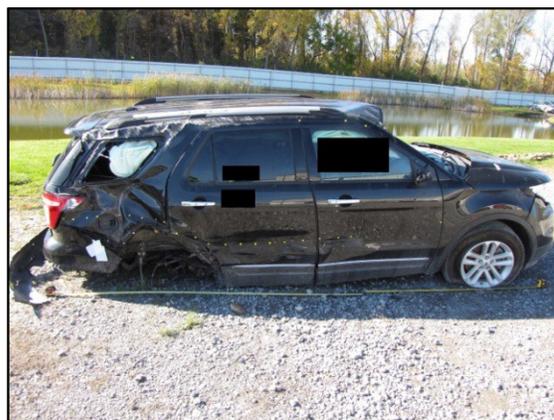
The Event 1 damage was located on the Ford's right plane and began at the midpoint of the right front door 119 cm (47.0 in) aft of the right front axle (**Figure 10**). The forward momentum of the Ford (relative to the front plane of the Oldsmobile) resulted in sideswipe-type damage that extended 229 cm (60.0in) rearward across the right rear door to the lower C-pillar. The damage pattern then changed to lateral crush over a 99 cm (39.0 in) length from the lower C-pillar to the rear corner as the vehicles reached maximum engagement. The right rear suspension fractured and the wheel assembly separated as a result of the impact.

Figure 10: Right side view of the Ford depicting the impact damage associated with Event 1.

The combined length of the direct and induced damage measured was 252 cm (99.0 in). The residual crush profile was as follows: C1 = 26 cm (10.2 in), C2 = 29 cm (11.4 in), C3 = 14 cm (5.5 in), C4 = 5 cm (1.6 in), C5 = 1 cm (0.4 in), C6 = 0. A complete analysis of this impact was outside of the scope of the WinSMASH program due to the non-central location of the impact beyond the occupant compartment, the corresponding lack of vehicle stiffness data at that location, and the lack of a common velocity between the vehicles during the impact.

However, for comparative purposes, a borderline analysis using the WinSMASH Missing Algorithm was calculated. This yielded the following results: the total velocity change (delta-V) of the Ford was 17 km/h (10.6 mph), with longitudinal and lateral components of -11 km/h (-6.8 mph) - 13 km/h (-8.1 mph), respectively. The maximum longitudinal and lateral delta-V components recorded by the EDR were -9.93 km/h (-6.17 mph) and -10.75 km/h (-6.65 mph), respectively. The Collision Deformation Classification (CDC) assigned to the damage pattern was 02RZEW3.

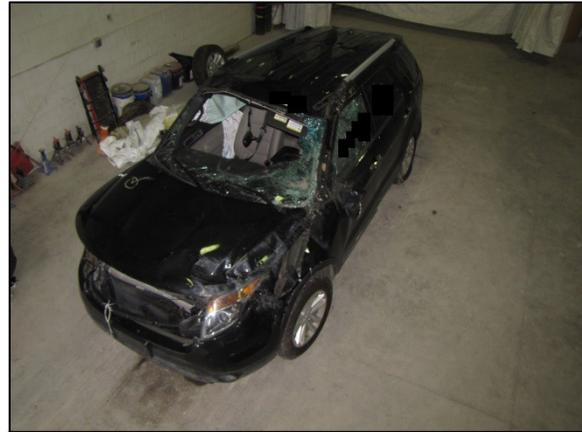
The Event 2 rollover resulted in damage to the right, top and left planes of the Ford (**Figure 11**). The aft aspect of the right roof side rail was abraded and crushed from contact with the stone driveway during the first-quarter turn of the rollover sequence. The damage continued onto the right load bar of the OEM roof rack. Minor abrasions with deformation were present to the mid-aspect of the roof between the C- and D- pillars. This did not result in intrusion of the passenger compartment.

Figure 11: Overhead view of the Ford.

The left upper A-pillar struck the ground during the third quarter-turn causing lateral displacement of the pillar and an upward bucking of the windshield header. The pillar displacement fractured the windshield and resulted in a bond separation. The maximum lateral and vertical deformation was located at the left A-pillar/header juncture and measured 10 cm (4.0 in) and 8 cm (3.0 in), respectively. Scattered abrasions were present on both side planes with the heaviest concentration located at the left side of the hood and the left front fender areas. This abrasion pattern measured 157 cm (62 in) in length from the hood's left front corner extending onto the left door with lateral deformation of 15 cm (6.0 in). The left fender deformed vertically 10 cm (4.0 in). Both outside mirrors were fractured from their bases. The CDC descriptive of this damage was 00RDAO3.

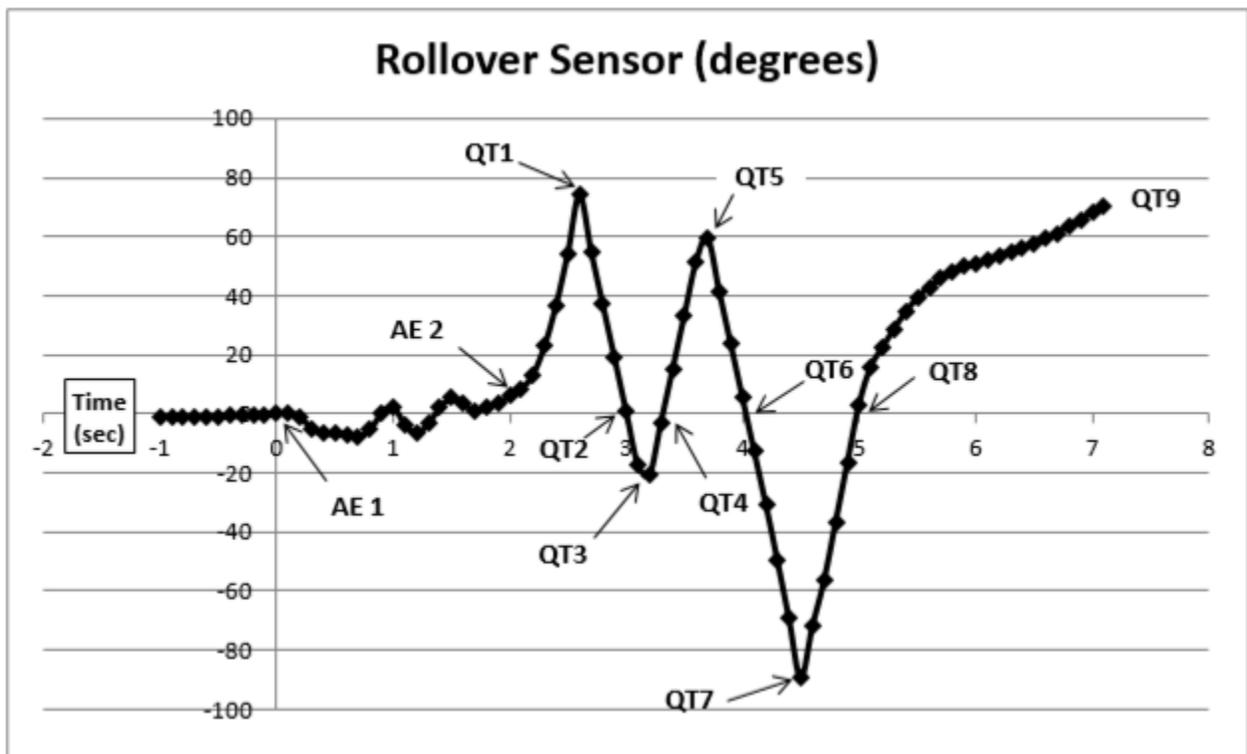
The dynamics of the Ford's rollover were captured and recorded by rollover sensor. This data was consistent with the nine quarter turns of the SCI reconstruction. The recorded roll angle was centered on zero degrees and fluctuated over a range of plus and minus (+/-) 90 degrees. The chart below is a depiction of the combined rollover sensor data for the First and Second Records relative to the time history of the First Record. The total length of the combined data recording was 7.1 seconds. The timing of specific dynamics of the crash sequence (AE) and the quarter turns (QT) are highlighted in the chart below.

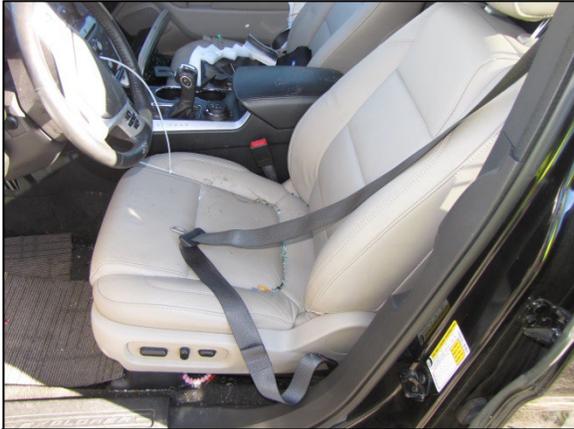
The driver seat was adjusted to a mid-to-rear track position which measured 7 cm (2.8 in) forward of full rear (**Figure 12**). The total seat track travel measured 24 cm (9.5 in). The seatback was reclined 30 degrees aft of vertical. The horizontal distance from the seatback to the center hub of the steering wheel measured 55 cm (21.5 in). The front row right seat was adjusted 3 cm (1.0 in) forward of full rear with the seatback reclined 25 degrees (**Figure 13**). The horizontal distance from this seatback to the vertical face of the instrument panel measured 80 cm (31.3 in).

Figure 12: Left interior view of the Ford's driver seat.

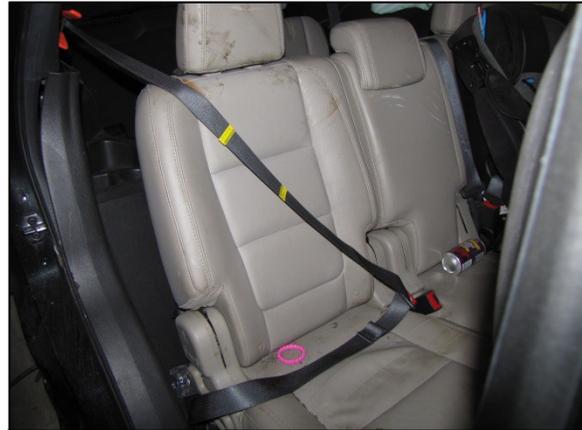
The second row seat belt systems retracted onto switchable ELR/ALR retractors. The left seat belt was used to secure the CRS in the vehicle. The seat belt webbing was routed through the forward-facing belt path of the CRS. At examination, this retractor was in the ELR mode, the installer of the CRS did not engage the ALR feature. A single vertical polymer loading transfer was present on the seat belt webbing. This transfer was in the belt path of the CRS and possibly occurred during the lateral movement of the CRS during the crash. The second row right occupant was restrained by the 3-point lap and shoulder belt system while she was seated in a backless booster CRS. The webbing of this seat belt was in the stowed position at inspection. Occupant loading of the seat belt was evidenced by a 6 cm (5.5 in) long crease that was located in the shoulder portion of the webbing 116-130 cm (45.8-51.3 in) above the lower anchor (**Figure 14**).

Figure 14: Interior view of the Ford's second row right seat and seat belt.

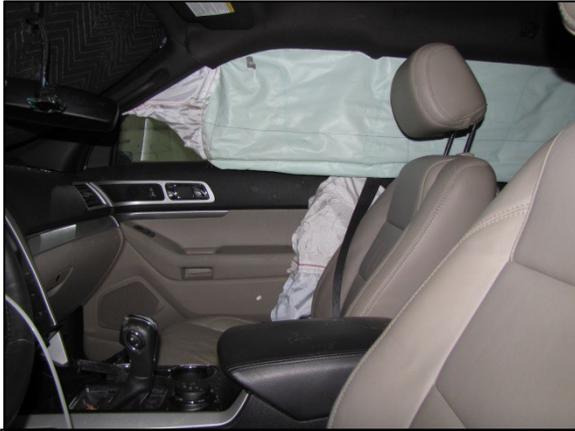
The IC air bags deployed through a separation of the headliner from the roof side rails (**Figures 15 and 16**). The overall length of the IC air bags measured 251 cm (99.0 in), inclusive of a 23 cm (9.0 in) sail panel that filled the triangular void at the A-pillar areas. The IC air bags extended approximately 5 cm (2.0 in) below the level of the beltline in its deflated state. There was no residual evidence of occupant contact to the IC air bags.

Figure 15: Interior view of the Ford depicting the deployed air bags at the front row right position.

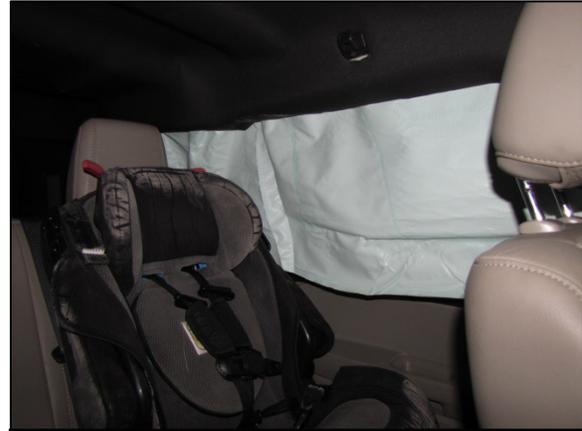
Figure 16: Interior view of the Ford depicting the deployed left IC air bag at the second row left position.

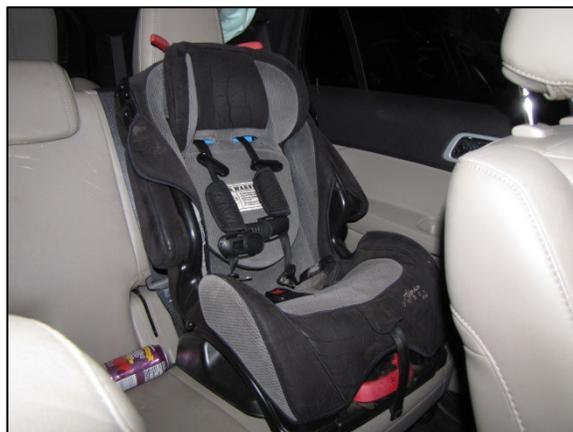
The CRS was installed with the vehicle 3-point lap and shoulder belt routed through the forward-facing belt path (**Figure 17**). The ALR mode of the retractor was not engaged; therefore the CRS was secured to the vehicle using the ELR mode of the switchable retractor. Post-crash, there was 8 cm (3 in) of lateral movement of the CRS at the belt path and 9 cm (3.5 in) of forward movement. The SCI inspection of the CRS determined that there was no damage to the CRS or loading evidence to the integral harness system. Additionally, there was no vehicle seat belt loading evidence at the belt path of the CRS.

Figure 17: Image of the CRS in the second row left position of the Ford.

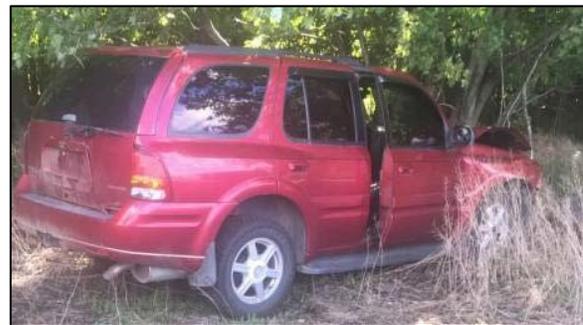
The other vehicle in this crash was a 2002 Oldsmobile Bravada, four-door SUV (**Figure 18**). The Oldsmobile was not registered and was being operated by a driver who fled the scene after the crash. At the time of the case assignment, the Oldsmobile had been released from the tow yard and could not be located for inspection. Based on specifications for this vehicle, the Oldsmobile was powered by a 4.2-liter V-6 gasoline engine linked to a 4-speed automatic transmission with all-wheel drive.

Figure 18: Image of the Oldsmobile taken during its recovery by police. Image obtained from an Internet news source.

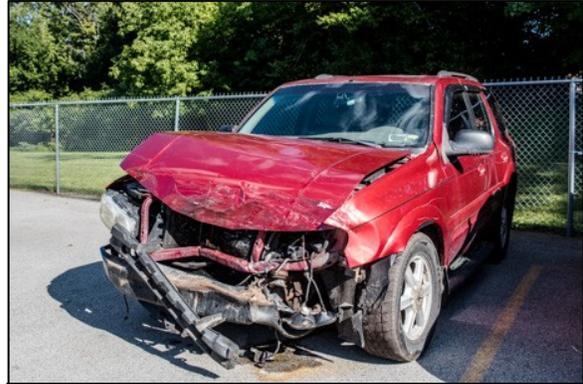
Two images obtained from Internet news sources depicted the exterior damage to the Oldsmobile. The vehicle sustained impact deformation that was distributed across the frontal plane (**Figure 19**). The heaviest concentration of damage was located at the front left corner with separation of the bumper fascia, crush of the bumper reinforcement, and contact damage to the leading edge of the left front fender and hood face. The maximum crush was an estimated 25 cm (10.0 in) located at the left aspect of the front bumper. The direct contact damage extended across the entire width of the vehicle. The grille, air conditioning condenser, and upper radiator support appeared to have been sustained impact and damage. All glazing was intact and all four doors appeared to have remained closed and operational post-crash. The CDC for this Event 1 damage pattern was 11FDEW1.

Figure 19: Front view of the Oldsmobile after recovery by the police. Image supplied by an Internet news source.
