DOT HS 812 595

Special Crash Investigations On-Site Guardrail End Treatment Impact Investigation Vehicle: 2000 Volkswagen Jetta Location: Pennsylvania Crash Date: December 2016

SPECIAL CRASH INVESTIGATIONS
CASE NO.: CR16039
ON-SITE GUARDRAIL END TREATMENT IMPACT INVESTIGATION
VEHICLE: 2000 VOLKSWAGEN JETTA
LOCATION: PENNSYLVANIA
CRASH DATE: DECEMBER 2016

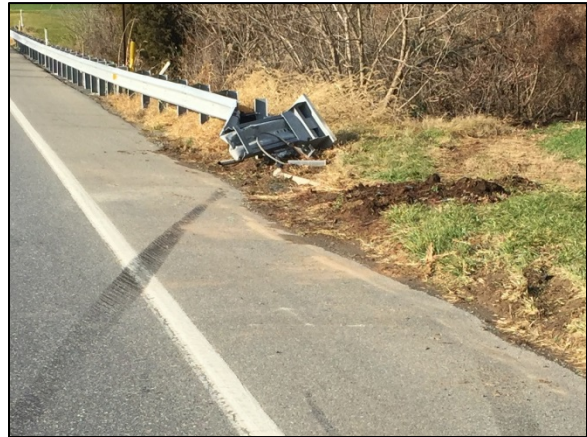
This report documents the on-site investigation of an impact into an ET-Plus guardrail end treatment (**Figure 1**) by a 2000 Volkswagen Jetta. The crash occurred when the Volkswagen departed the east edge of a local roadway in a clockwise yaw. The vehicle tripped and initiated a left side-leading rollover sequence and then impacted the end terminal with its left plane. Crash forces deformed the end treatment, and the vehicle ultimately rolled through the guardrail system and along the roadside. The crash resulted in fatal injuries to the Volkswagen's unbelted 34-year-old female, who was completely ejected during the rollover sequence and contacted by the vehicle as it rolled.

Figure 1: North-facing view of the damaged ET-Plus guardrail end treatment.

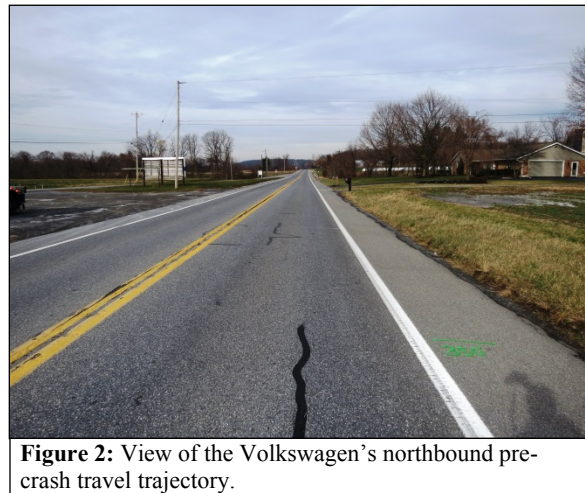
In the area of the crash, the two-lane roadway was straight and level. However, for the Volkswagen's pre-crash trajectory, the straight portion of the roadway where the crash occurred was preceded by a sweeping, large-radius right curve with positive grade. The curve ended approximately 250 m (820 ft) south of the impacted guardrail end treatment. **Figure 2** depicts a north-facing view of the Volkswagen's pre-crash trajectory on approach to the crash location. A crash diagram is included at the end of this technical report.

Figure 2: View of the Volkswagen's northbound pre-crash travel trajectory.

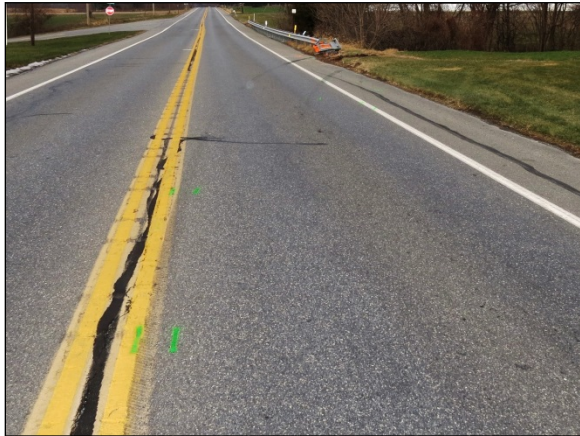
While the Volkswagen continued northbound, it began to drift right. Its right-side tires entered the shoulder. The driver then provided a left steering input in an attempt to maintain the roadway. She overcorrected, and the vehicle was directed left toward the roadway's centerline. The driver then reversed her steering input back to the right as she attempted to maintain control of the vehicle in the northbound lane. However, the back-and-forth movement of the vehicle, combined with the decreased friction of the roadway associated with the rain and corresponding wet surface, resulted in a loss of traction of the vehicle's tires. This produced a clockwise rotation to the Volkswagen about its vertical axis, which initiated a clockwise yaw.

Figure 3: North-facing view of the tire marks from the Volkswagen's left rear, left front, and right front tires that evidenced the vehicle's clockwise yaw and control loss.

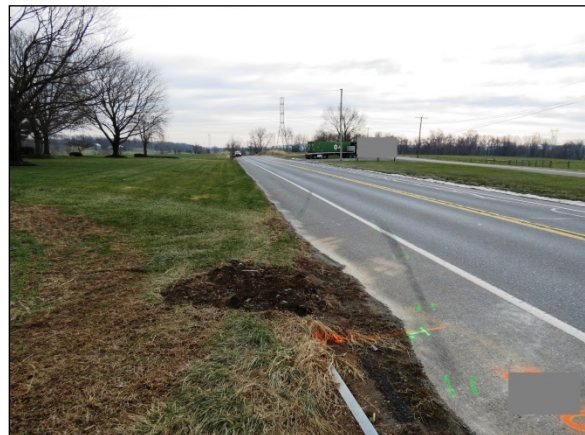
Instability was created with respect to the Volkswagen's center of mass by the lateral drag force load on the left front tire/wheel as it began to furrow into the soft soil surface of the roadside. Simultaneously, the left rear tire skidded laterally across the shoulder. This initiated the dynamics of a left-side leading tripped rollover (Event #1). However, the location of the vehicle's roadside departure and its yawing trajectory coincidentally aligned its left plane with the guardrail end treatment. As the left-side rollover began, the left plane of the vehicle then impacted the impact face of the end terminal in the area of the driver's door (Event #2). **Figure 4** depicts a south-facing lookback view of the yawing tire marks and roadside departure, with the ground strut of the end treatment installation visible in the bottom of the image.

Figure 4: South-facing view of the Volkswagen's yawing tire marks and roadside departure from beyond the location of the end terminal impact.

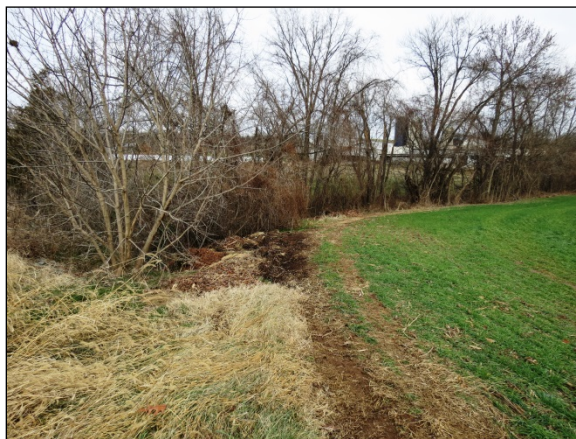
During the rollover event, the unbelted driver became displaced from her pre-crash position in the driver's seat and was completely ejected from the vehicle. Her ejection occurred as the vehicle completed its first complete roll and entered the fifth quarter-turn, which projected the driver forward and into the path of the rolling vehicle's trajectory. This subjected the driver to contact by the vehicle as it rolled. The Volkswagen ultimately came to final rest in the roadside (**Figure 5**), located 20.1 m (65.9 ft) northeast of Post 1 of the installation and 27.0 m (88.6 ft) northeast of the initial left front tire/wheel roadside departure. At rest, the vehicle was on its top plane facing east. An impact diagram is included at the end of this technical report.

Figure 5: Northeast-facing view of the location of the Volkswagen's final rest position in the east roadside.

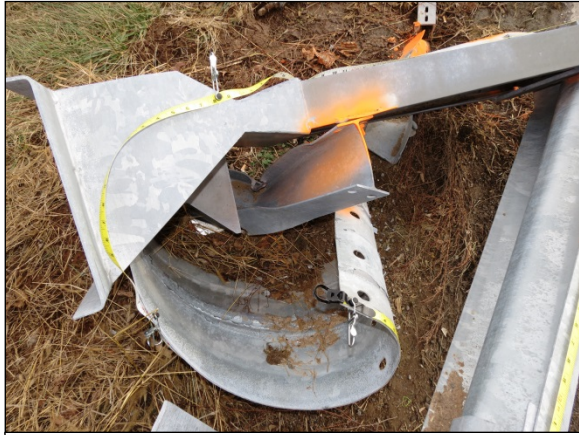
During the crash, the Volkswagen struck the impact face of the end terminal (originally located at Post 1) and displaced it northward along the W-beam. This flattened the guardrail, and it curled on the field side of the impact head. There was 1.0 m (3.5 ft) of flattened W-beam extruded from the impact head. Due to the configuration of the crash and the initiation of the vehicle's rollover dynamics prior to impact and engagement of the vehicle with the end terminal, the impact head and guardrail were directed toward the east as the system deformed. The lateral (east/west) component of the force exceeded the longitudinal (north/south) component of the force with respect to guardrail system and its installation. This resulted in decreased displacement of the impact head and increased bending displacement of the rail. The impact head's displacement then ceased, and the vehicle deformed the guardrail and system to the east along its crash trajectory. This formed a bend in the system in advanced of the impact head located 2.7 m (9.0 ft) downstream from the system's rail end as the impact head wrapped into the field side. The bend was not classified as a kink due to the direction of the forces involved, as it did not impede the impact head's displacement and was not related to a force directed along the rail. There was no intrusion or penetration of the system into the occupant compartment of the Volkswagen. A Post-Impact Guardrail Diagram is included at the end of this technical report.

Figure 7: View of the impact head and extruded rail from an overhead perspective.

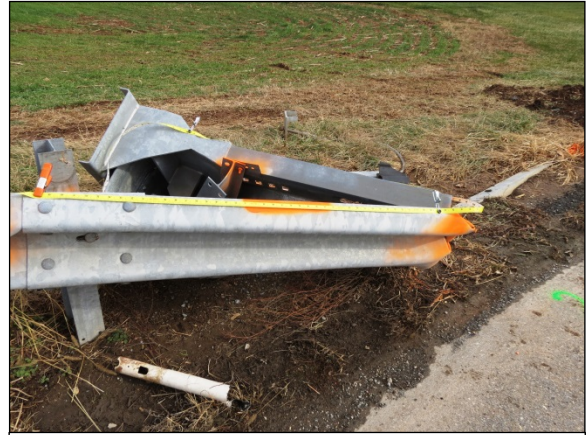
Figure 8: Southeast-facing view of the damaged ET-PLUS end treatment.

Post 1 consisted of a 10 x 15 cm (4.0 x 6.0 in) steel I-beam, which was attached via a hinge bolt to a lower post section that was embedded into the ground. The end terminal was attached to the I-beam by two shear bolts. The force of the impact caused the I-beam to shear at the hinged connection, which allowed the post to be displaced with the impact head. It remained connected to the impact head by the upper shear bolt at the time of the SCI inspection. The cable anchor, originally attached between Post 1 and the W-beam, was displaced an unknown distance to the northeast by the impact. The ground strut was not damaged in the crash.

Post 2 consisted of a 10 x 15 cm (4.0 x 6.0 in) I-beam SYT post with weakening holes installed approximately at ground level. At this post, the W-beam was originally bolted through a slot in the flange of the upper section of the post. During the crash, the W-beam separated from the post and the upper section of Post 2 was deformed 90-degrees to the northeast and partially sheared in the area of its weakening holes at ground level. At the time of the SCI inspection, the deformed upper section of Post 2 was in contact with the ground.

Post 3 was a 10 x 15 cm (4.0 x 6.0 in) I-beam SYT post with weakening holes at ground level, and had a composite block-out and carriage bolt that supported the W-beam. During the crash, the head of the carriage bolt pulled through the W-beam by deforming the slot in the rail. The composite block-out was fractured, but remained attached to the post. Post 3 was not deformed or displaced by the crash.

The damage to the end treatment's posts ended at Post 3. Due to the length of the rail sections, however, the W-beam guardrail itself required replacement to Post 5. Neither Post 4 nor Post 5 were damaged by the crash, and the W-beam remained installed with carriage bolts securing the W-beam to Posts 4 and 5 through undamaged composite block-outs.

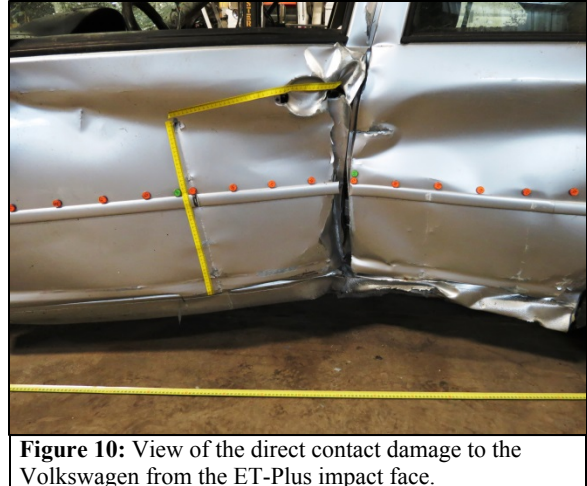
The impact with the ET-Plus end terminal's impact face (Event 2) resulted in a distinct pattern of direct contact to the Volkswagen's left plane that was highlighted by pronounced vertical marks from the protruding outer edges of the impact face. It began on the aft edge of the left front door on the B-pillar 106 cm (41.7 in) forward of the left rear axle, and extended 43 cm (16.9 in) forward to 149 cm (58.7 in) forward of the left rear axle. There were also pronounced marks from the vertical supports of the impact head on the left rear door. **Figure 10** depicts the distinct damage to the Volkswagen from the impact face of the end terminal (highlighted by yellow masking tape). The total length of the direct damage from the impact head and guardrail began 39 cm (15.4 in) rearward of the left rear axle and extended 188 cm (74.0 in) forward.

Figure 10: View of the direct contact damage to the Volkswagen from the ET-Plus impact face.

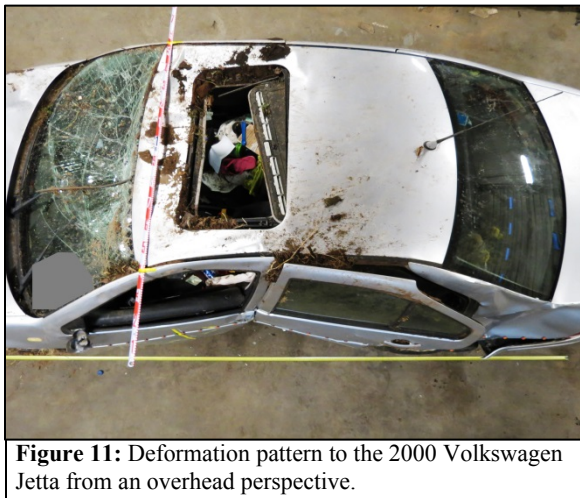
Figure 11: Deformation pattern to the 2000 Volkswagen Jetta from an overhead perspective.

A direct and induced damage length (Field-L) of 269 cm (105.9 in) was used to document a residual crush profile for the Volkswagen's Event 2 damage pattern. The Field-L began 61 cm (24.0 in) rearward of the left rear axle and extended 246 cm (96.9 in) forward. The crush profile (**Figure 11**) was documented by the SCI investigator using a Nikon Nivo 5.M+ total station mapping system, and was measured at mid-door level and adjusted to account for free-space. This profile produced the following measurements: C1 = 3 cm (1.2 in), C2 = 12 cm (4.7 in), C3 = 21 cm (8.3 in), C4 = 18 cm (7.1 in), C5 = 12 cm (4.7 in), and C6 = 2 cm (0.8 in). Maximum crush was located at the left B-pillar, and measured 22 cm (8.7 in). The Collision Deformation Classification (CDC) assigned to the Volkswagen for the ET-PLUS end treatment impact damage was 09LZEW2.

The impact yielded the end treatment, and involved the translation of crash forces to a non-horizontal direction during the later stages of engagement (due to the initiation of the rollover dynamics prior to impact). Although these characteristics were beyond the scope of analysis for the WinSMASH program, its barrier algorithm was used to calculate an estimated delta-V for the impact. The calculated barrier equivalent speed was 22 km/h (14 mph). Based on the visible damage sustained by the Volkswagen and SCI expertise, this appeared reasonable.

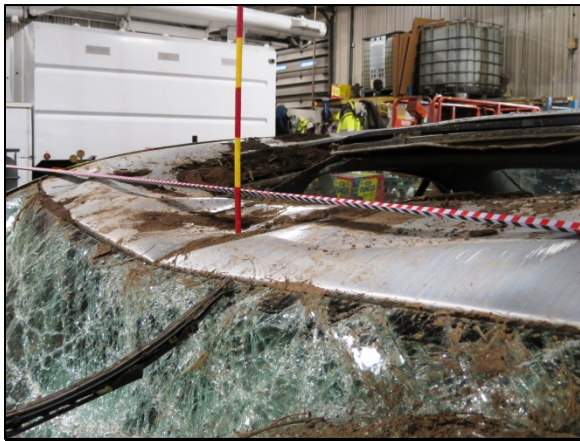
Damage associative to the rollover (Event 1) was visible to the top, left, and right planes of the Volkswagen. On the top plane, the roof exhibited minor deformation biased to its forward aspect, between the windshield header and the sun roof. The glazing of the sun roof remained intact, but the entire unit was completely separated from the vehicle. Clumps of soil with grass vegetation covered the roof's exterior surface. Deformation surrounded the windshield header, and the AS-1 laminated windshield glazing was fractured across its entire surface (not holed). Minor scratches and abrasions were visible to the surface of the hood. On the left plane, the side mirror was fractured from the vehicle. Minor deformation was visible to the left rear quarter panel. The side mirror was also fractured from the vehicle on the right plane, with dents in the upper right C-pillar and minor immeasurable deformation to the right front fender.

Figure 12: Vertical deformation to the Volkswagen's windshield header associative to the rollover event.

Maximum deformation to the Volkswagen associative to the rollover measured 10 cm (4.0 in) vertically to the windshield header near the vehicle's centerline. The deformation included 5 cm (2.0 in) from the level of the roof side rails (**Figure 12**) and an additional 5 cm (2.0 in) to account for the concavity of the roof structure. Associated with this deformation was minor vertical interior deformation/intrusion. No lateral deformation associative to the rollover could be discerned. The CDC assigned to the Volkswagen for the rollover damage was 00TDDO2. No

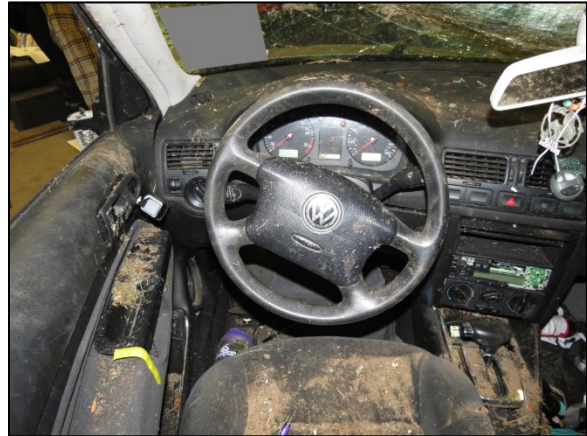
The steering column was equipped only with tilt adjustment, and was positioned between center and fully-upward at the time of the SCI inspection. No deformation was observed to the steering wheel rim or column. The area surrounding the driver's seat position (**Figure 13**) was inspected for occupant contact. Evidentiary of the lateral nature of the associated crash forces, no contact evidence was found on any of the forward components. However, several strands of the driver's hair were found captured in the weather stripping along the upper aspect of the left front door near the left roof side rail (**Figure 14**). There was also obvious deformation and displacement of the armrest and controls of the left front door panel (**Figure 15**) with scuffing on the upper rear aspect of the left front door panel. The combination of these three areas of occupant contact evidenced the driver's left lateral loading of the door during the impact and engagement with the ET-Plus end treatment, as well as her path of complete ejection through the left front glazing opening during the rollover sequence.

Figure 13: Interior of the Volkswagen as viewed from the driver's perspective during the SCI vehicle inspection.

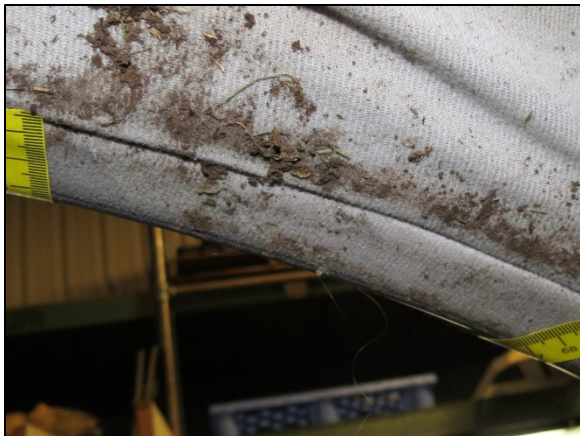
Figure 14: Image depicting strands of hair captured in the weather stripping near the left roof side rail from contact by the driver's head during her ejection.

During her ejection, the driver's head struck the upper aspect of the left front door near the left roof side rail, evidenced by hair captured in the vehicle's weather stripping. Her left hip loaded and scuffed the rear upper quadrant of the left front door. It is unknown if these contacts and loading produced injuries to the occupant, as the driver's complete ejection resulted in significant injuries that otherwise masked and/or exacerbated other previously sustained injuries.

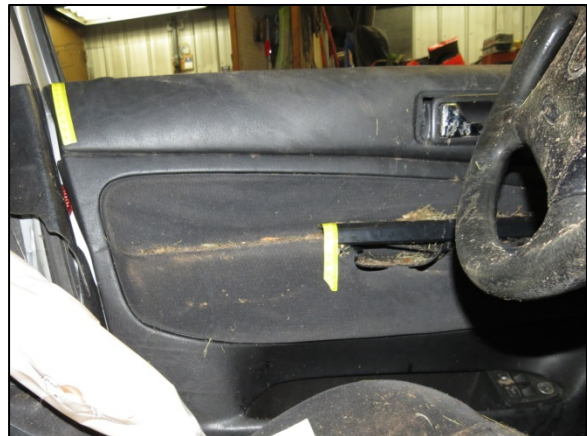
Figure 15: View of the Volkswagen's left front door with contact evidence from the driver to the armrest and rear upper quadrant.

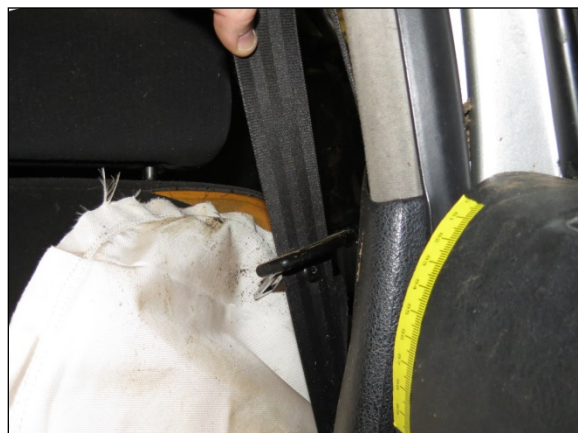
Inspection of the driver's seat belt system found the webbing retracted against the left B-pillar (**Figure 16**). Actuation of the retractor pretensioner had pulled the seat belt system taught against the B-pillar. Although there was evidence of historical use, no loading evidence could be found on the driver's seat belt system. Based on the retracted status of the belt system and lack of loading evidence, combined with the driver's completely ejected status, it was apparent to the SCI investigator that the system was not in use at the time of the crash.

Figure 16: Driver's seat belt system in the Volkswagen at the time of the SCI vehicle inspection.

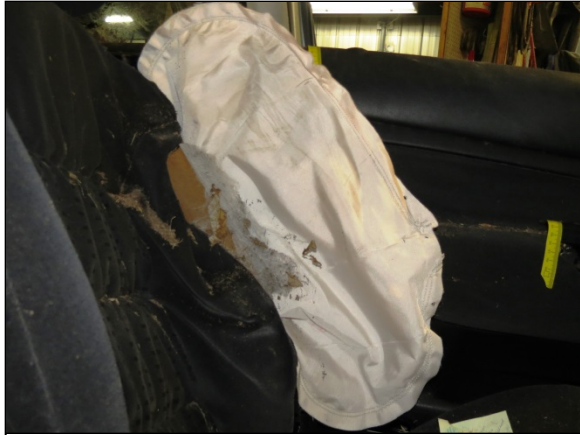
Figure 17: Driver's deployed seat-mounted side impact air bag in the Volkswagen at the time of the SCI vehicle inspection, with post-crash dirt/debris.

The driver's seat-mounted side impact air bag (**Figure 17**) deployed through the stitching on the leading edge of seatback. In its deflated state, the air bag measured 58 cm (22.8 in) in overall height and 24 cm (9.4 in) in overall width. A 4 cm (1.6 in) vent was located on the forward lower aspect of the air bag. There was no discernable occupant contact to the seat-mounted air bag. Despite the lack of physical evidence, the driver contacted and loaded the air bag during the crash sequence. It should be noted that the air bag had dirt and dry leaves on it at the time of the SCI inspection.
