DOT HS 812 596

Special Crash Investigations On-Site ET-2000 Guardrail End Terminal Investigation Vehicle: 2007 Toyota Camry Location: Missouri Crash Date: November 2015

INDIANA UNIVERSITY
TRANSPORTATION RESEARCH CENTER
ON-SITE ET-2000 GUARDRAIL END TREATMENT INVESTIGATION
CASE NUMBER - IN15030
LOCATION - MISSOURI
VEHICLE - 2007 TOYOTA CAMRY
CRASH DATE - November 2015

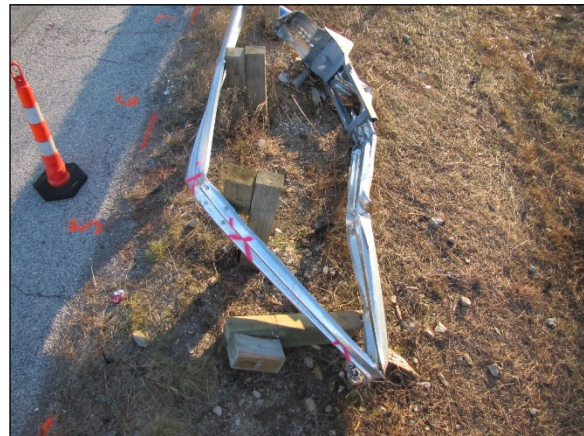
Figure 1: The damaged guardrail and ET-2000

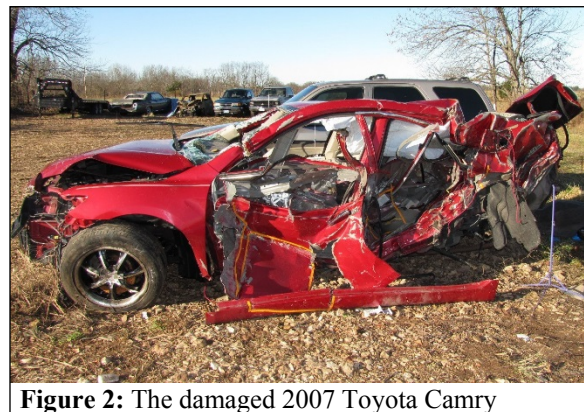
Figure 2: The damaged 2007 Toyota Camry

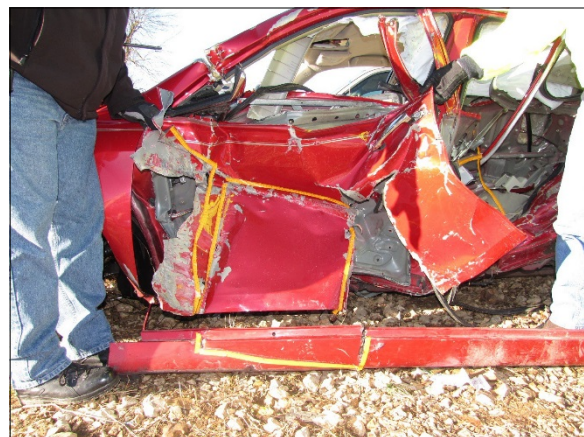
Crash: The left front door of the Toyota (Figure 5) impacted the ET-2000 (Figure 6, event 1). The calculated speed at impact (Attachment A) was 92 km/h (57 mph). The EDR-reported speed at trigger was 104 km/h (64.6 mph). The accuracy of this value is not known since the vehicle was in a yaw and the driver was applying the brakes prior to trigger. At the moment of impact, the left side of the vehicle was oriented approximately 90 degrees to the end terminal. The angle of the approach path of the vehicle's Center of Mass (COM) relative to the end terminal was approximately 20 degrees. The force direction on the Toyota was within the 11 o'clock sector based on the travel path of the COM relative to the guardrail. The impact resulted in deployment of the driver's seat-mounted side impact air bag and the left IC air bag. The Event Data Recorder (EDR)-reported the maximum Delta Vs occurring at the air bag control module sensor, B-pillar sensor, and C-pillar sensor as 19.8 km/h (12.3 mph), 20.1 km/h (12.5 mph), and 23.4 km/h (14.6 mph), respectively. The Toyota rotated counterclockwise as it remained engaged with the guardrail following impact and traveled approximately 12 m (39 ft) as the guardrail was deformed and displaced in a southwesterly direction. The vehicle then rolled over (event 2), right side leading, an estimated 13 quarter turns across a distance of 45 m (147.6 ft), coming to final rest near the bottom of the ravine on its left plane heading west. The "Rollover Initiation" type was classified as "Climb Over."

Figure 5: Damage to the left front door and sill of the Toyota from the impact with the ET-2000

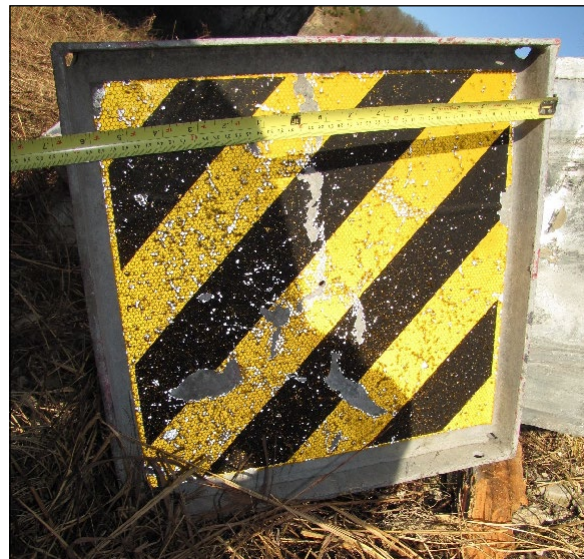
Figure 6: The damaged ET-2000, tape measure in feet and tenths of feet and centimeters

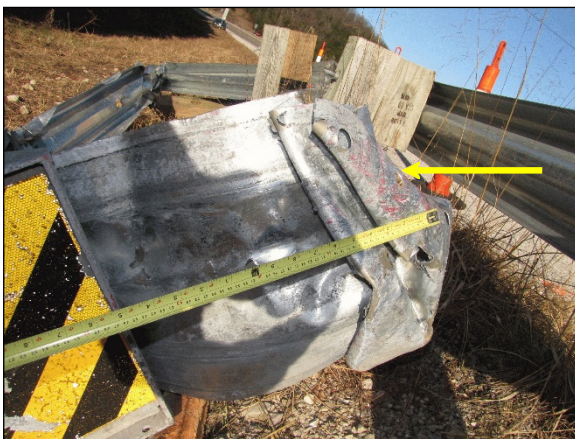
The left plane impact of the Toyota to the ET-2000 extruded 1.09 m (3.6 ft) of guardrail (**Figure 7**) toward the field side of the guardrail. Posts 1-4 were fractured and separated from the guardrail (**Figures 8 and 9**), while post 5 was slightly displaced within the ground (**Figure 10**) and the blockout was slightly displaced and damaged. The blockout for post 6 was slightly damaged and displaced, and the post slightly displaced (**Figure 11**) within the post hole. A 9.1 m (30.0 ft) length of guardrail was damaged by the impact. There were three kinks in the damaged guardrail downstream of the ET-2000 and one within the ET-2000. The kink within the ET-2000 (**Figure 12**) impacted the vehicle's left rear door (**Figures 13**) as the guardrail deformed, crushing the door and penetrating 23 cm (9.1 in) into the second row (**Figure 13**) and contacting the back of the driver's seat. The extruded section of guardrail impacted and deformed the front portion of the left front door (**Figure 5**). The FHWA Guardrail Form is attached to the end of this report as Attachment B.

Figure 7: Extruded guardrail from the ET-2000; arrows shows red paint from contact the Toyota's left front door

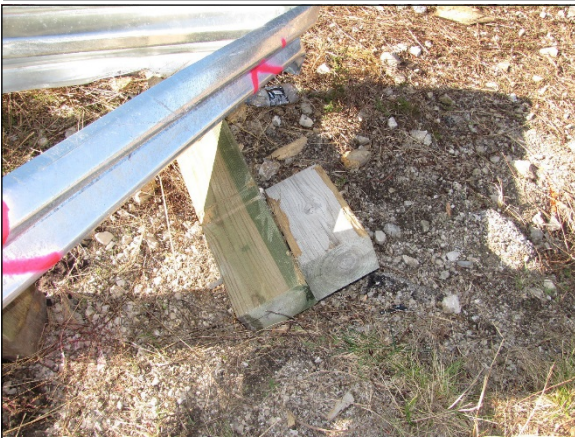
Figure 9: Damaged post 4, view west to field side,

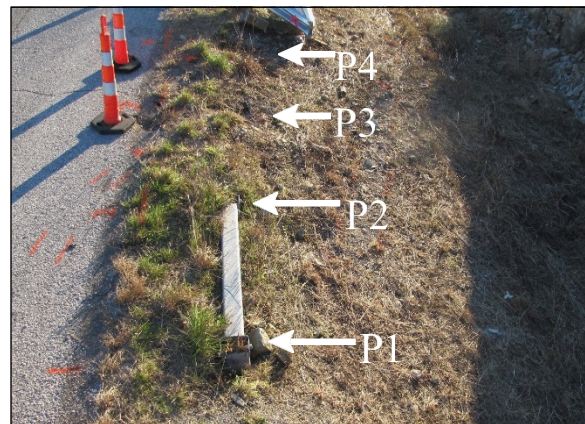
Figure 8: Post 1 - 4 were fractured and displaced, view southwest

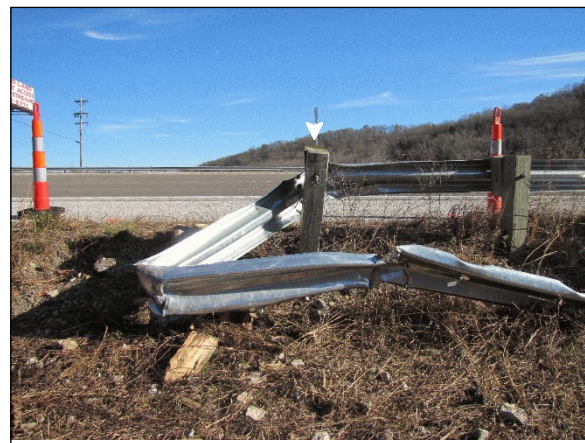
Figure 10: Slightly displaced post 5, view east

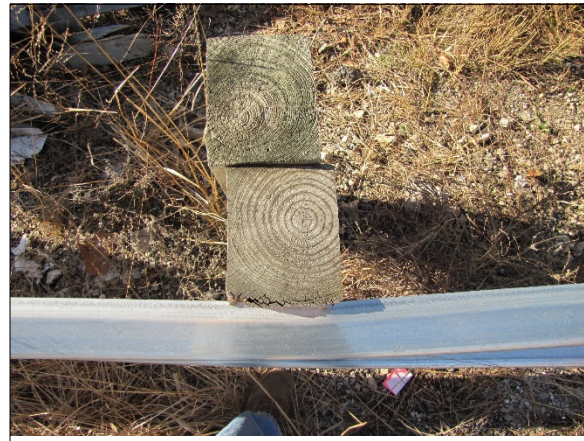
Figure 11: Block-out of post 6 slightly damaged

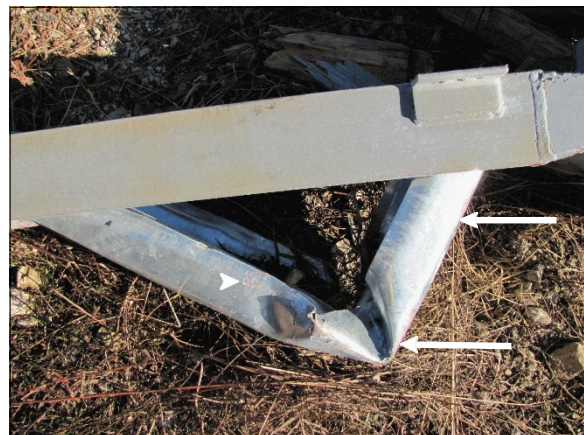
Figure 12: The kink within the ET-2000; arrows show red paint from contact with Toyota's left rear door

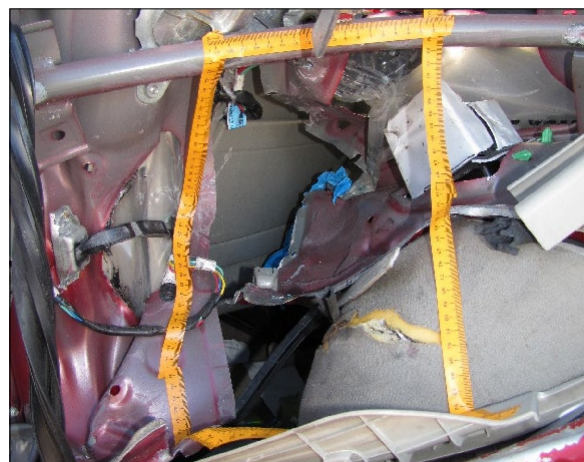
Figure 13: Hole in left rear door from contact by guardrail kink
