DOT HS 812 614

# **Special Crash Investigations Remote Vehicle Fire/Child Restraint System Investigation**

**Vehicle: 2004 Lincoln LS**

**Special Crash Investigations**  
**Remote Vehicle Fire/Child Restraint System Investigation**  
**Case Number: DS16028**  
**Vehicle: 2004 Lincoln LS**  
**Location: California**  
**Date: March 2012**

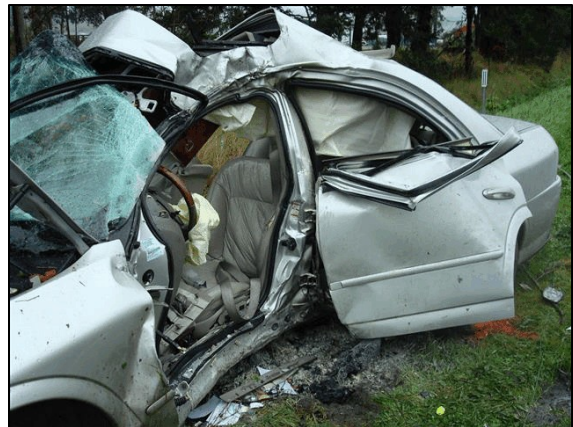
**Figure 1.** 2004 Lincoln LS (police photo)

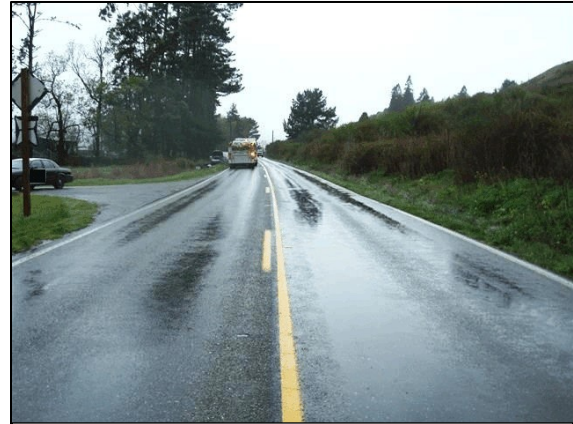
The crash occurred on a curved and level section of an undivided east/west State-maintained highway in California (**Figure 2**). Crash site data including roadway measurements were obtained from the police report, police on-scene images, and satellite images. The roadway was asphalt surfaced and was configured with one eastbound lane, one westbound lane, and narrow paved shoulders. The eastbound and westbound lanes each measured 3.7 m (12.0 ft) in width and the shoulders each measured (0.3 ft) in width. The travel lanes were separated by a double solid and dashed yellow painted stripe and bordered by solid white painted fog lines. The roadway appeared to be in good condition. The left curve had a radius of 1,250 m (4,101 ft) at the south fog line. The roadside on the left edge was unpaved and covered with grass. A wooden utility pole of an unknown diameter stood 2.7 m (9.0 ft) south of the south roadway edge. This pole supported electrical power lines and transformers. The posted speed limit was 89 km/h (55 mph). The investigating police officer noted no unusual conditions present at the time of the crash.

**Figure 2.** Crash site looking west (police photo)

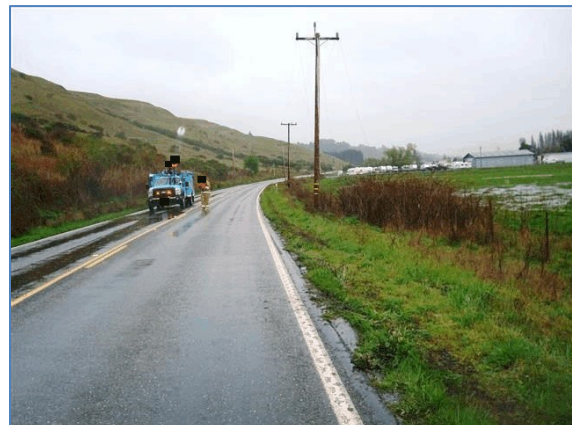
**Figure 3.** Crash site look-back view looking east (police photo)

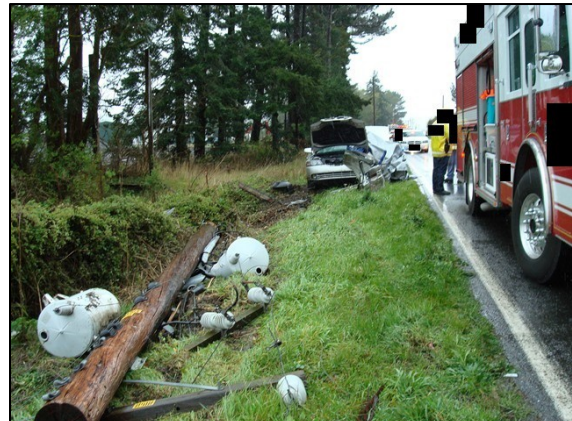
**Figure 4.** Utility pole, transformers, and power lines (foreground) and 2004 Lincoln LS (background) (police photo)

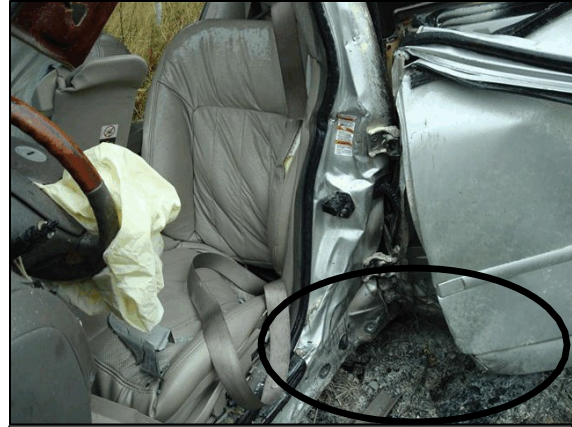
On-scene police photos indicate the fire burned adjacent to and underneath the vehicle's left plane (**Figure 5**). The photos of the interior suggest the fire did not spread to the engine compartment or interior of the vehicle or burn long enough to cause significant damage. The fire was extinguished prior to police and fire units arriving on-scene. Given the witness statements and police report, the investigation determined the original source of the fire was downed power lines lying near the vehicle.

**Figure 5.** Burn area, 2004 Lincoln LS (police photo)

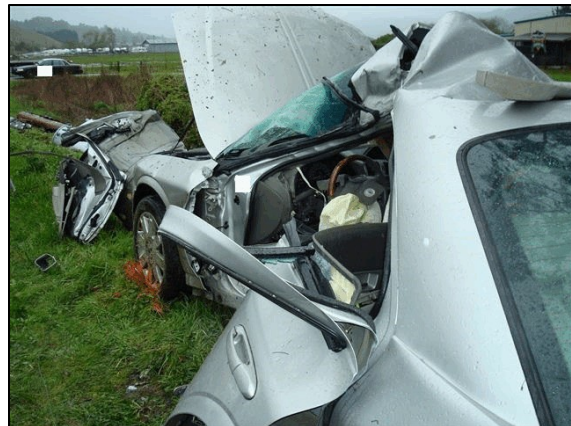
The front row left side door was removed during post-crash extrication efforts. Contact damage caused by the pole impact was located in the passenger sector of the left plane. Crush damage from the pole impact appeared to be located primarily in the area extending longitudinally from the left A-pillar to the left B-pillar and vertically extending from the left sill to the left roof (**Figure 6**). The estimated Collision Deformation Classification (CDC) for the Lincoln in Event 1 was 10LPAW3.

**Figure 6.** Direct damage to left roof, 2004 Lincoln LS (police photo)

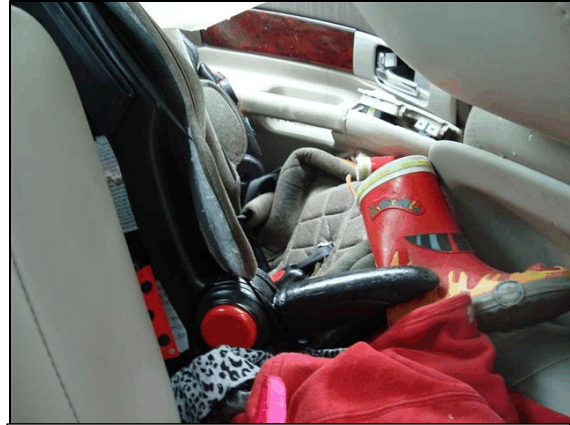
during extrication efforts. The instrument panel was fractured and the front row left seat cushion and back were deformed rearward and to the right. Lateral intrusion as seen in photographs reduced the front row at the left instrument panel, left door panel, sill, roof side rail, A-pillar, B-pillar, roof and driver's seat cushion, and back. Lateral intrusion reduced the second row at the left door and left roof side rail which contacted the CRS installed in the left seat position (**Figure 7**).

**Figure 7.** Second row left side door intruding into occupant compartment, 2004 Lincoln LS (police photo)

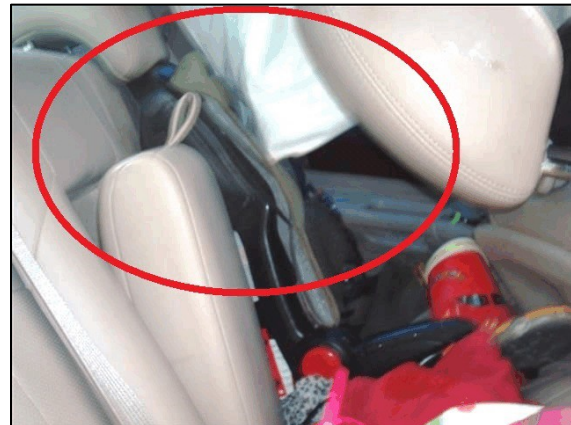
The Lincoln's supplemental restraint systems (SRS) included dual stage frontal air bags for the driver and front right occupant, seat-mounted side impact air bags for the front row occupant, and side impact inflatable curtain (IC) air bags for both rows. During the crash, the driver's frontal air bag and left IC air bag deployed. The deployed left IC air bag was adjacent to the CRS-restrained occupant seated in the second row left position and it appears this air bag possibly contacted the CRS and occupant during the crash (**Figure 8**).

**Figure 8.** Deployed left IC air bag and CRS installed in second row left position, 2004 Lincoln LS (police photo)

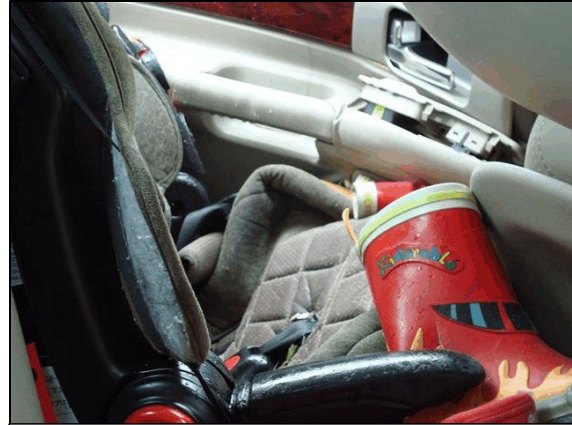
The 3-year-old male occupant of the Lincoln was seated in the second row left seat position and using a CRS of an unknown make and model (**Figure 9**). The CRS appears to be a forward-facing model configured with headrest, armrests, padded cushion, and an integrated 5-point harness system. The method for installing the CRS in the vehicle was unknown. Witnesses who were the first to arrive on-scene indicated to police that they removed the child from the CRS and vehicle. The occupant using this CRS occupant weighed 17 kg (37 lb) and his height at the time of the crash is unknown. No further details regarding this occupant's restraint usage were known.

**Figure 9.** CRS in second row left seat position, 2004 Lincoln LS (police photo)
