DOT HS 812 621

# **Special Crash Investigations On-Site SKT Guardrail End Treatment Investigation Vehicle: 1996 Chevrolet Tahoe Location: Missouri Crash Date: March 2016**

**Indiana University  
Transportation Research Center  
On-Site SKT Guardrail End Treatment Investigation  
Case Number - IN16008  
Location - Missouri  
Vehicle - 1996 Chevrolet Tahoe  
Crash Date - March 2016**

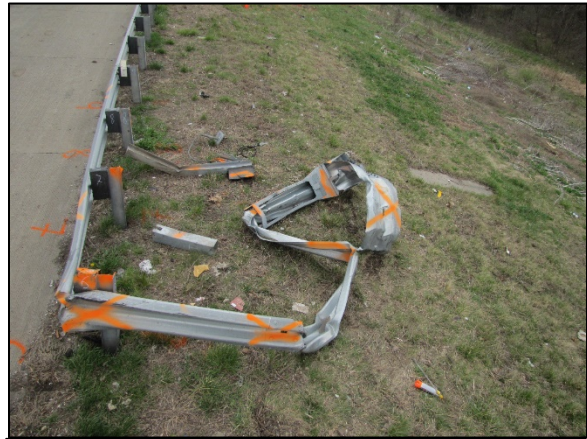
**Figure 1:** The damaged SKT and guardrail, view west

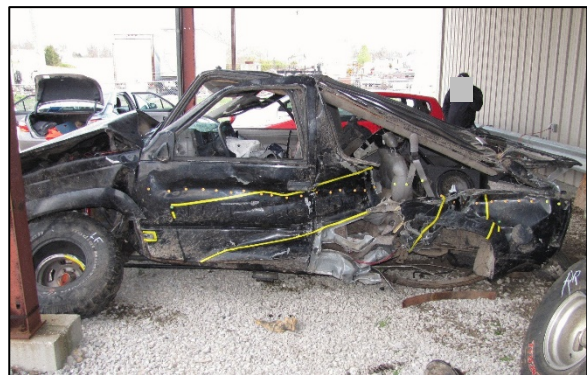
**Figure 2:** The damaged 1996 Chevrolet Tahoe

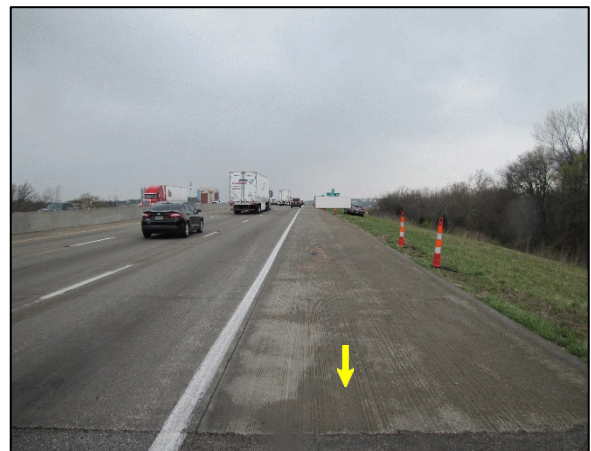
**Figure 3:** Approach of the Chevrolet to impact with the Saab parked on the shoulder (arrow), view west

The Chevrolet was traveling west in the right westbound through lane at an unknown speed. The driver began to pass an unknown vehicle by traveling to the right of that vehicle and onto the right shoulder (**Figure 3**), according to the police crash report. The Saab was unoccupied and parked on the right shoulder directly in the path of the Chevrolet (**Figure 3**).

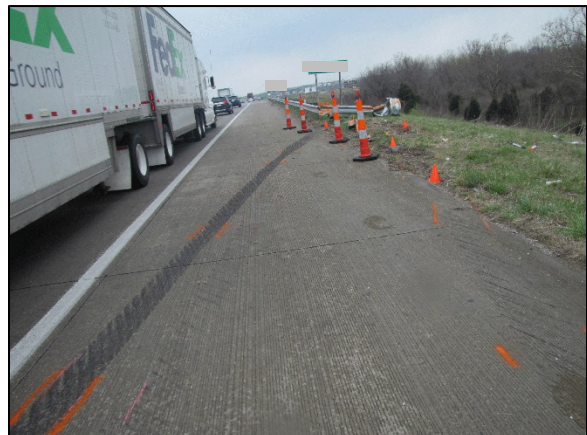
**Figure 5:** Path of travel of Chevrolet in clockwise yaw approaching impact with the end terminal, view west

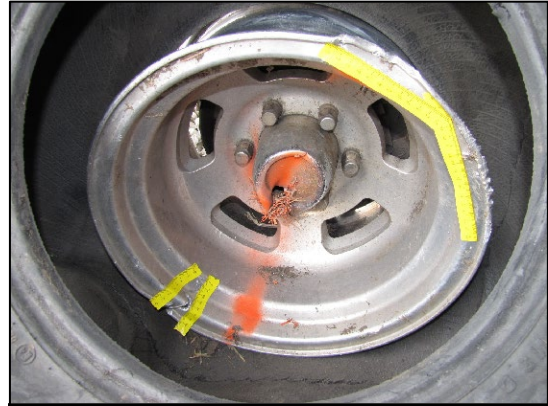
**Figure 6:** Damage to the Chevrolet’s left front wheel rim from the impact with the end terminal

**Exterior Damage Event 2:** The left front wheel and wheel well were directly damaged when the left plane struck the end terminal. Approximately half of the rim was directly damaged and the shape of the rim was stamped into the face of the end terminal. The end terminal and guardrail also contacted and damaged the left front door and the sheet metal rear of the door as the guardrail deformed during the impact. The sheet metal was sliced and a kink in the guardrail located at the entrance to the guide chute on the end terminal penetrated approximately 18 cm (7 in) into the second row left seating position where it contacted and deformed the second row seat back. The slice in the sheet metal was 64 cm (25.2 in) long and began 188 cm (74.0 in) rear of the left front axle. The area where the guardrail kink penetrated into the second row was located 240 cm (94.5 in) rear of the left front axle. The total length of the direct damage was 322 cm (126.8 in) beginning at the left front axle. A crush profile was measured at the mid-door level and the maximum residual crush was 26 cm (10.2 in) occurring 240 cm (94.5 in) rear of the left front axle. The crush values were:  $C_1 = 0$  cm,  $C_2 = 24$  cm (9.4 in),  $C_3 = 26$  cm (10.2 in),  $C_4 = 13$  cm (5.1 in),  $C_5 = 5$  cm (2.0 in),  $C_6 = 0$  cm.

**Damage Classification Event 2:** The CDC was 10LDEW3 (290 degrees). WinSMASH was used to calculate a barrier equivalent speed (BES) of 31 km/h (19 mph) based on the damage to the left plane. The result appeared reasonable.

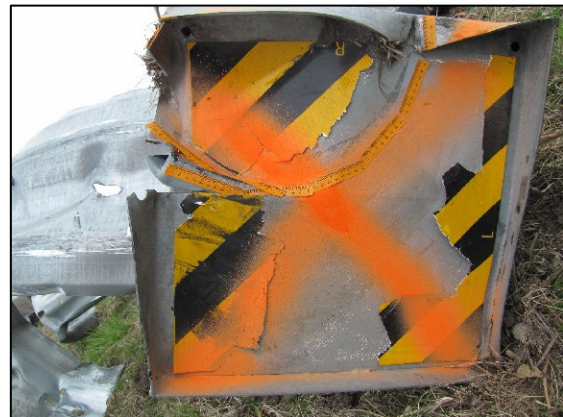
**Figure 7:** Shape of Chevrolet’s left front wheel rim stamped into face of end terminal

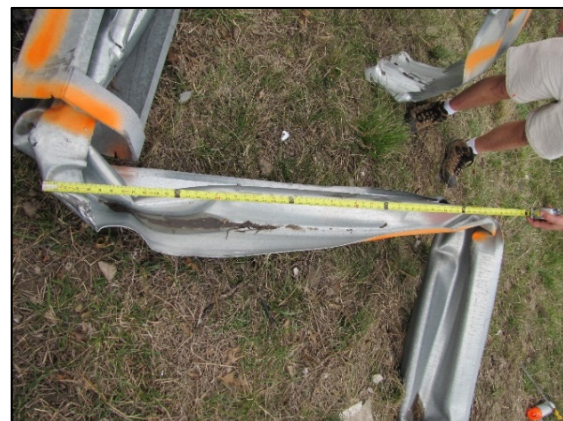
**Figure 8:** Kink in guardrail at entrance chute to end terminal

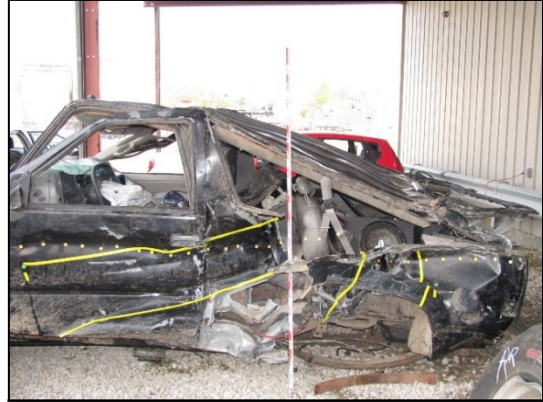
**Figure 9:** Area of guardrail kink penetration into second row

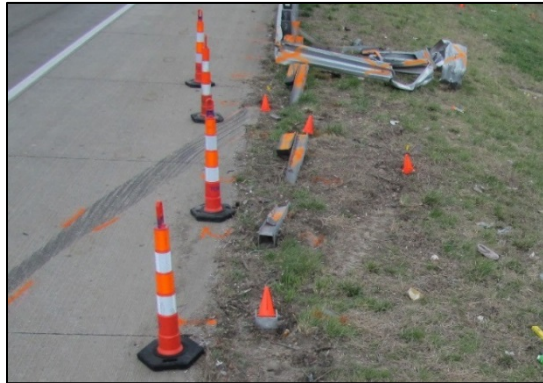
**Figure 10:** Guardrail separated from posts 1 - 5, view west

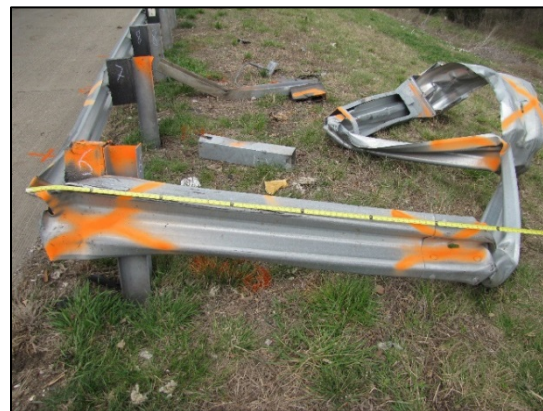
The Chevrolet's left plane impact to the end terminal extruded 2.7 m (8.8 ft) of guardrail toward the field side of the guardrail. The total length of damaged guardrail was 11.6 m (38.2 ft). An imprint of approximately half of the vehicle's left front wheel rim was stamped into the face of the end terminal. There also was an 18 cm (7.1 in) long slice in the face of the end terminal and transfer of rubber from the vehicle's left front tire. Posts 1 to 5 were separated from the guardrail (**Figure 10**). Post 1 was separated from its metal base and found on the field side of the guardrail between posts 6 and 7. Post 2 was rotated downstream on its pivot bolt to the ground. Post 3 was bent to the ground and its offset block remained attached to the post. Post 4 was pulled out of the ground and found on the field side of the guardrail between posts 7 and 8. Its offset block remained attached to the post. Post 5 was bent downstream approximately 40 degrees and its offset block remained attached to the post. Post 6 was bent approximately 10 degrees downstream and the bolt was pulled through the guardrail. Its offset block remained attached to the post. Post 7 was slightly displaced, but remained attached to the guardrail, and there was a slight bend in the guardrail at this post. MoDOT's paint markings for replacement of the guardrail and posts ended at Post 7. The bolts for Posts 1 to 6 were pulled through the guardrail. The guardrail was kinked in four locations (**Figure 11**). The first kink was located at the entrance to the guide chute on the end terminal. The last kink occurred at post 6 with the other two kinks located between these two. The anchor cable was displaced from the guardrail and found on the field side of the guardrail at post 8. There was no damage to the connection of the feeder channel to the end terminal

**Figure 11:** Four kinks in the guardrail and extruded guardrail from the end terminal, each black mark on tape is 0.3 m (1.0 ft), view west
