DOT HS 812 627

Special Crash Investigations On-Site ET-Plus Guardrail End Treatment Crash Investigation

Vehicle: 1996 Toyota Camry

Location: Missouri

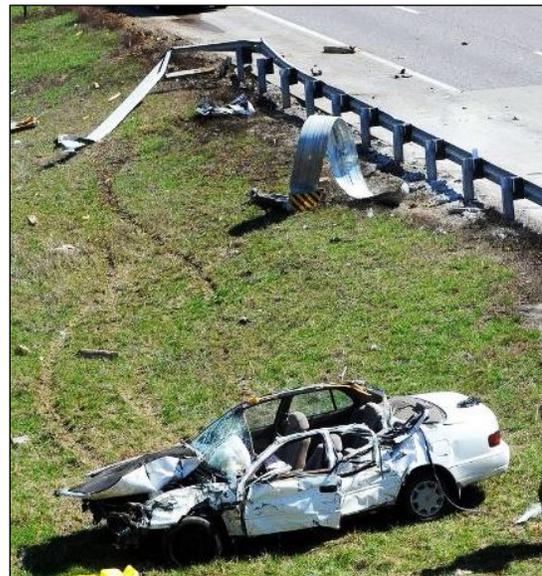
Figure 1: East-facing view of the Toyota and guardrail following the crash (*on-scene image obtained from an online news source*).

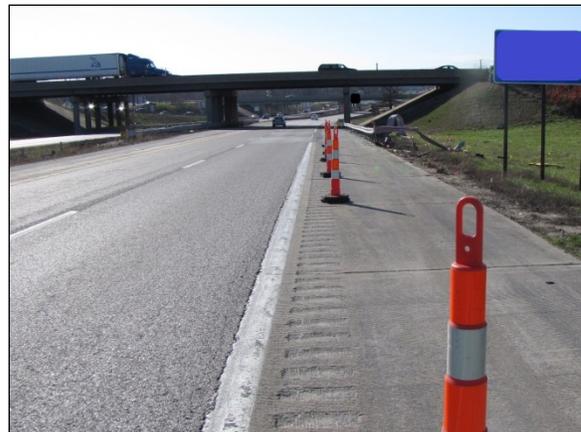
Figure 2: View of the Toyota's westbound pre-crash travel trajectory on the limited access roadway.

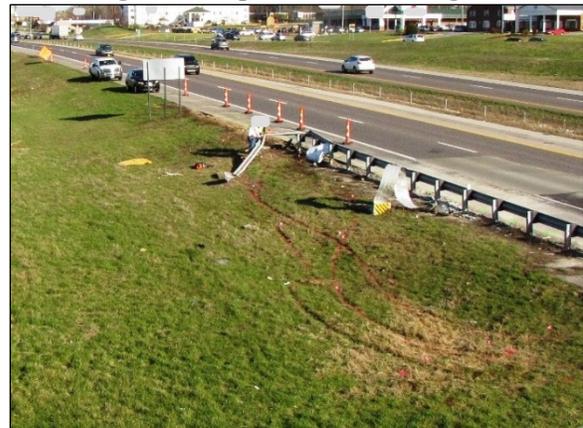
Figure 3: East-facing view of the crash site, the deformed guardrail, and vehicle tire marks, visible from a nearby overpass at the time of the SCI inspection.

behind the guardrail, the Toyota completed 270-degrees of counterclockwise rotation through the soil surface of the roadside. The Toyota's trajectory through the roadside was evidenced by tire marks (**Figure 3**) through the grass and soil surface.

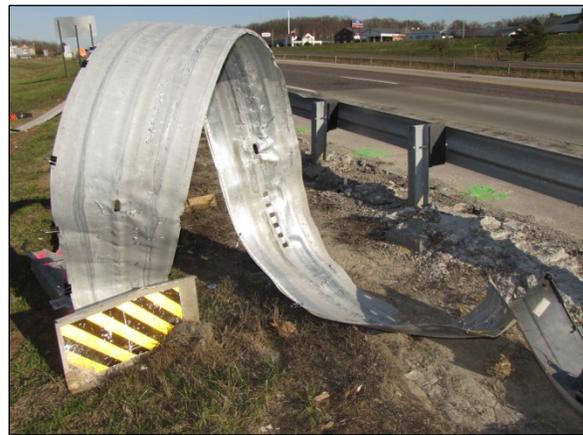
During the crash, the Toyota struck the impact-face of the end terminal (originally located at Post 1) and displaced it westward along the W-beam. This flattened the guardrail, and it curled on the field side of the impact head. Approximately 4.9 m (16.1 ft) of flattened W-beam extruded from the impact head. This corresponded to the approximate location of Post 4, evidenced by the presence of the carriage bolt hole/slot for Post 4 in the exit chute of the end terminal's impact head. Based on the SCI inspection, it was determined that a kink developed in the W-beam between Post 4 and Post 5 ahead of the impact head as it was displaced along the rail. This kink allowed the W-beam guardrail to override the left front fender and hood of the Toyota. The W-beam penetrated through the Toyota's windshield, contacted the top instrument panel and steering wheel, and then engaged the windshield header of the vehicle. This sheared the roof from the Toyota and severed the W-beam guardrail. No occupant contact occurred during this penetration of the guardrail. The severed section of guardrail, which included the end terminal impact head, was projected along the Toyota's crash trajectory. It struck the W-beam guardrail between Post 12 and Post 15, deformed Post 15, and came to final rest in the roadside (**Figure 5**).

Figure 5: West-facing view of the ET-Plus end terminal impact head and deformed W-beam guardrail in their displaced position following the crash.

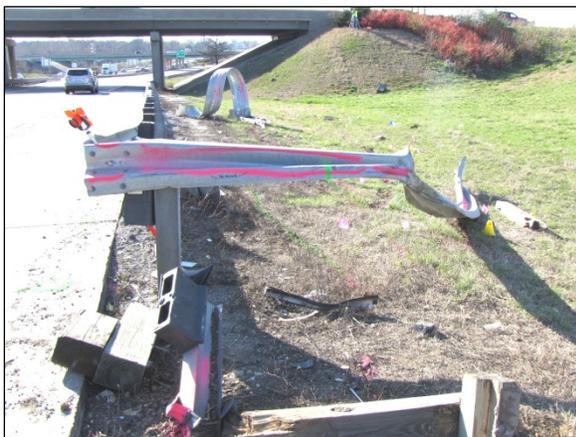
Figure 6: West-facing view of the deformed guardrail at the time of the SCI inspection.

up to Post 9 was displaced into the area of protection by the Toyota. At the time of the SCI inspection, this 8.9 m (29.2 ft) length of W-beam extended from Post 9 at an approximate 30-degree angle in the direction of the Toyota's crash trajectory (**Figure 6**). The ET-Plus guardrail was inspected post-crash and documented by the SCI Investigator through a combination of

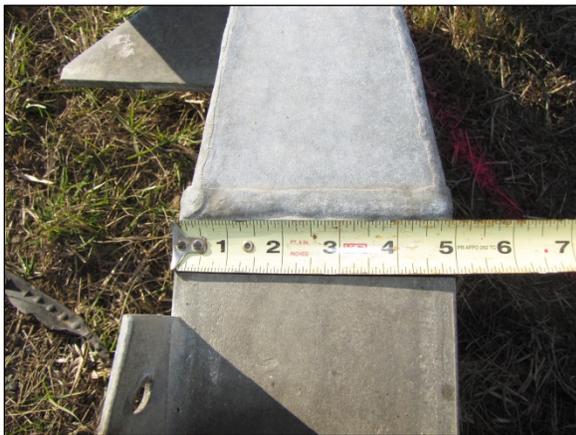
The height of the W-beam was 69 cm (27.0 in), measured at an undamaged section between Post 13 and Post 14. Dimensions of the impact-face of the end terminal measured 39 x 71 cm (15.5 x 28.0 in), width x height. The extruder head's length was 50 cm (19.7 in) and the guide chute's length was 92 cm (36.2 in), producing a total overall length for the ET-Plus end terminal device of 142 cm (55.9 in). The width of the guide chute (**Figure 7**) was 12.5 cm (4.9 in).

Figure 7: Measurement of the guide chute width of the ET-Plus end terminal device at the time of the SCI crash site inspection.

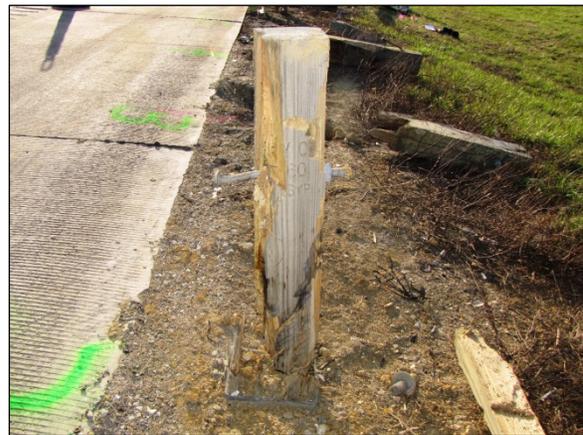
The first seven posts, all of which were all wood, were sheared approximately at ground level. Further damage was sustained by steel posts at post locations 8, 9, and 15. The SCI Investigator examined all remnants of posts, which were strewn in the roadside in the crash trajectory of the Toyota. A reconstruction was performed to match each post to its original location for examination purposes. **Figure 8** depicts sheared Post 2, replaced and resting on its base during

Figure 8: View of damaged Post 2 (repositioned for documentation during SCI reconstruction) and other sheared posts at the crash site.

inspection. Other sheared posts can be seen in the background. The W-beam guardrail sustained damage from Post 1 to Post 10, with a total damaged length of 15.4 m (50.5 ft). A separation in the guardrail had occurred between Post 4 and Post 5.

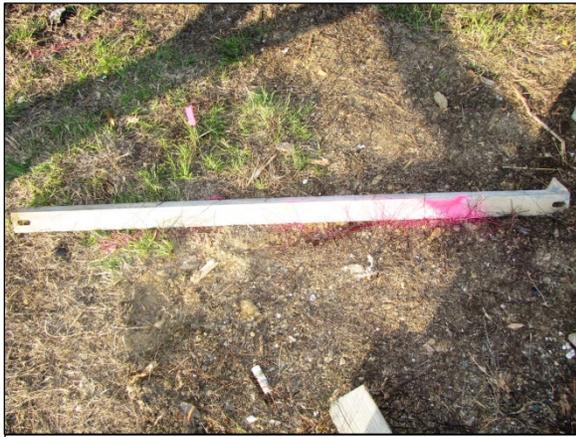
Figure 9: Displaced ground angle strut.

A ground angle strut was originally installed between Posts 1 and 2 on the field side. This strut tensioned the system and was bolted to the side of the steel post sleeves. During the crash, the angle strut was sheared from its mounting location and displaced along the Toyota's crash trajectory. **Figure 9** depicts a view of the traffic-side of the separated ground angle strut at the time of the SCI crash site inspection. As positioned in the image, the right aspect of the strut was attached to the field side of the Post 1 sleeve.

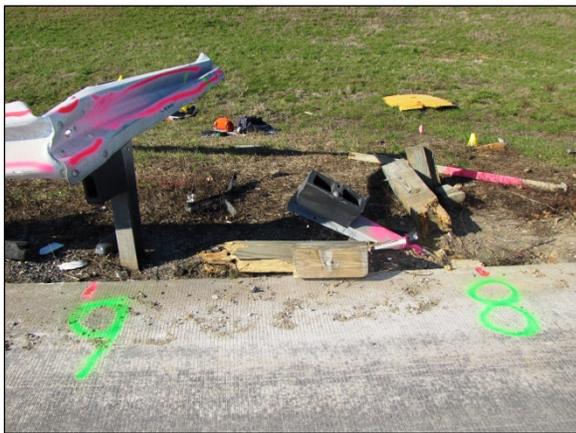
Figure 10: View of deformed Post 8 and Post 9 at the time of the SCI crash site inspection.

Post 8 marked the transition from the end treatment to the standard guardrail barrier. From Post 8 onward, all posts were nominal 10 x 15 cm (4 x 6 in) steel I-beams and the W-beam was supported by 19 cm (7.5 in) composite block-outs with carriage bolts. Post 8 was deflected approximately 60-degrees in the direction of the Toyota's crash trajectory, and rotated approximately 45-degrees counterclockwise. The composite block-out remained attached to the post with the carriage bolt, which had pulled through the hanger slot in the guardrail. It was apparent that the Toyota had directly engaged

Post 8 during the crash. **Figure 10** depicts deformed Posts 8 and 9, as well as the location of the displaced angle strut and several of the displaced and sheared wooden posts. Post 9 remained in a vertical position. The block-out remained attached to the face of the post, though the carriage bolt had pulled through the hanger slot in the guardrail. Although it did not appear to be deflected by the crash, it was rotated approximately 10-degrees clockwise. There was no visible direct contact to Post 9 from the Toyota. At Post 10, the guardrail was separated from the post

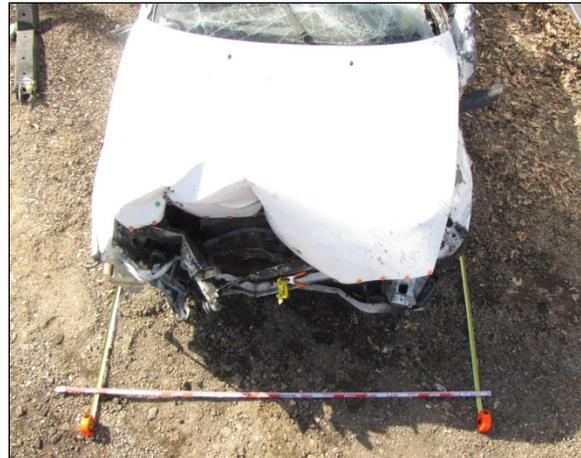
The Toyota sustained impact damage to its front, left, and top planes, consistent with the events of the crash. Direct contact damage on the front plane from the initial impact with the ET-Plus end terminal impact head began 4 cm (1.6 in) right of center and extended 36 cm (14.0 in) to the right. This damage was evidenced by vertically-oriented impressions and crush that mirrored the profile of the impact head. The front bumper cover was fractured and separated during the impact. Longitudinal deformation was sustained by the bumper beam, radiator support, hood, and engine compartment components. The right front headlight assembly was disintegrated, and the hood was deformed. **Figure 12** depicts an overhead view of the Toyota's front plane and the damage associative to the initial impact with the ET-Plus end terminal impact head.

Figure 12: Overhead view of the Toyota depicting the frontal deformation.

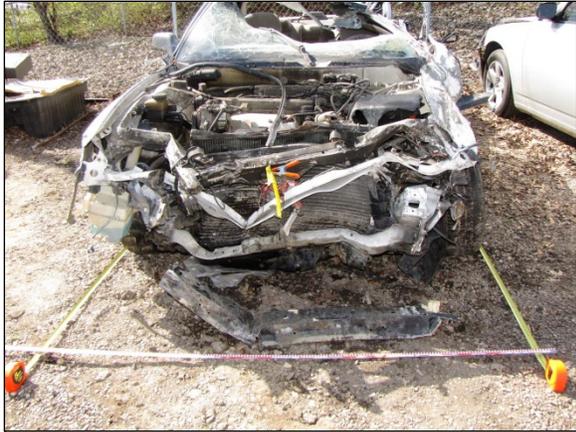
Figure 13: Front plane view of the 1996 Toyota Camry.

A residual crush profile was documented by the SCI Investigator using a Nikon Nivo 5.M+ total station mapping system. Due to the separation of the bumper beam (**Figure 13**), the crush profile was measured along both the lower radiator support and leading edge of the hood. However, the magnitude of the hood crush was not sufficient to warrant an averaged profile, and the hood measurements were dropped. The Field-L width measured 118 cm (46.5 in) across the front plane.

The documented residual crush profile produced the following resultant measurements: C1 = 5 cm (2.0 in), C2 = 11 cm (4.3 in), C3 = 22 cm (8.7 in), C4 = 41 cm (16.1 in), C5 = 38 cm (15.0 in), and C6 = 19 cm (7.5 in). Maximum crush measured 60 cm (23.6 in), observed between the C4 and C5 measurement locations. The collision deformation classification (CDC) assigned to the damage pattern was 12FZEN2. This crash type was outside of the WinSMASH program's scope for analysis due to the yielding property of the impact. A borderline reconstruction of the crash severity (delta-V) was calculated using Barrier algorithm of the WinSMASH model. The calculated barrier equivalent speed (BES) was 37 km/h (23 mph). Based on SCI expertise, the estimated vehicle velocity change (delta-V) of the impact was 24-32 km/h (15-20 mph).

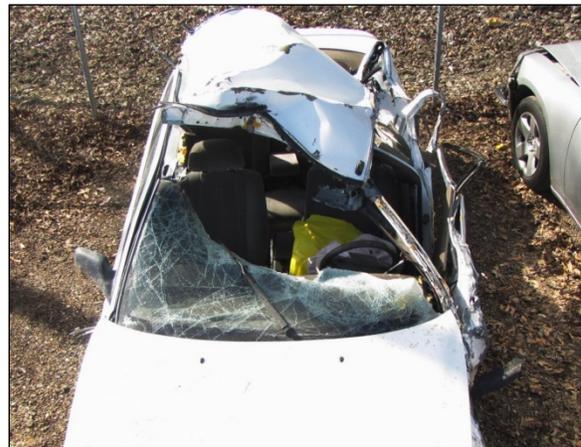
The second impact event consisted of engagement of the guardrail kink between Posts 4 and 5 with the Toyota that resulted in separation of the Toyota's entire roof structure. Induced lateral deformation of the left A-pillar, left B-pillar, and left roof side rail accompanied the damage pattern. Direct contact damage began on the upper aspect of the left front fender, extended onto the hood, penetrated into the occupant compartment adjacent to the left A-pillar, and extended vertically to the windshield header. No specific measurements could be obtained to accurately document the damage profile. The CDC assigned to the damage was 00LYHW6.

This impact was outside of the scope of the WinSMASH program; no representative or comparison value could be calculated. The estimated delta-V was of moderate-severity. **Figure 14** depicts the Toyota with the separated roof repositioned on the damaged vehicle.

Figure 14: Overhead view of the Toyota with the separated roof repositioned for documentation purposes.

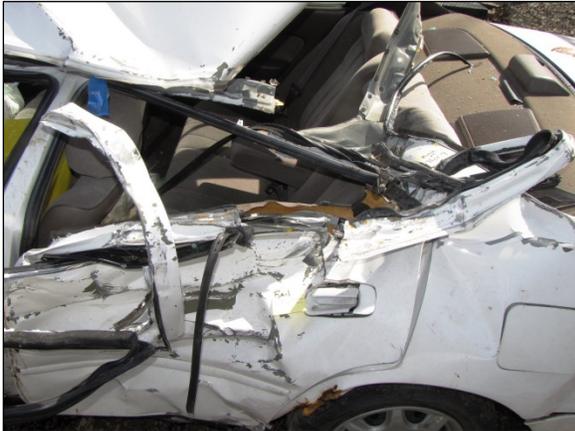
Figure 15: View of the Event 3 area of damage to the Toyota's left plane.

The third event involved the engagement of a secondary kink in the guardrail, located between Posts 8 and 9, with the left plane of the Toyota. Direct contact damage began near the center aspect of the left rear door and continued at beltline level to the left C-pillar. In this area, the upper aspect of the left rear door and the left upper C-pillar were deformed toward the interior of the vehicle. **Figure 15** depicts the area of the Event 3 damage pattern. The guardrail penetrated the interior through the left rear glazing opening and contacted the upper aspect of the second row left seatback.

No specific measurements could be obtained to accurately document the Event 3 damage profile. The CDC assigned to the damage was 00LZHN3. This impact was also outside of the scope of the WinSMASH program; no representative or comparison delta-V value could be calculated. The severity of this impact was also rated as moderate.

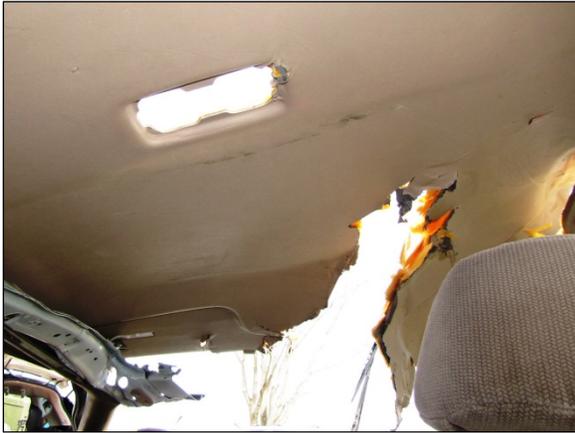
Figure 18: Forward-looking view of the Toyota's headliner as viewed from the second row right position.

The penetrating guardrail continued vertically and engaged the windshield header and roof structure of the Toyota. This resulted in lateral deformation to the left upper pillars and left roof side rail, and separated the entire roof structure. Direct contact damage associated with the second event extended from the left plane across the vehicle's centerline, above the front row right seat position.

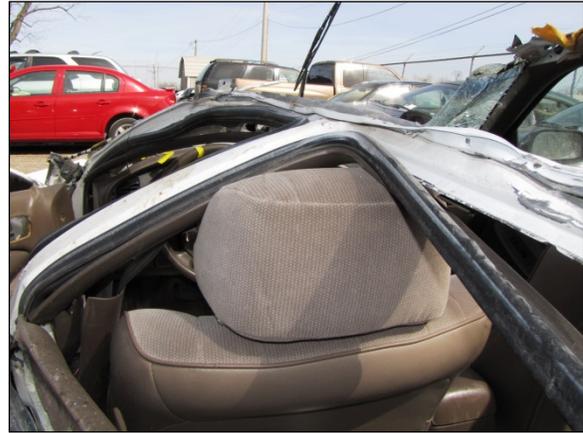
Figure 19: Intrusion of the Toyota's left B-pillar and left roof side rail induced by the engagement of the kinked guardrail with the roof structure.

Intrusions into the Toyota's interior that were related to the first guardrail kink and penetration included 20 cm (8.0 in) lateral intrusion of the left roof side rail and 21 cm (8.2 in) lateral intrusion of the left B-pillar. Significant penetration and damage was visible to the separated roof's headliner (**Figure 18**). Also associated with the first kink and roof separation were the 22 cm (8.5 in) vertical intrusion of the left B-pillar and 24 cm (9.5 in) vertical intrusion of the left roof side rail (**Figure 19**).

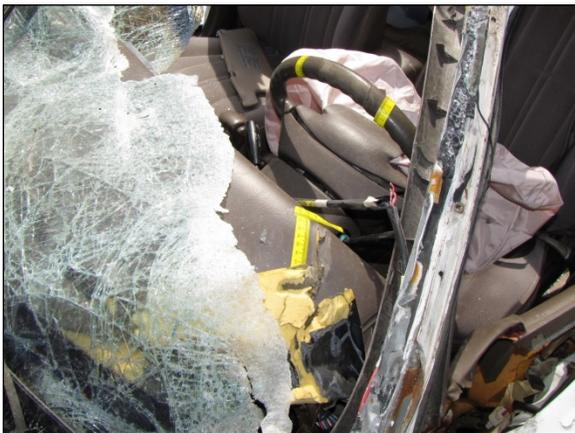
The first guardrail penetration resulted when the W-beam kinked between Posts 4 and 5 during the initial stages of the crash sequence. The kink occurred in advance of the ET-Plus impact head as it was displaced along the guardrail. The kink overrode the left aspect of the Toyota's hood and penetrated into the vehicle's interior through the base of the windshield, adjacent to the left A-pillar. The guardrail then contacted the top of the left instrument panel, deforming the foam and polymer surface (**Figure 16**). It also contacted the top of the steering wheel rim and the top of the deployed driver's frontal air bag, which resulted in a cut, abrasions, and rearward deformation of the steering wheel rim, as well as an abrasion to the driver's air bag. **Figure 17** depicts the damage to the top of the steering wheel rim from the penetrating guardrail.

Figure 16: Penetration damage to the windshield, instrument panel, and steering wheel rim from the guardrail associated with Event 2.

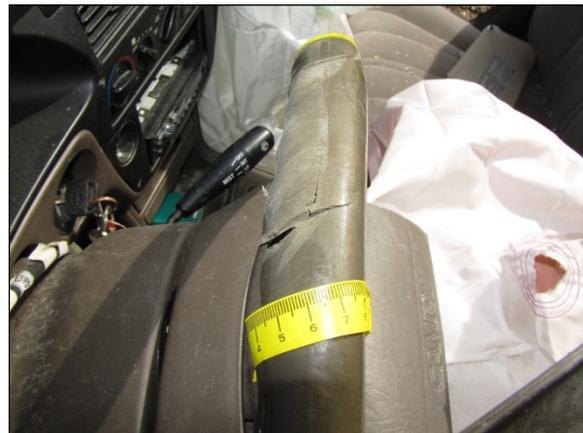
Figure 17: Damage to the steering wheel rim that resulted from contact with the guardrail as it penetrated into the Toyota's interior.

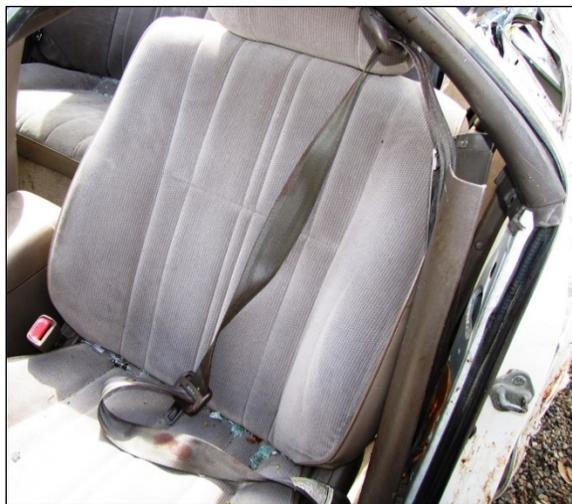
Inspection of the driver's safety belt system found the webbing extended from the retractor. It was locked in position due to deformation to the B-pillar and corresponding engagement of the ELR. There was historical wear to the latch plate and webbing, though no significant loading evidence was identified. It should be noted that significant loading evidence would not be expected in a crash of these circumstances due to the relatively low to moderate severity of the impact's delta-V and its distribution of force over an extended time period.

Figure 20 depicts the driver's safety belt system. The SCI Investigator did identify several areas of blood droplets on the webbing, as well as on the latch plate. Based on the post-crash condition of the safety belt system and the driver's status, the SCI Investigator determined that the driver was restrained by the manual safety belt system at the time of the crash.

Figure 20: Toyota driver's lap and shoulder safety belt system at the time of the SCI vehicle inspection.

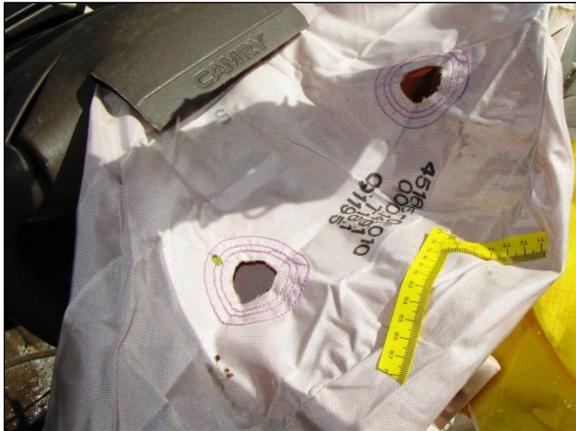
The driver’s air bag deployed from the module without damage or occupant contact to the module cover flaps. Nomenclature located on the air bag between its two vent ports included “45165-06010,” “0001491,” T181,” and “091195.” Aside from manufacturer part numbers, the nomenclature indicated that the air bag was manufactured on September 11, 1995. A small scuff/abrasion was located on the forward-facing aspect of the air bag above the vent ports, at the 12 o’clock position (**Figure 21**).

Figure 21: Abrasion to the top of the Toyota’s driver air bag from contact with the intruded guardrail.

This abrasion was in alignment with the gouge on the top of the steering wheel, and was determined to have resulted from contact with the intruding guardrail during the crash sequence. On the air bag’s face, there were a few droplets of blood at the upper aspect (**Figure 22**).

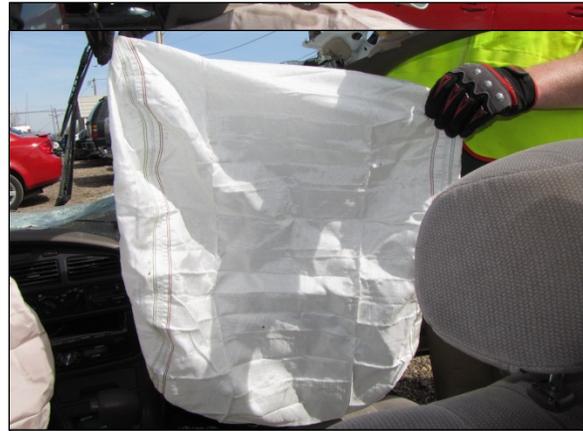
Figure 23: View of the deployed front right air bag in the Toyota at the time of the SCI inspection.

The front right air bag also deployed from its module without damage to the air bag or its cover flaps. The large air bag was vented on each side near its upper aspect. Inspection of the front right air bag was unremarkable. **Figure 23** depicts the large deployed air bag in its deflated state. There was no occupant contact from the restrained driver to the front right air bag.
