DOT HS 812 639

# **Special Crash Investigations On-Site Guardrail End Treatment Impact Investigation Vehicle: 2002 Kia Sportage Location: Missouri Crash Date: April 2016**

**INDIANA UNIVERSITY**  
**TRANSPORTATION RESEARCH CENTER**  
**ON-SITE GUARDRAIL END TREATMENT INVESTIGATION**  
CASE NUMBER - IN16011  
LOCATION - MISSOURI  
VEHICLE - 2002 KIA SPORTAGE  
CRASH DATE - APRIL 2016

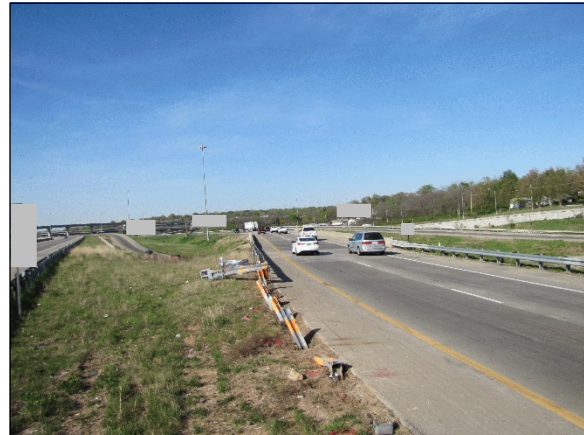
**Figure 1:** View north to the damaged guardrail

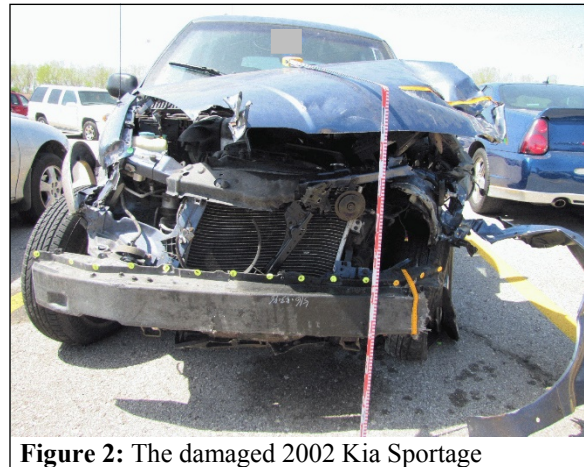
**Figure 2:** The damaged 2002 Kia Sportage

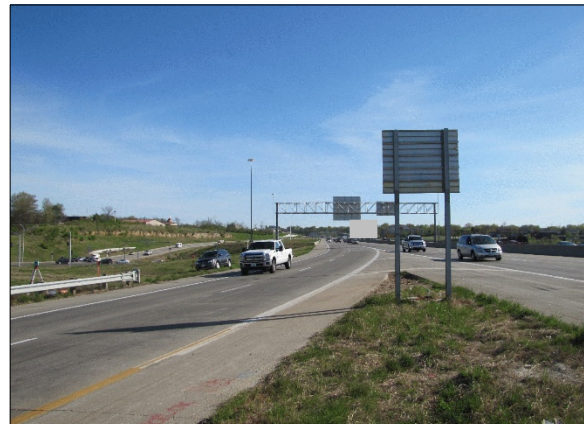
**Pre-Crash:** The Kia was traveling north in the left exit ramp lane (**Figure 3**). The driver fell asleep and the vehicle departed the left (west) side of the exit ramp (**Figure 4**) and entered the gore heading straight at the SKT.

**Figure 3:** View south from the end of the damaged guardrail to the approach of the Kia

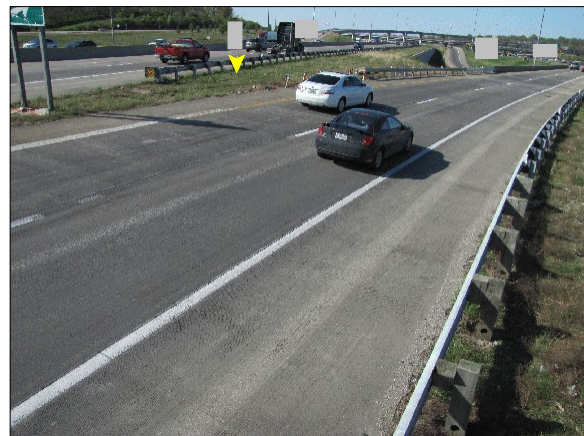
**Figure 4:** View northwest to the area of impact with the SKT

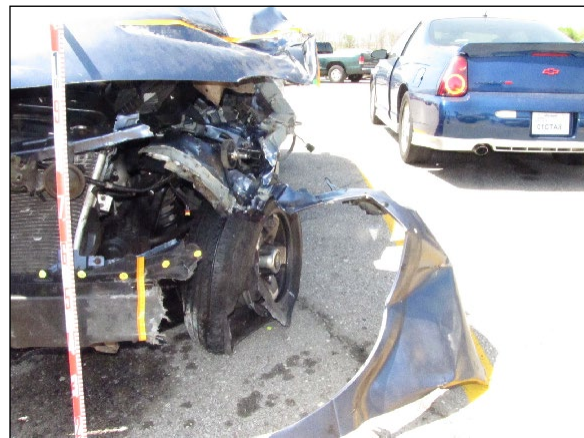
**Crash:** The left corner of the Kia’s front plane (**Figure 5**) struck the SKT (**Figure 6**). The right half of the front plane also sustained damage from contact with the traffic side of the guardrail as it was deformed and displaced as the vehicle rotated counterclockwise. The force direction on the Kia was in the 12 o’clock sector and the impact resulted in deployment of both frontal air bags and the driver’s knee air bag.

**Figure 5:** Damage to the Kia from impact with the SKT

**Exterior Damage Event 1:** The front plane sustained direct damage to 15 cm (5.9 in) of the left corner of the front bumper bar, left headlamp/turn signal assembly, fender, and hood from the initial impact with the SKT. Direct damage also occurred to the remaining 137 cm (53.9 in) portion of the front plane as the vehicle rotated counterclockwise and the guardrail deformed (**Figure 2**). This damage occurred above the bumper. The sheet metal of the hood was torn and the radiator and radiator frame were crushed. The totality of the damage involved the full width of the front plane, 152 cm (59.8 in). A set of crush measurements was taken on the bumper bar and a second set on the upper radiator frame. The maximum crush at the bumper level was 10 cm (3.9 in) occurring at C<sub>1</sub>. The maximum crush at the upper radiator frame was 49 cm (19.3 in), also occurring at C<sub>1</sub>. The two levels of crush measurements were averaged in accordance

**Damage Classification Event 1:** The Collision Deformation Classification (CDC) was 12FDEW3. The severity of the damage was moderate.

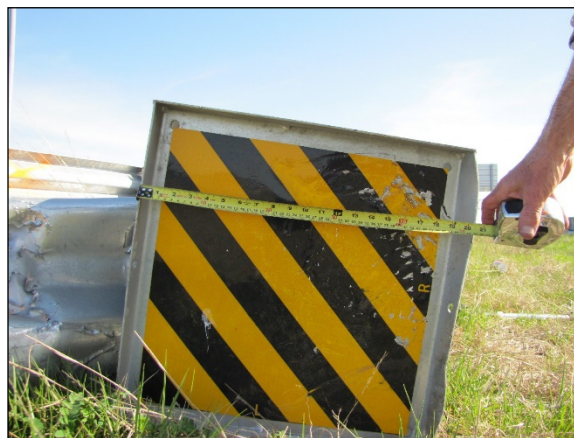
WinSMASH could not be used to calculate delta-V since impacts with a yielding object are out of scope for the program; however, the barrier algorithm of WinSMASH was used to calculate a barrier equivalent speed (BES) of 26 km/h (16 mph) based on the crush to the front plane. The impact extruded 8.7 m (28.6 ft) of guardrail from the SKT and displaced eight posts as the vehicle rotated counterclockwise. The right corner of the vehicle's back plane struck the guardrail as the vehicle rotated (event 2), and the vehicle came to final rest heading southeast with the front portion of the vehicle on the roadway and the back portion on the west shoulder. The driver then drove the vehicle to the east shoulder of the exit ramp and waited for emergency responders to arrive according to the driver's statement to police. The police schematic also showed the final rest position of the vehicle on the east shoulder heading southwest.

**Figure 6:** The damaged SKT

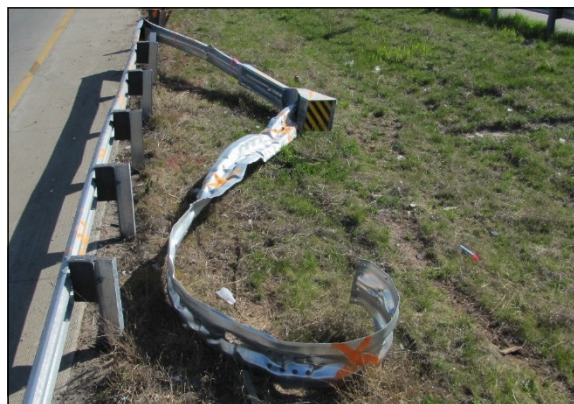
A placard on the SKT identified the model as an “SKT 350 Guardrail Terminal” manufactured by Road Systems, Inc. The front plane impact of the Kia to the SKT resulted in the extrusion of 8.7 m (28.6 ft) of guardrail toward the field side (**Figure 7**). The guardrail was displaced from posts 0 to 6<sup>1</sup>. The anchor cable was displaced from the guardrail and was not present at the scene. Posts 0 and 1 were bolted, hinged steel posts. Post 0 was not present at the SCI inspection; however, the post hinge bolt was present and remained attached to the post base. No strut plate was present between posts 0 and 1. Post 1 was displaced to the ground in the downstream direction and remained attached to the post hinge bolt. Post 2 was displaced downstream 50 degrees off vertical. The offset block was displaced from the post and was not present at the scene. Post 3 was displaced downstream approximately 60 degrees off vertical and was twisted approximately 80 degrees toward the field side. The offset block was displaced off the post and was not present at the scene. Post 4 was displaced downstream approximately 45 degrees off vertical and was twisted approximately 80 degrees toward the field side. The offset block remained attached to the post. Post 5 was displaced downstream 60 degrees off

**Figure 7:** Extruded guardrail from the SKT and posts 6 to 12, view south

vertical and twisted approximately 80 degrees to the field side. The offset block remained attached to the post. Post 6 was displaced downstream approximately 15 degrees off vertical and was twisted approximately 30 degrees toward the field side. The guardrail remained attached at post 7, which was displaced downstream approximately 20 degrees off vertical. A kink was formed in the guardrail at post 7 as the guardrail was displaced to the field side. Posts 8 to 12 were undamaged. There were small deformations in the guardrail near posts 8 and 10 that appeared related to the displacement of the guardrail during the crash. These were not considered kinks. Two kinks were located in the guardrail, one at post 7 and one near the bolt holes for post 6. The total length of damaged guardrail was 17.0 m (55.8 ft). MoDOT markings identifying sections of guardrail to be replaced ended just prior to post 12. The “In-Service End Treatment Evaluation Data Collection Form” is attached to the end of this report as **Appendix A**.

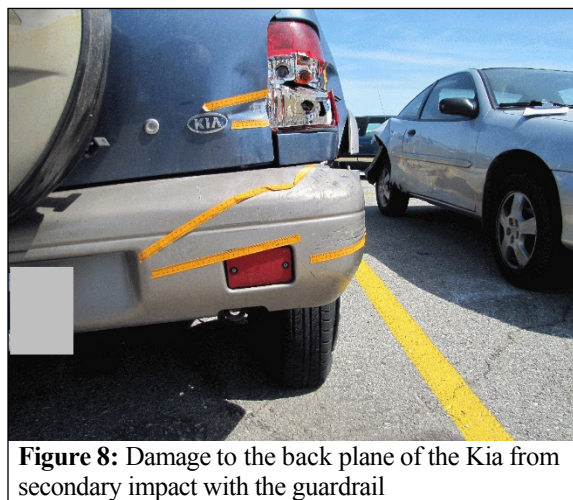
**Exterior Damage Event 2:** The Kia sustained direct damage to the right corner of the back plane (Figure 8) during the secondary impact with the guardrail as the vehicle rotated counterclockwise. The direct damage began at the right corner of the back bumper and extended 40 cm (15.7 in) to the left. The maximum residual crush was 3 cm (1.2 in) occurring at  $C_1$ . The crush values were:  $C_1 = 0$  cm,  $C_2 = 0$  cm,  $C_3 = 0$  cm,  $C_4 = 0$  cm,  $C_5 = 0$  cm,  $C_6 = 3$  cm (1.2 in).

**Figure 8:** Damage to the back plane of the Kia from secondary impact with the guardrail

**Damage Classification Event 2:** The CDC was 05BREE1. The severity of the damage was minor.
