DOT HS 812 646

Special Crash Investigations On-Site SKT Guardrail End Treatment Investigation Vehicle: 1996 Ford Mustang Location: Missouri Crash Date: August 2016

Case Number: IN16021

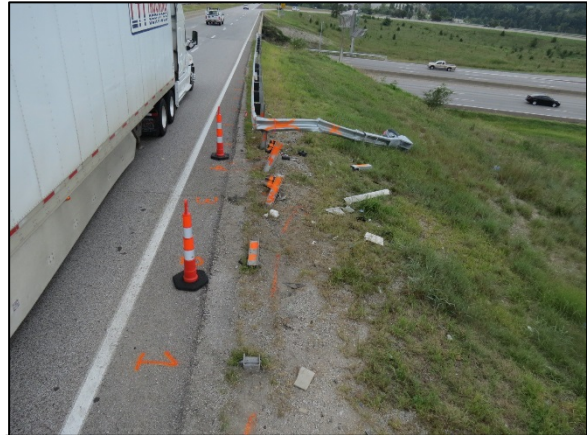
This report documents the on-site investigation of a passenger vehicle impact to a Sequential Kinking Terminal (SKT) guardrail end treatment (**Figure 1**) that is of interest to the Federal Highway Administration (FHWA). This crash was identified by an engineer with the Missouri Department of Transportation (MoDOT), who submitted photographs of the vehicle and the damaged guardrail end treatment to the FHWA. The FHWA determined that the guardrail end treatment and crash type were of interest. This crash investigation was then initiated by the National Highway Traffic Safety Administration (NHTSA) in August 2016 and assigned to the Special Crash Investigation Team at the Indiana University Transportation Research Center. This single-vehicle crash involved a 1996 Ford Mustang (**Figure 2**). The crash occurred in Missouri in August 2016 at 0053 hours, and was investigated by a local police agency. The vehicle, guardrail, and crash scene were inspected in August 2016. A telephone interview was conducted with the driver of the Ford in September 2016.

Figure 1: The damaged SKT and guardrail, view south

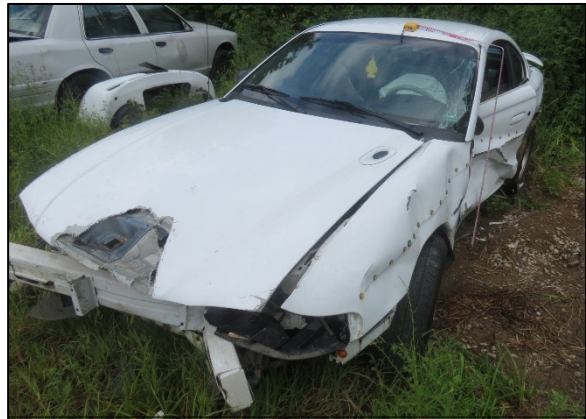
Figure 2: The damaged 1996 Ford Mustang

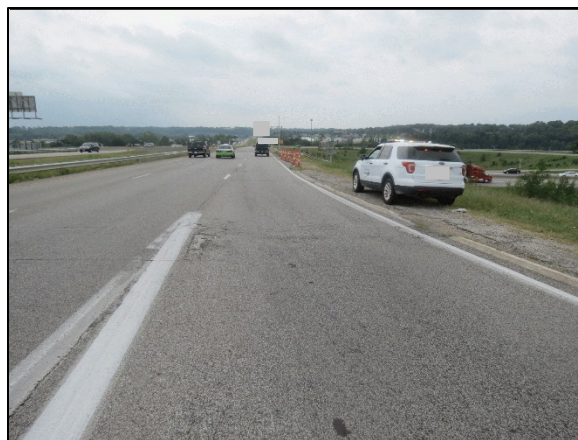
Figure 3: Southerly approach of the Ford and the area of control loss

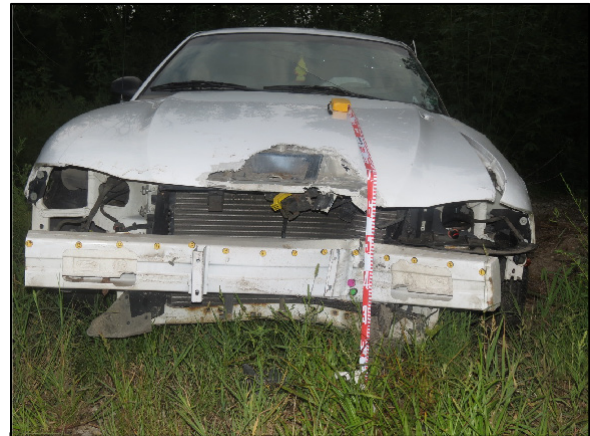
The front plane of the Ford (**Figure 4**) impacted the SKT (**Figure 5**, event 1) at an estimated speed of 56 km/h (35 mph). The Ford was rotated clockwise approximately 50 degrees from its original heading on the roadway at the moment of impact. The force direction was within the 11 o'clock sector and the impact resulted in deployment of both frontal air bags. The vehicle continued to rotate clockwise as 1.8 m (5.8 ft) of guardrail was extruded from the SKT. The left plane of the vehicle (**Figure 6**) then impacted the traffic side of the deformed guardrail (event 2) as it was displaced in a southwesterly direction. The distinctive crush pockets at the front of the left front door (**Figure 6**) and immediately rear of the B-pillar indicated areas where kinks in the guardrail impacted the left plane. The vehicle rotated clockwise a total of 165 degrees from its heading at impact with the SKT and came to final rest heading northeast with the back plane next to the deformed guardrail. The crash damaged a total of 8.2 m (27.0 ft) of guardrail and displaced five posts.

Figure 4: Damage to the Ford's front plane from the impact with the SKT

Exterior Damage Event 1: The Ford sustained direct and induced damage to the front plane during the impact with the SKT. The front bumper, grille, and hood were directly damaged. The direct damage began 43 cm (16.9 in) right of the front bumper's left corner and extended 41 cm (16.1 in) to the right. The Field L was 123 cm (48.4 in). Crush measurements were taken on the bumper bar using a Nikon Total Station 5M+ and the maximum residual crush was 16 cm (6.3 in) occurring 30 cm (11.8 in) left of the vehicle's centerline. The crush values were: $C_1 = 0$ cm, $C_2 = 12$ cm (4.7 in), $C_3 = 16$ cm (6.3 in), $C_4 = 7$ cm (2.8 in), $C_5 = 0$ cm, $C_6 = 0$ cm.

Damage Classification Event 1: The Collision Deformation Classification (CDC) was 11FYEW1 (330 degrees). The WinSMASH program could not be used to calculate Delta V since an impact with a yielding object is out of scope for the program. However, WinSMASH was used to calculate a Barrier Equivalent Speed (BES) of 15 km/h (9 mph) based on the crush to the front plane.

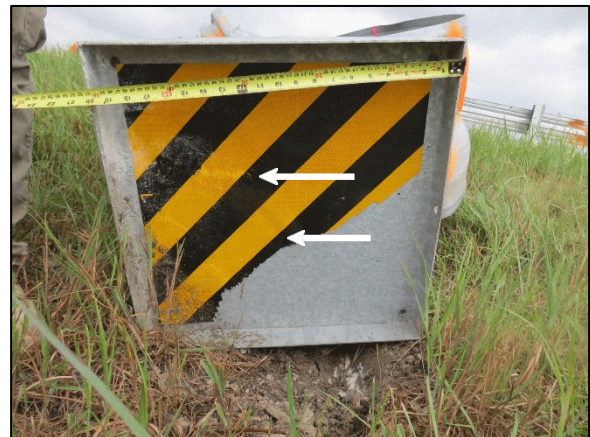
Figure 5: Area of contact to the face of the SKT from the impact with the Ford

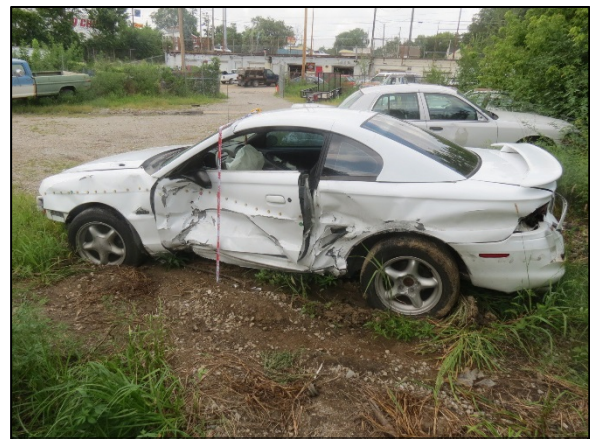
Figure 6: Damage to the left plane of the Ford from the impact with the deformed guardrail

Exterior Damage Event 2: The left plane sustained direct and induced damage when the vehicle rotated clockwise from the impact with the SKT and the left plane impacted the deformed guardrail. The direct damage involved the fender, door, quarter panel, rear wheel, taillight assembly, and back bumper fascia. The direct damage began 280 cm (110.2 in) forward of the left rear axle and extended 362 cm (142.5 in) rearward. The Field L was 395 cm (155.5 in). Crush measurements were taken at the upper door level and the maximum residual crush was 30

cm (11.8 in) occurring 85 cm (33.5 in) rear of the left front axle. The crush values were: $C_1 = 0$ cm, $C_2 = 5$ cm (2.0 in), $C_3 = 16$ cm (6.3 in), $C_4 = 10$ cm (3.9 in), $C_5 = 1$ cm (0.4 in), $C_6 = 0$ cm.

Damage Classification Event 2: The CDC was 09LDEW3. WinSMASH calculated the BES as 20 km/h (12 mph).

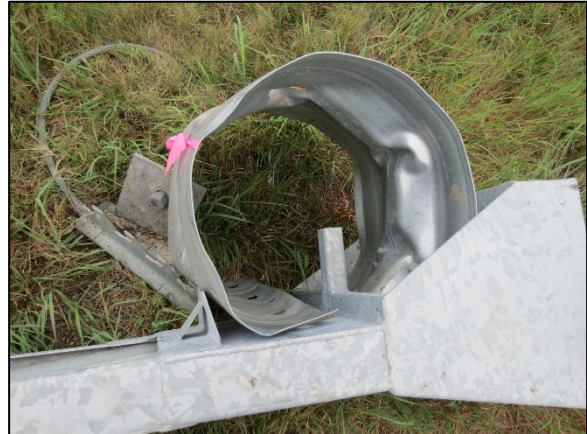
The Ford's front plane impact to the SKT extruded 1.8 m (5.8 ft) of guardrail to the field side (Figure 7) and damaged five posts (Figure 8). The direct damage on the face of the SKT was 23 cm (9.1 in) wide beginning on the traffic side edge of the SKT. The guardrail was displaced from posts 1-4. Post 1 was separated from its base at the bolt hinge. Post 2 was rotated to the ground in the downstream direction about its hinge bolt. Post 3 was bent in the downstream direction approximately 60 degrees from vertical. The composite offset block was damaged but remained attached to the post. Post 4 was bent in the downstream direction approximately 45 degrees from vertical and was twisted in the ground toward the field side. The composite offset block was damaged but remained attached to the post. The guardrail remained attached to post 5 and the post was slightly displaced, while the guardrail was bent approximately 90 degrees toward the field side at the post. The guardrail was kinked in five locations. Four of the kinks were in the first section of guardrail (Figure 9) that ended at post 5. A minor kink was present in the second section of guardrail 0.6 m (2.0 ft) beyond post 5. The face of the SKT was 51.0 cm (20.1 in) wide and 51.0 cm (20.1 in) high. The width of the feeder channel was 11.4 cm (4.5 in) and the guide chute exit height was 34.3 cm (13.5 in). The connection of the feeder channel to the head was not damaged and the anchor cable was present, but disconnected from its anchor. The "In- Service End Treatment Evaluation Data Collection Form" is attached to the end of this report as **Appendix**.

Figure 7: Extruded section of guardrail to the field side of the SKT

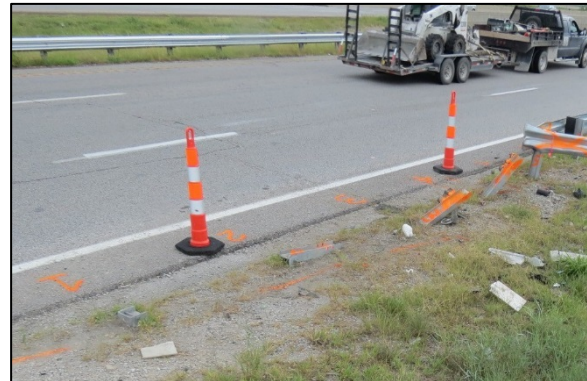
Figure 8: Damaged posts 1 - 5, view southeast

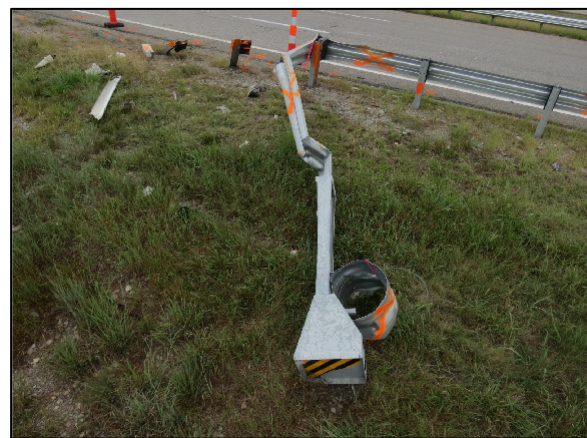
Figure 9: Kinks in the guardrail

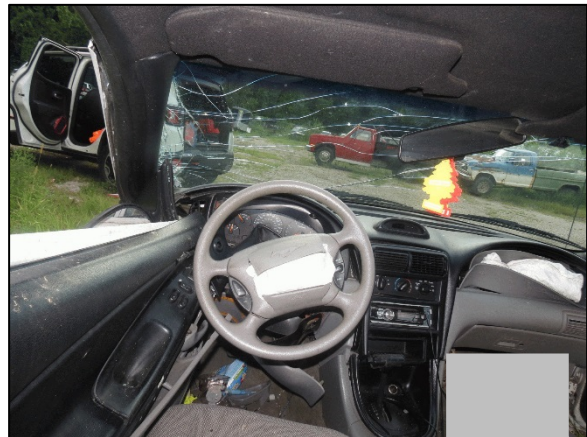
The interior of the Ford sustained moderate damage from intrusion when a kink in the guardrail impacted the left front door. The forward upper quadrant of the door intruded laterally 12 cm (4.7 in) into the driver's seating area (**Figure 10**), while the lower left instrument panel and lower left A-pillar intruded laterally 10 cm (3.9 in) and 8 cm (3.1 in), respectively. Evidence of occupant contact consisted of a deformed lower left instrument panel from contact by the driver's left knee. The rearview mirror was displaced from possible contact by the front passenger's head. The back of the front row right seat was scuffed and the seat back release lever was bent, probably from contact by the second row right occupant's chest and right lower leg, respectively. The left front door was jammed shut and the right front door remained closed and operational. The left front glazing was disintegrated from impact forces and the windshield was cracked from impact forces. The remaining glazing was undamaged.

Figure 10: Intrusion of the Ford's left front door
