DOT HS 812 647

# **Special Crash Investigations On-Site Guardrail End Treatment Investigation Vehicle: 2014 Ford F-150 Location: Missouri Crash Date: April 2017**

**Indiana University  
Transportation Research Center  
Special Crash Investigations  
On-Site Guardrail End Treatment Investigation  
Case Number - IN17017  
Vehicle - 2014 Ford F-150  
Location - Missouri  
Crash Date - April 2017**

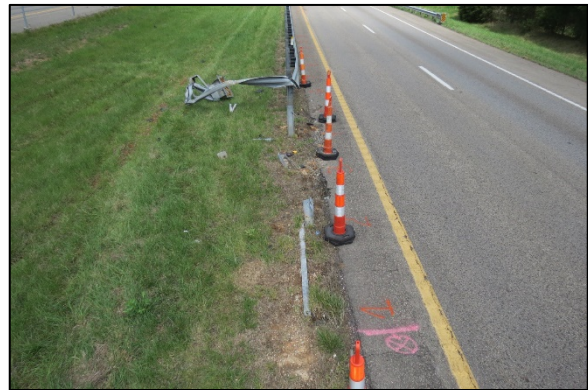
This report documents the on-site investigation of a pickup truck impact to an ET-Plus 10 cm (5 in) model guardrail end treatment (**Figure 1**) that is of interest to the Federal Highway Administration (FHWA). This crash was identified by an engineer with the Missouri Department of Transportation (MoDOT), who submitted photographs of the damaged guardrail end treatment to the FHWA. The FHWA determined that the guardrail end treatment and crash type were of interest. This crash investigation was then initiated by the National Highway Traffic Safety Administration in April 2017 and assigned to the Special Crash Investigation team at the Indiana University Transportation Research Center. This single-vehicle crash involved a 2014 Ford F-150 pickup truck (**Figure 2**). The crash occurred in Missouri in April 2017 during early morning hours and was investigated by local police. The guardrail, crash scene, and vehicle were inspected in April 2017.

**Figure 1:** The damaged guardrail and End terminal

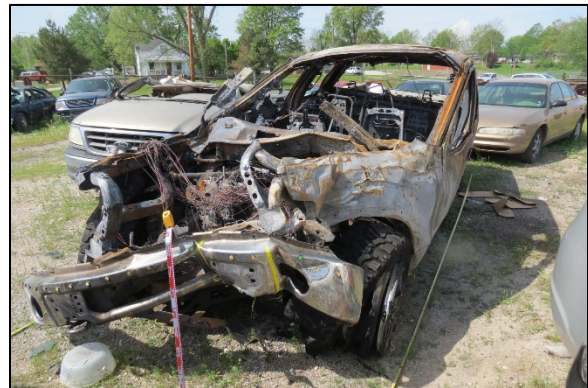
**Figure 2:** The damaged 2014 Ford F-150

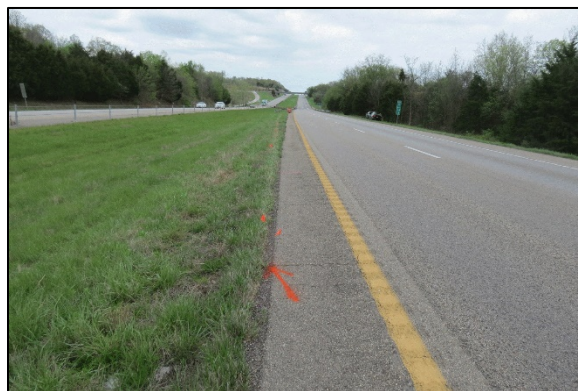
The Ford was traveling northwest in the northbound lanes. Witnesses told police following the crash that the vehicle was traveling at a very high rate of speed and was weaving in and out of traffic as it passed several vehicles.<sup>1</sup> The witnesses stated that the vehicle nearly ran a tractor-semitrailer off the roadway. The vehicle then departed the right side of the roadway after passing a vehicle that was traveling in the right lane. The driver of the Ford initiated a left steering maneuver and the vehicle returned to and crossed the roadway. The vehicle departed the left side of the roadway and crossed the shoulder and its left side wheels entered the median (**Figure 3**). The left side tires produced a rolling tire mark in the grass as the vehicle traveled partially in the median. The tire mark curved back toward the roadway as the vehicle approached impact with the End terminal (**Figure 4**) indicating that the driver was attempting to steer the vehicle back onto the roadway. The vehicle traveled a total distance of 88.9 m (291.6 ft) with the left side tires in the grass as it approached impact with the End terminal.

**Figure 3:** View northwest of the area the Ford entered the median

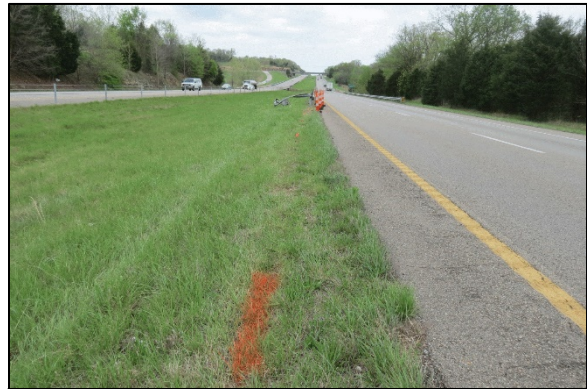
**Figure 4:** Approach of the Ford to impact with the End terminal, view northwest

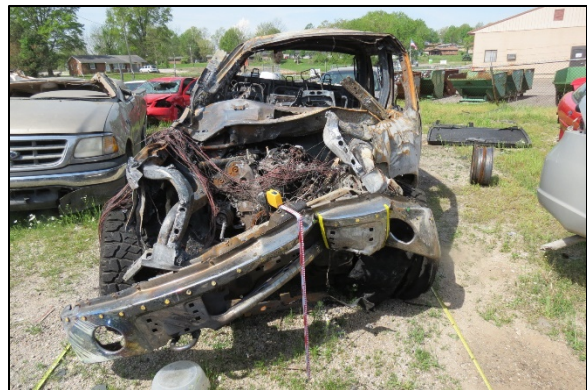
The front plane of the Ford (**Figure 5**) struck the end terminal (**Figure 6**, Event 1). The vehicle's speed at impact is not known,<sup>2</sup> but was determined to be in excess of 114 km/h (71 mph) as indicated by combining the speeds<sup>3</sup> calculated from the vehicle's front plane crush (i.e., the barrier equivalent speed [BES]) and from the subsequent rollover as discussed below. A specific impact speed could not be determined since the energy dissipated during deformation and displacement of the guardrail is not known.

The impact occurred to the left corner of the vehicle's front plane and the force direction was in the 12 o'clock sector. The damage to the vehicle indicated that the driver's frontal air bag likely deployed. WinSMASH could not be used to calculate delta-V since an impact with a yielding object is out-of-scope for the program. However, WinSMASH was used to calculate a barrier equivalent speed (BES) of 28 km/h (17 mph) based on the damage to the front plane. The impact damaged 11.5 m (37.7 ft) of guardrail and four posts and displaced the damaged guardrail into the roadway.

**Figure 5:** Damage to the front plane from the impact with the End terminal

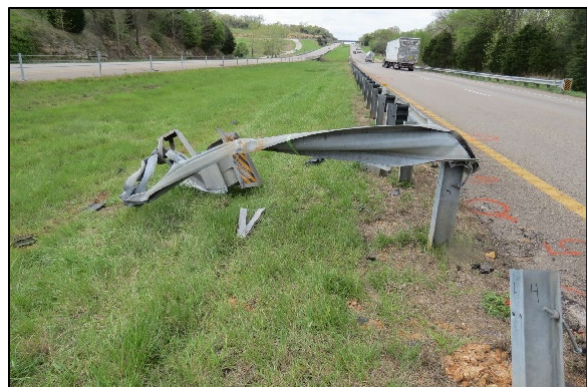
**Figure 6:** The damaged End terminal and guardrail (guardrail moved post-crash), view northwest

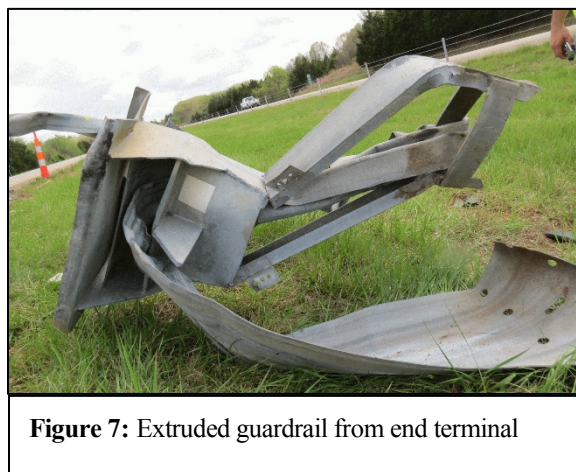
The front plane impact of the Ford to the end terminal extruded 1.8 m (5.8 ft) of guardrail to the field side (**Figure 7**) and damaged 11.5 m (37.7 ft) of guardrail and four posts. The direct damage involved the full width and height [38 cm (15.0 in and 70 cm (27.6 in)] of the face of the End terminal. The guardrail was displaced from posts 1 to 4. It remained bolted to posts 5 and 6 but the composite offset block was displaced from each post. Post 1 was separated from its base at the bolt hinge. Posts 2 and 3 were bent to the ground in the downstream direction. The composite offset block was displaced from post 3.

Post 4 was bent approximately 20 degrees from vertical in the downstream direction and the composite offset block was displaced from the post. The guardrail was kinked in five locations (**Figure 8**). One kink was located at the entrance to the guide chute. A second kink was located

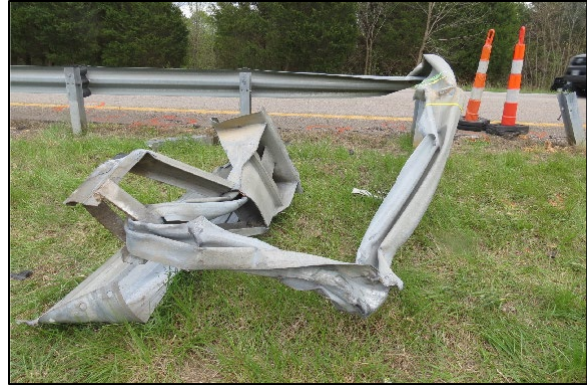
at the entrance to the feeder channel. There were two kinks between the entrance to the feeder channel and post 5, and one kink at post 5. The width of the feeder channel was 12.7 cm (5.0 in) and the guide chute exit height was 50.8 cm (20.0 in). The height of the guardrail was 71 cm (28.0 in). The connection of the feeder channel to the head was damaged and one of the two welds that connect the head to feeder channel was broken. The anchor cable was present but disconnected from its anchor. The FHWA guardrail form is attached to the end of this report as **Appendix A**.

**Figure 8:** Kinks in the guardrail

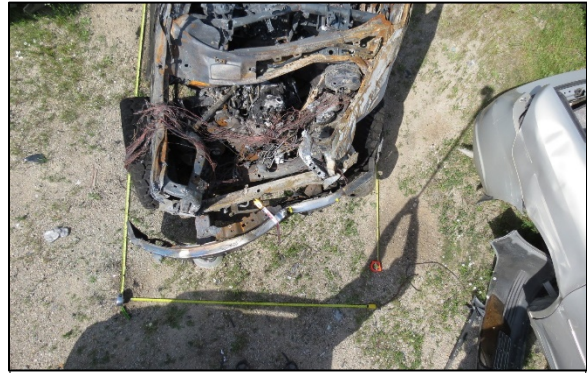
***Exterior Damage Events 1:*** The Ford sustained direct damage to the front plane during the impact with the end terminal. The direct damage began 20 cm (7.9 in) right of the front left bumper corner and extended 47 cm (18.5 in) to the right. The Field L also was 182 cm (71.7 in) long and began at the left corner of the front bumper. Crush measurements were taken on the bumper and the maximum residual crush was 36 cm (14.2 in) occurring at the front left bumper corner. The crush values were:  $C_1 = 36$  cm (14.2 in),  $C_2 = 31$  cm (12.2 in),  $C_3 = 21$  cm (8.3 in),  $C_4 = 6$  cm (2.4 in),  $C_5 = 0$  cm,  $C_6 = 0$  cm.

**Figure 9:** Top view of the crush to the front plane of the Ford

***Damage Classification Event 1:*** The Collision Deformation Classification (CDC) was 12FLEW2 (350 degrees).
