DOT HS 812 651

Special Crash Investigations On-Site SKT Guardrail End Terminal Crash Investigation Vehicle: 2010 Hyundai Elantra Location: Pennsylvania Crash Date: May 2017

SPECIAL CRASH INVESTIGATIONS
CASE NO.: CR17014
ON-SITE SKT GUARDRAIL END TERMINAL CRASH INVESTIGATION
VEHICLE: 2010 HYUNDAI ELANTRA
LOCATION: PENNSYLVANIA
CRASH DATE: MAY 2017

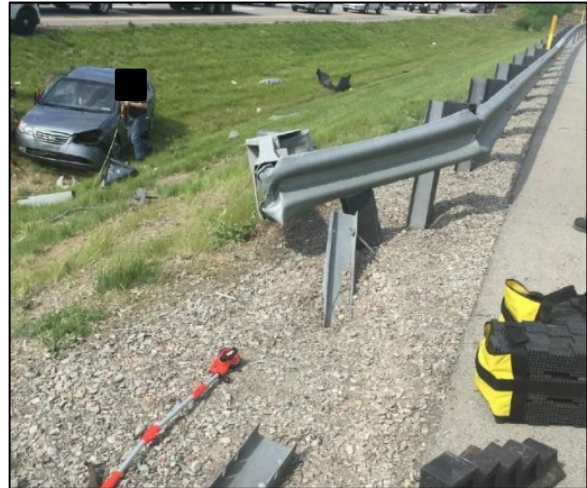
This report documents the on-site investigation of a sequential kinking terminal (SKT) guardrail end terminal struck by a 2010 Hyundai Elantra (**Figure 1**) operated by a 26-year-old unbelted female. The driver was completely ejected through the right front door window opening during the crash and sustained fatal injuries. The prolonged impact sequence involved two areas of the vehicle's right plane. The right-side impact air bag system consisted of front seat-mounted and inflatable curtain (IC) air bags that deployed during the second interaction. The crash was identified by the Pennsylvania Department of Transportation (PENNDOT), which submitted notification to the Federal Highway Administration (FHWA). The FHWA determined that the crash type and guardrail end treatment met the criteria for further research and subsequently forwarded the notification to the Crash Investigation Division (CID) of the National Highway Traffic Safety Administration in June 2017. The CID assigned an on-site investigation of the crash to the Special Crash Investigations (SCI) team at Crash Research & Analysis, Inc., on the same day. The SCI team initiated contact and gained cooperation with PENNDOT, and conducted the on-site scene investigation in June 2017. The Hyundai was inspected in July 2017 due to a delay in obtaining cooperation to conduct an inspection.

Figure 1: On-scene police image of the damaged end treatment and the final rest position of the Hyundai.

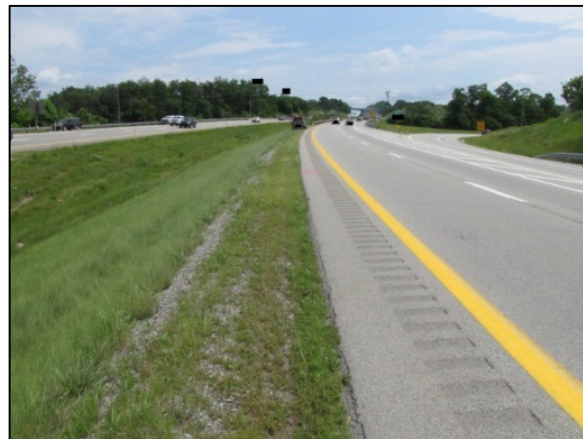
The crash occurred on a divided interstate roadway during daylight hours. At the time of the crash, the National Weather Service reported the conditions as clear with a temperature of 28.9°C (84 °F), humidity at 94 percent and south-southwest winds at 10.0 km/h (16.1 mph). All road and off-road surfaces were dry. The interstate's crash site vicinity consisted of two lanes in each of the north and southbound travel directions separated by a depressed grass median. The posted speed limit was 89 km/h (55 mph). An exit ramp was located to the east of the northbound lanes. A painted gore area separated the exit ramp from the through lanes. The left northbound lane measured 3.7 m (12.1 ft) in width. The right northbound lane was 3.5 m (11.5 ft) wide. Lane delineations consisted of a solid white east lane line, a broken center line separating the two northbound lanes, and a solid yellow west edge line. Both travel lanes were 3.7 m (12 ft) in width and were bordered by paved shoulders. All travel lane and shoulder surfaces were asphalt. The east shoulder consisted of the wide gore area. The west shoulder was 1.1 m (3.6 ft) wide. A tactile warning strip (rumble strip) was cut into the surface of the west shoulder. **Figure 2** is an overall northbound view of the crash site.

Figure 2: Northbound trajectory view of the Hyundai's approach to the crash site.

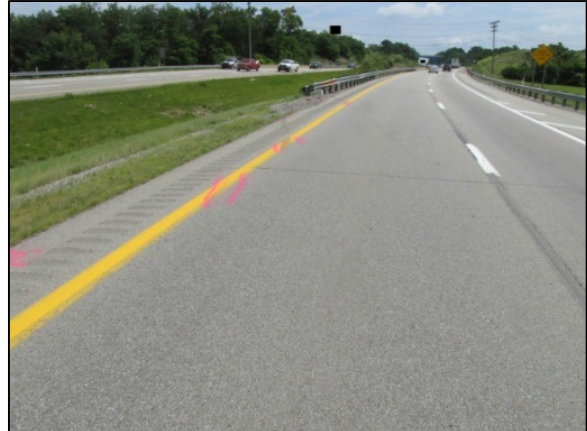
The driver responded to the road departure by initiating a clockwise steering input in an attempt to regain the left northbound travel lane. The Hyundai initiated a clockwise yaw on the median evidenced by the diverging left side tire marks as the vehicle traveled 45.3 m (142.7 ft) along the roadside. The Hyundai reentered the left travel lane and crossed into the right northbound lane as the driver counter-steered to the left. This counterclockwise steering input transitioned the Hyundai's yaw from clockwise to counterclockwise. The vehicle traversed the left lane and the west shoulder as it rotated approximately 30 degrees counterclockwise of its intended northbound heading. Tire marks from the right front, left front and left rear axle positions were present on the left lane and west shoulder. The left rear mark measured 12.6 m (41.3 ft) in length. The angle of the road side departure was approximately 20 degrees. The Hyundai's counterclockwise yaw tire marks are depicted in **Figure 3**. Over the course of its 116 m (380.6 ft) off road and yawing trajectory the Hyundai slowed by road friction to an estimated 72 km/h (45 mph) as it approached the end terminal.

Figure 3: North-facing view of the Hyundai's yaw tire marks as it departs the left travel lane toward the guardrail impact.

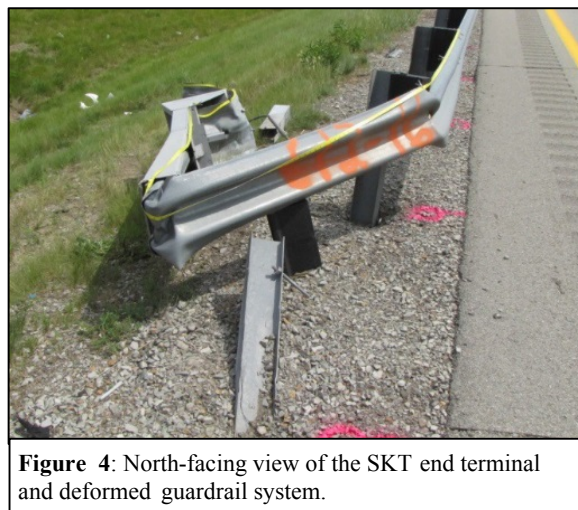
The end terminal was displaced northward along the W-beam during the initial contact evidenced by the extrusion of 2.4 m (8.0 ft) of guardrail. As the vehicle continued on its northwesterly trajectory and right plane of the vehicle fully engaged the deforming guardrail, additional damage occurred at the right B-pillar and sill from the subsequent post contact. The end terminal impact, located at the vehicle's CG, neutralized the vehicle CCW rotation.

The right plane/back aspect of the Hyundai engaged the guardrail at the (relatively) stiffer structures of the right rear wheel assembly (Event 3). This engagement resulted in the deployment of the right front seat-mounted and IC air bags. The guardrail deformed by bending at the Post 3 location into a V-shaped pattern due to the angularity of the engagement (**Figure 4**). This lateral impact force located aft of the Hyundai's center of gravity reversed the vehicle's rotation from counterclockwise to clockwise as it separated from the guardrail. The Hyundai rotated approximately 270 degrees as it traveled down the embankment into the median. As the Hyundai came to rest, the front right undercarriage partially overrode the ejected driver. At final rest, the Hyundai was facing south in the center of the depressed median 15.4 m (50.5 ft) from the end terminal impact.

Figure 4: North-facing view of the SKT end terminal and deformed guardrail system.

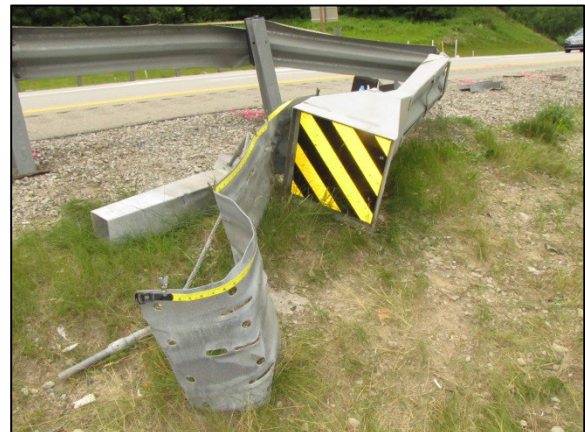
The struck guardrail was a tangent system installed adjacent to the left shoulder of the interstate. The height of the W-beam measured 75 cm (29.5 in) in an undamaged section of the beam between Post 6 and 7. The Hyundai struck the impact face of the end terminal (**Figure 6**) originally located at Post 1. The impact face measured 51 x 51 cm (20.0 x 20.0 in). There was no discernable direct contact damage to impact face. The force of the impact displaced the end terminal to the north and extruded 2.4 m (8 ft) of the W-beam. The extruded W-beam curled to the field side, away from the road.

Posts 1 to 4 of the installation were damaged during the crash along with a total length of 3.8 m (22.4 ft) of W-beam. Damage to the installation required replacement of the W-beam to the splice at Post 5. The deformed guardrail was inspected and documented through measurements and photographs. A diagram depicting the deformed guardrail is included at the end of this report. The FHWA Guardrail Form documenting the crash and installation is included at the end of this report as **Appendix A**.

Figure 6: Southeast-facing image depicting the struck end terminal and the extruded W-beam.

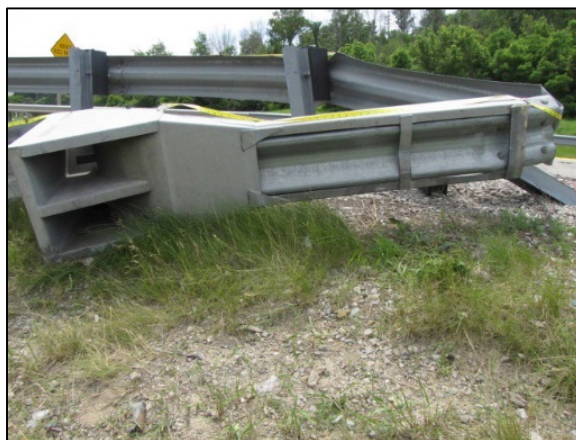
As the impact developed, the right plane of the Hyundai engaged the (road) side of the end terminal due to the angularity of the impact. The lateral component of the impact force caused the W-beam to bend at Post 3 and Post 4. The W-beam bent into a V-shape pattern (**Figure 7**). Post-crash, the end terminal was located 6.8 m (22.3 ft) north of Post 1 through a combination of its extruded displacement and the bending of the W-beam.

Figure 7: East facing side view depicting the location of the displaced end terminal.

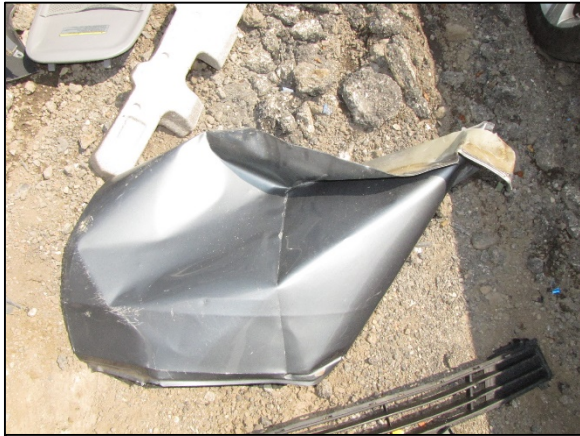
The right plane of the Hyundai struck the SKT end terminal of the guardrail system (Event 2). The direct contact damage from the face of the end terminal was located on the mid-aspect of the right front door and involved distinct creases in the door panel that extended vertically 53 cm (20.75 in) and 46 cm (18.0 in) horizontally (**Figure 9**) and matched the dimensions of the end terminal. The vertical crease was located 90 cm (35.3 in) aft of the right front axle location. As

Figure 9: Direct contact damage on the right front door panel from the head of the SKT end treatment.

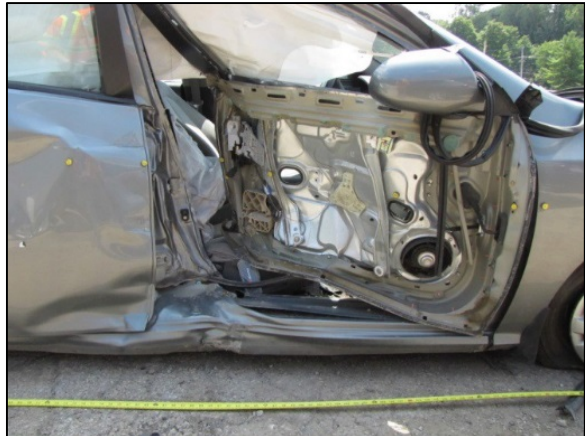
the Hyundai struck the guardrail, the door crushed laterally (inward) resulting in separation of the door latch striker from the B-pillar (**Figure 10**). The B-pillar also displaced laterally and was torn at the sill over a length of 23 cm (9 in). The sill of the Hyundai below the right B-pillar struck guardrail Post 2, crushing the component approximately 5 cm (2 in). The crush profile for the damage pattern was documented at the mid door level resulting in the following profile: C1 = 3 cm (1.2 in), C2 = 8 cm (3.1 in), C3 = 20 cm (7.9 in), C4 = 17 cm (6.7 in), C5 = 10 cm (3.9 in), C6 = 2 cm (0.8 in). The maximum lateral displacement of the door measured 39 cm (15.2 in). The CDC attributed to this damage was 03RPEW4.

Figure 10: Deformation to the right front door of the Hyundai from the impact end terminal.

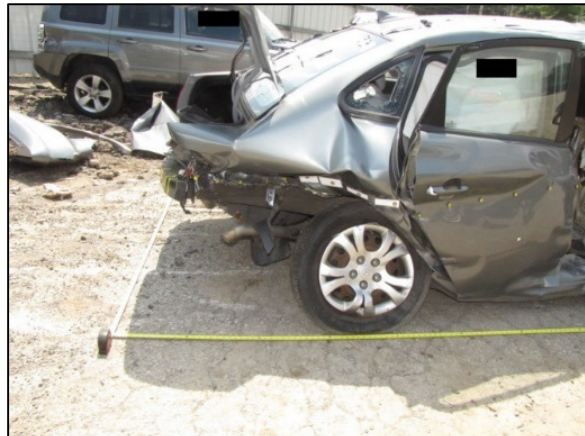
The Event 3 impact involved the back aspect of the right plane. The direct contact damage began on the quarter-panel 227 cm (89.5 in) aft of the right front axle and extended 116 cm (45.5 in) to the rear bumper corner (**Figure 11**). Included in the damaged region was the right rear tire wheel assembly and suspension. This axle position was displaced forward 8 cm (3.2 in) and the steel wheel was deformed at the bead which aired out the tire. The impact energy was transferred into the axle location and deformed the assembly laterally to the left. The crush profile documented along this damage plane accounting for free space was as follows: C1=17 cm (6.7 in), C2 = 36 cm (14.2 in), C3 = 29 cm (11.4 in), C4 = 23 cm (9.1 in), C5 = 6 cm (2.4 in), C6 = 2 cm (0.8 in). The CDC for this event was 03RBEW4. The barrier equivalent speed of this damage profile calculated by the WinSMASH program was 17 km/h/ (10 mph). The reconstruction of the crash was considered borderline due to the yielding properties of the impact configuration and the magnitude of the barrier equivalent speed was to be low based on SCI field experience.

Figure 11: Right lateral image of the Hyundai depicting the Event 3 damage.

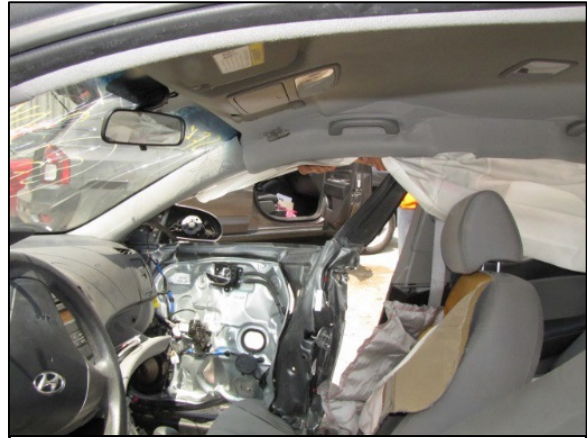
The occupant compartment of the Hyundai sustained damage from exterior deformation that resulted in multiple intrusions of the occupant space and damage associated with occupant contact. Maximum intrusion was 43 cm (16.75 in) of lateral displacement of the aft aspect of the right front door (**Figure 12**) as it overrode the front right seat cushion due to the striker separation from the B-pillar. The deformation of the door separated the interior door panel. The lower right B-pillar intruded laterally 20 cm (8 in) into the front row right occupant space.

Figure 12: Lateral interior image of the Hyundai depicting the door intrusion

Additional intrusions of this area included 8 cm (3 in) of lateral displacement of the sill and 34 cm (13.5 in) of window frame intrusion. The second-row right seat position was reduced in size by 10 cm (4 in) of lateral intrusion of the forward aspect of the right rear door panel and 5 cm (2 in) of longitudinal displacement of the front row right seat back.

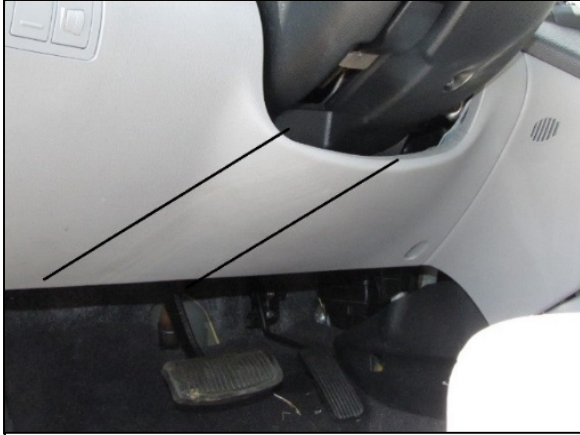
The unbelted driver moved laterally across the interior of the Hyundai prior to ejection. Her left lower leg and foot swiped or scuffed the lower left instrument panel knee bolster to the left of the steering column (**Figure 13**). The scuff mark was directional, originating from the lower aspect and translating up and right with respect to the interior of the Hyundai. The driver's right thigh contacted and displaced the console-mounted automatic shifter lever to the right (**Figure 14**). The driver's continued lateral movement to the right in the vehicle resulted in a complete ejection through the right front door window opening. No contact evidence on the window frame or door panel was observed (e.g., hair, tissue, fibers).

Figure 13: Left leg/foot scuff to the lower instrument panel/knee bolster.

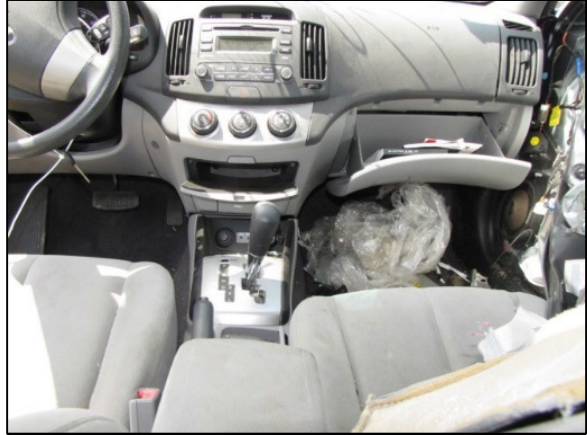
Figure 14: Console-mounted shifter deflected right from driver right thigh contact.

As the driver moved right, her left lower leg scuffed the lower instrument panel/knee bolster left of the steering column. Her right thigh contacted and displaced the console mounted shifter to the right. Her head and upper body began to travel through the right front window frame. The driver was completely ejected through the window opening (**Figure 16**) onto the median. The front right door lost integrity as the striker plate separated from the B-pillar, allowing the door to intrude and override the right front seat cushion.

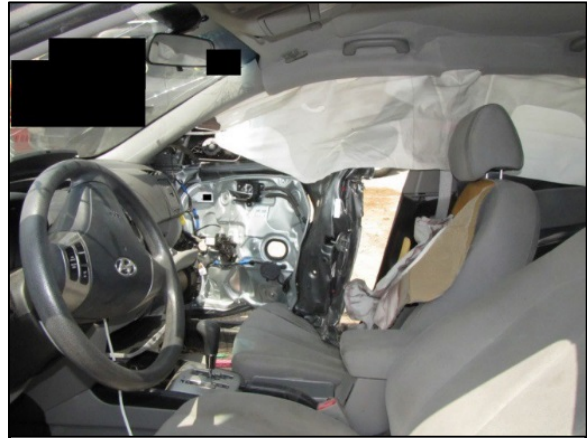
The right seat-mounted and IC air bags deployed (**Figure 15**) as a result of the Event 3 impact with the guardrail system. The seat-mounted air bag deployed through the right-side seat back stitching. The air bag was 48 cm (19.0 in) in height and extended 30 cm (12.0 in) forward. There was no damage or occupant contact to this air bag. The right IC air bag deployed from the juncture of the roof side rail and the headliner. The IC air bag was tethered to the right A-pillar via a 15 cm (6.0 in) tether that remained intact. There was no sail panel to fill the void of the right A-pillar. The rectangular air bag measured 152 cm (60 in) in length and provided coverage for both occupant rows. At the mid-point of the front row, the vertical height of the IC air bag was 38 cm (15.0 in). At the same location of the second row, the IC air bag was 36 cm (14.0 in) in height. The IC air bag was not damaged and there was no occupant contact evidence. The intrusion of the right front door window frame displaced the IC air bag inward with respect to the interior of the vehicle. The inflation of the IC air bag was not altered, and the supplemental restraint system still offered crash protection and ejection mitigation.

Figure 15: Right interior view of the Hyundai depicting the deployed air bags.

Based on the SCI vehicle inspection and the circumstances of the crash, the driver was ejected prior to the deployment of the right IC air bag. Observations of the interior inspection revealed the separation of the door striker plate from the B-pillar and the presence of numerous sharp edges that would have abraded or cut the seat-mounted side impact air bag had it deployed during the initial right door engagement (Event 2) with the end terminal. Secondary, the driver was cleanly ejected through the right front door window opening as all other glazing remained intact and all doors remained closed. The right front door opened but intruded into the front row right position. The 21 cm (8.4 in) wide opening gap at the B-pillar was absent any physical evidence of occupant contact and was too small for the driver to fit through. Had the IC air bag deployed during Event 2, her ejection path would have been mitigated by the inflated IC air bag. There was no physical evidence of any contact to the IC air bag, which indicated that it deployed as a result of Event 3, after the driver's ejection had occurred.

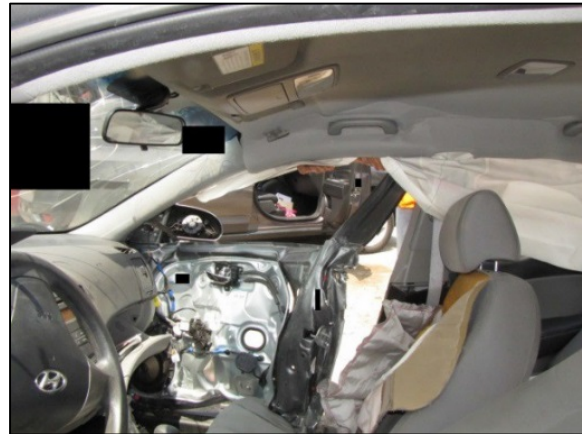
The Event 1 impact with the delineator did not displace the driver from her seated position or cause injury. As the Hyundai rotated counterclockwise, the driver was minimally displaced to her right by the centrifugal force of the rotation. At impact with the end treatment system of the guardrail (Event 2), the driver continued to move to her right in response to the lateral (3 o'clock) impact force. The AS2 window glazing was disintegrated by the impact and door deformation.

Figure 16: Right front door window opening was the ejection portal for the unbelted driver.
