DOT HS 812 668

Special Crash Investigations On-Site Air Bag Inflator Rupture Crash Investigation Vehicle: 2001 Honda Civic Location: California Crash Date: September 2016

Case Number: DS16020
Office of Defects Investigation
On-Site Air Bag Inflator Rupture Crash Investigation
Vehicle: 2001 Honda Civic
Location: California
Crash Date: September 2016

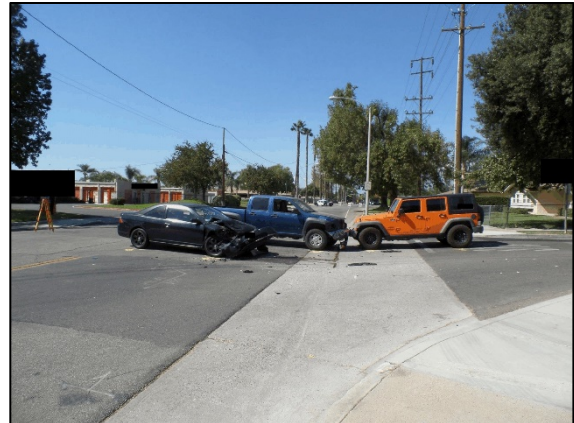
The Honda was displaced clockwise and came to rest facing northeast. The Chevrolet was displaced counterclockwise and struck the front of the Jeep (Event 2) where it came to rest (**Figure 5**).

Figure 5. Final rest, looking west (police photo).

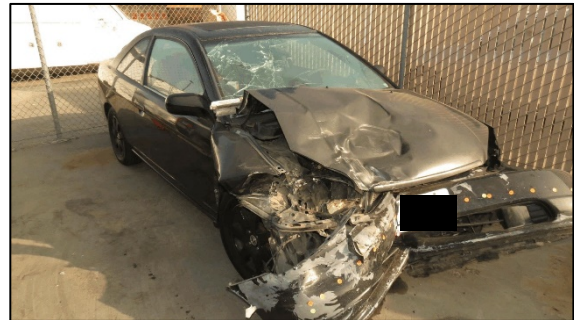
Figure 6. Frontal damage, 2001 Honda Civic.

The Honda sustained moderate severity frontal damage from the impact to the front of the Chevrolet (Figure 6). The direct damaged began at the right front bumper corner and extended 112 cm (44.0 in) to the left. The Field L extended from bumper corner to bumper corner. Seventeen measurements were taken at bumper level by the Nikon Total Station and the Faro Blitz program computed crush measurement in six increments as follows: $C_1 = 1$ cm (0.4 in), $C_2 = 0$ cm, $C_3 = 19$ cm (7.4in), $C_4 = 33$ cm (12.9 in), $C_5 = 21$ cm (8.2 in), $C_6 = 13$ cm (5.1 in). The Collision Deformation Classification (CDC) was 12FZEW2. The maximum crush was located 7 cm (2.7 in) right of the bumper centerline.

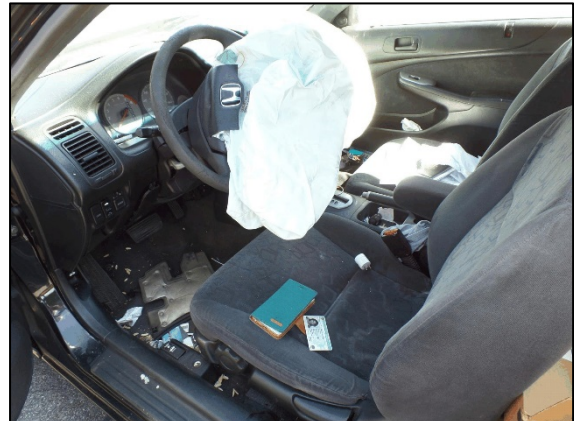
Figure 8. Driver's air bag, 2001 Honda Civic (police photo).

The driver's frontal air bag deployed from an H-configuration module cover located in the spokes of the steering wheel rim (**Figure 8**). The air bag was circular and measured 62 cm (24.4 in) in diameter in its deflated state. The air bag was configured with two rear-panel vent ports and two tethers. The air bag inflator ruptured during some phase of deployment. The air bag was holed in two locations on the front panel (**Figure 9**). The first hole was located adjacent to the tether stitching and measured 4 cm (1.6 in). The second hole was located along the center line and below the tether stitching. It measured 3 cm (1.2 in). A single small hole was documented to the back panel.

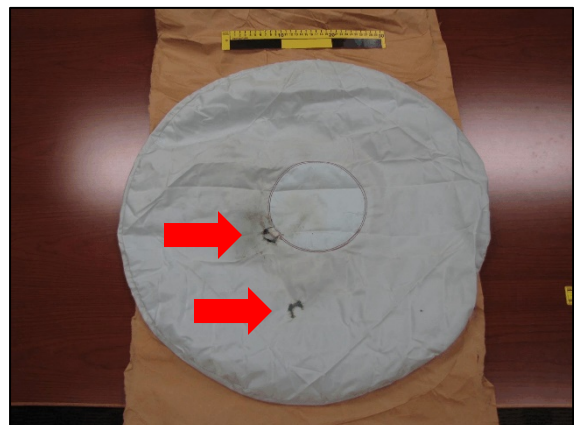
Figure 9. Holes in driver air bag front panel, 2001 Honda Civic.

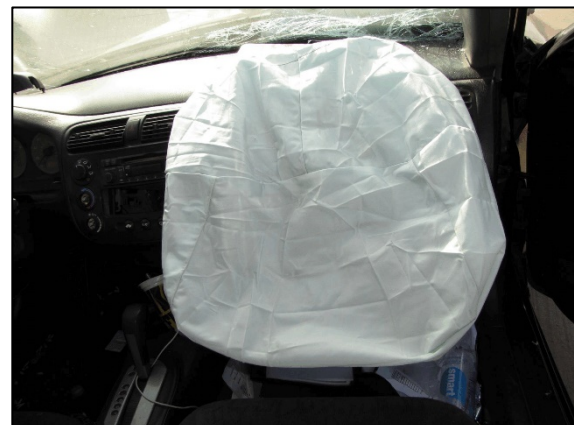
The passenger's frontal air bag was a top-mount design in the upper right instrument panel. The passenger air bag deployed from H-configuration cover flaps (**Figure 10**). The air bag measured 46 cm (18.1 in) wide and 59 cm (23.2 in) high. This vehicle was not equipped with the optional side impact air bags.

Figure 10. Passenger's frontal air bag, 2001 Honda Civic.

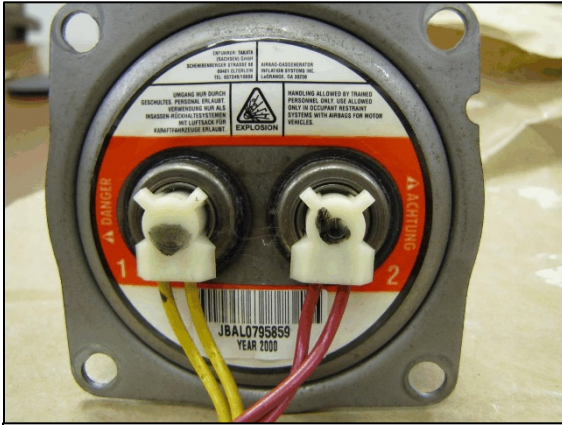
The driver's frontal air bag inflator was manufactured in July 2000 by Takata Corporation and was original to this vehicle (**Figure 11**). The air bag inflator contained phase-stabilized ammonium nitrate (PSAN) as a propellant. The inflator was seated in the air bag assembly and held in place by four lock nuts. During the deployment the air bag inflator ruptured (**Figure 12**). Fragments from the inflator holed the front and back panels of the air bag. Two moderately sized

Figure 11. Inflator manufacture date, 2001 Honda Civic.

The vehicle was subject to NHTSA Recall Numbers 15V-320 and 15V-370. The first recall indicates that the driver's frontal air bag inflator could produce excessive internal pressure at deployment that may cause the inflator to rupture. The second recall addresses the passenger's frontal air bag inflator. The remedy was for Honda to notify owners and dealers in all affected vehicles and to replace the inflators free of charge. The inflators in this vehicle were original to the vehicle. It is not known if any notifications

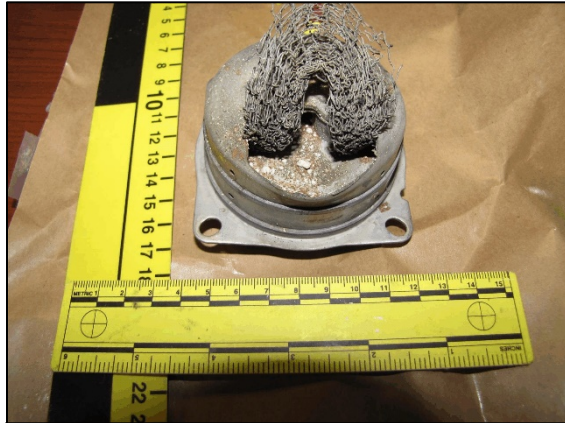
Figure 12. Ruptured inflator, 2001 Honda Civic.

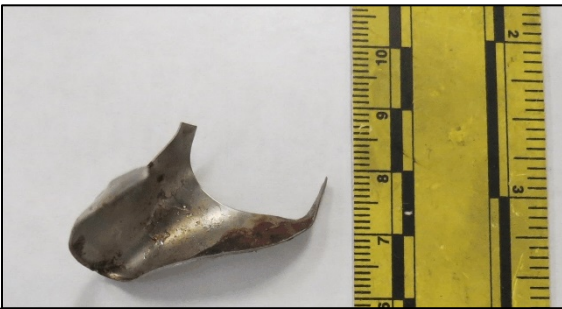
fragments were recovered from the driver. One was removed from the driver's cheek (**Figure 13**) and one was removed from the driver's lung (**Figure 14**). The first had a batwing shape measuring approximately 3 x 4 cm (1.1 x 1.5 in) and weighed 2.08 grams (0.07 oz). The second was irregularly shaped and measured approximately 2 x 3.5 cm (0.8 x 1.3 in) and weighed 1.87 grams (0.06 oz).

Figure 13. Fragment removed from driver's left cheek, 2001 Honda Civic.

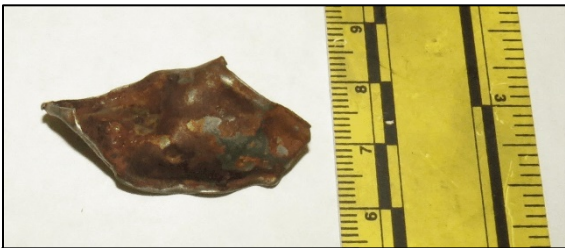
Figure 14. Fragment removed from driver's right lung, 2001 Honda Civic.

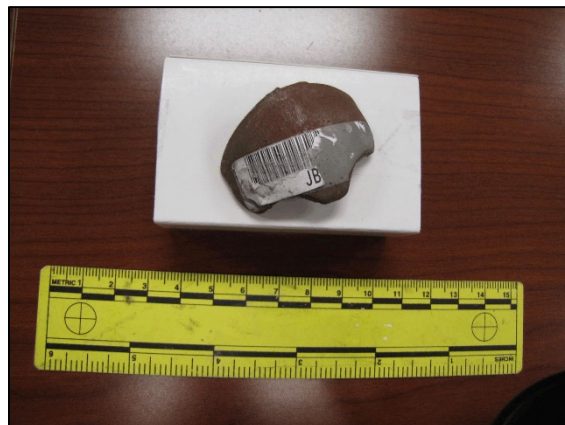
One 5 x 5.5 cm (1.9 x 2.1 in) fragment was recovered by the investigating agency inside the vehicle (**Figure 15**). Multiple smaller fragments were recovered from within the air bag.

Figure 15. Inflator fragment found in vehicle, 2001 Honda Civic.

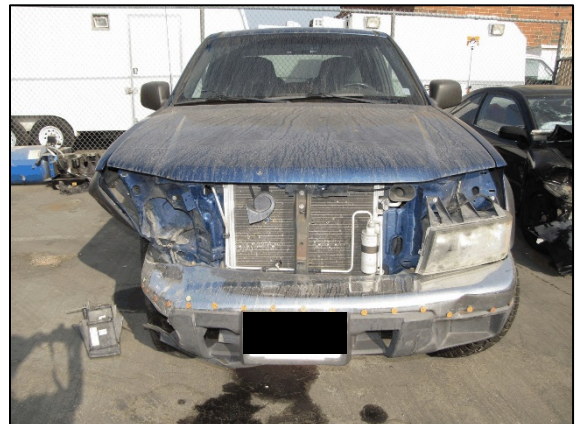
Figure 16. 2006 Chevrolet Colorado.

The Chevrolet sustained moderate severity frontal damage from the impact to the front of the Honda (Figure 16). The direct damaged began at the right front bumper corner and extended 23 cm (9.0 in) to the left. The Field L extended from bumper corner to bumper corner. Seventeen measurements were taken at bumper level by the Nikon Total Station and the Faro Blitz program computed crush measurement in six increments as follows: $C_1 = 0$ cm, $C_2 = 0$ cm, $C_3 = 1$ cm (0.4 in), $C_4 = 3$ cm (1.2 in), $C_5 = 5$ cm (1.9 in), $C_6 = 19$ cm (7.4 in). The CDC was 01FREE1. The maximum crush was located at the right front bumper corner.
