U.S. Department
of Transportation

**National Highway
Traffic Safety
Administration**

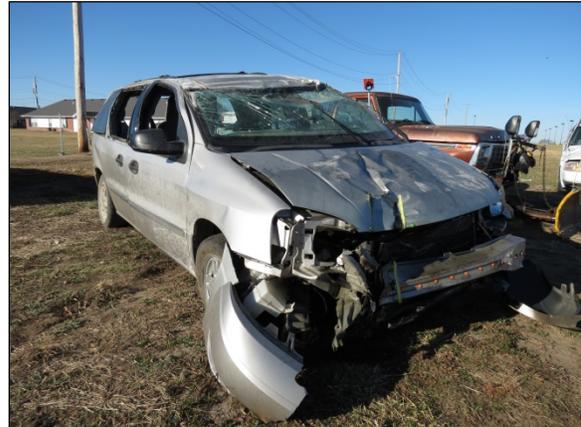
Figure 1: Front right oblique view of the Ford Freestar depicting the vehicle deformation.

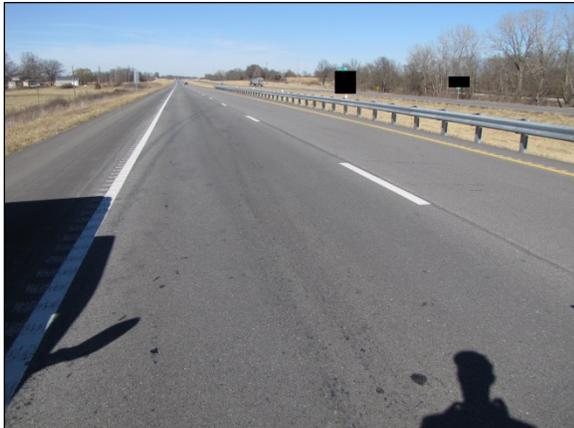
Figure 2: View of the roadway looking north from the crash site (lookback of approach).

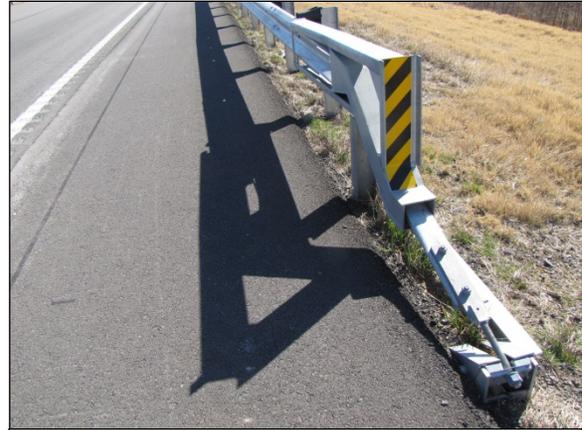
Figure 8: Image depicting an exemplar SoftStop end terminal and guardrail located approximately 5 km (3 miles) south of the crash site.

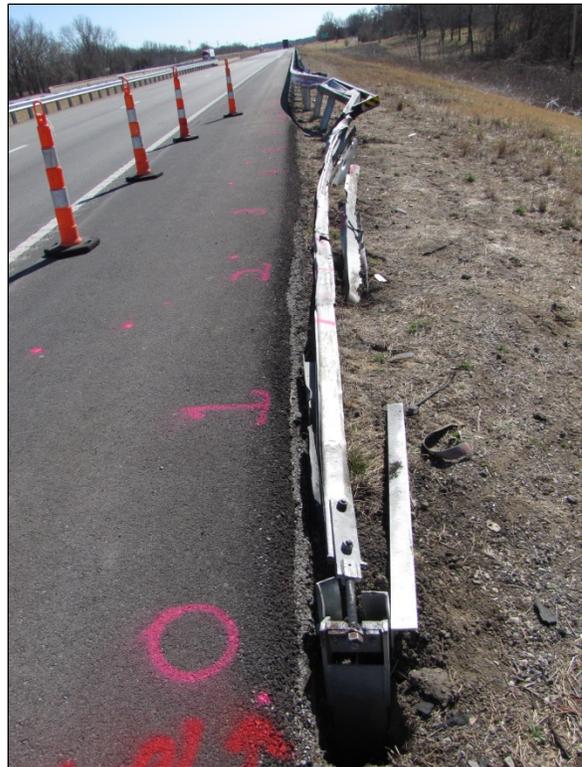
Figure 9: Overall image of the guardrail deformation looking south along the edge of pavement.

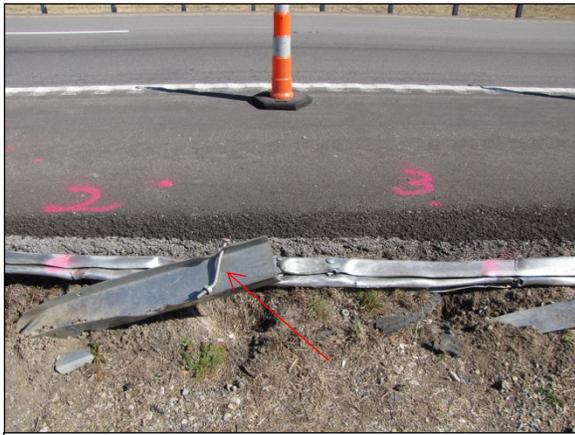
Figure 10: East-looking image depicting the Post 2 deformation and the deformed carriage bolt.

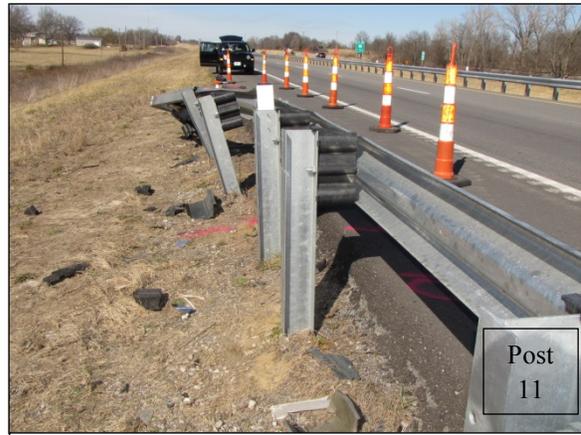
Figure 11: North-lookback view depicting the end of damage to the guardrail.

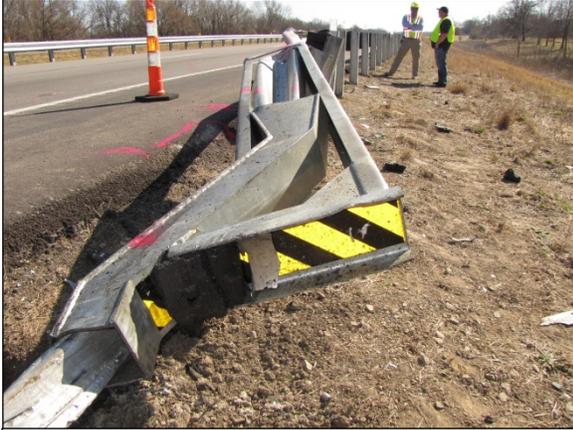
Figure 12: South-looking view of the struck and displaced end terminal.

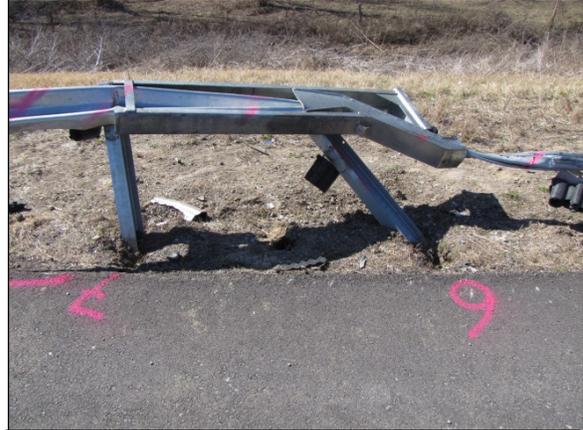
Figure 13: Image depicting the location and condition of the end terminal at Post 7 looking to the west.

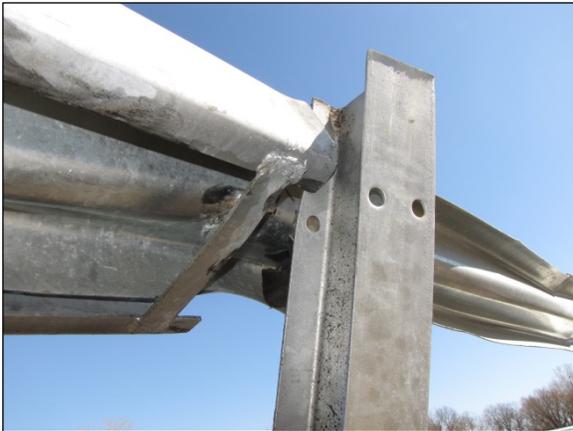
Figure 14: Close-up image of the end terminal depicting how it stopped at Post 7.

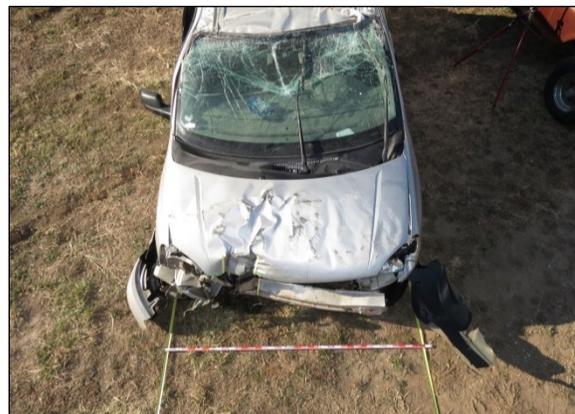
Figure 16: Overhead view of the Ford depicting the frontal deformation.

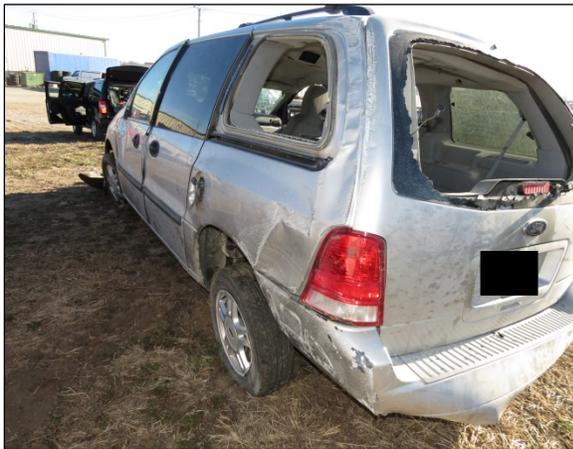
Figure 17: Left rear oblique view of the Ford depicting the rollover damage.

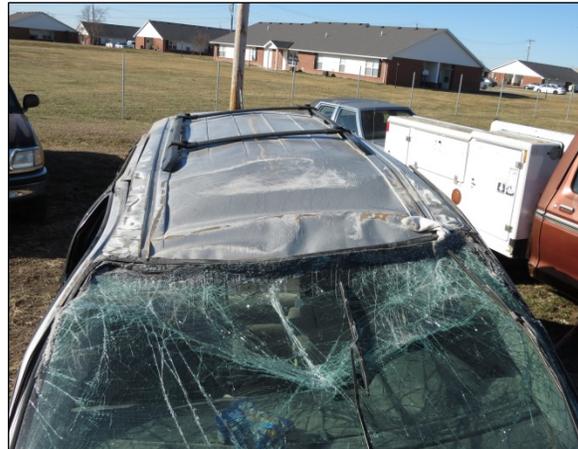
Figure 18: Image depicting the rollover abrasions and deformation to the Ford's roof.

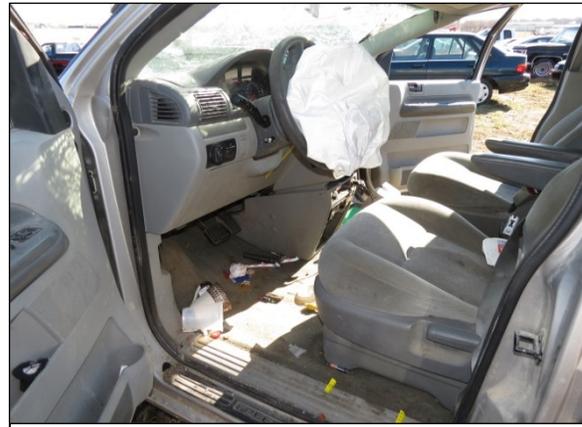
Figure 19: Interior image of the Ford.

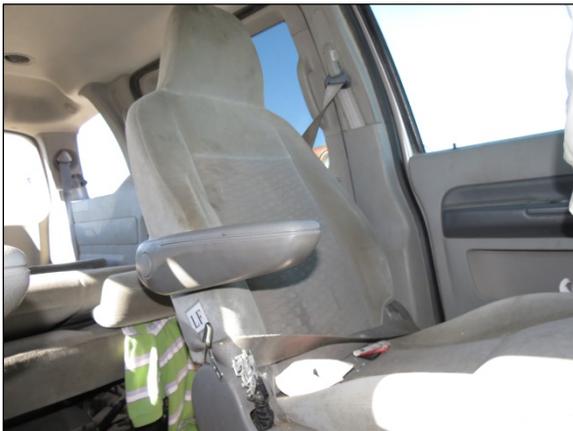
Figure 20: View of the Ford driver's seat belt webbing routed behind the seat back.
