DOT HS 812 685

**Special Crash Investigations  
On-Site Guardrail End  
Treatment Investigation  
Vehicle: 2015 Chevrolet  
Silverado 3500  
Location: Missouri  
Crash Date: November 2016**

**Special Crash Investigations**  
**Case No.: CR16031**  
**On-Site Guardrail End Treatment Crash Investigation**  
**Vehicle: 2015 Chevrolet Silverado 3500**  
**Location: Missouri**  
**Crash Date: November 2016**

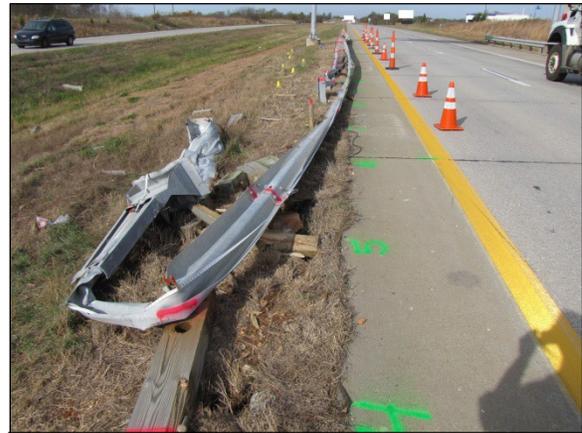
This report documents the on-site investigation of an impact to an ET-Plus guardrail end treatment (**Figure 1**) by a 2015 Chevrolet Silverado 3500 that resulted in fatal injuries to the vehicle's 50-year-old unbelted male driver. The Chevrolet was traveling west when it departed the left side of the road and struck the ET-Plus guardrail end treatment located in the median of a two-lane, divided highway. The Chevrolet deformed and then overrode the guardrail, traveled along the median, and struck a non-breakaway pole and its concrete base. The vehicle was then redirected over the guardrail system back into the roadway, where it came to final rest. The driver was transported from the crash site by ambulance for police-reported incapacitating (A-level) injuries but succumbed to his injuries and was pronounced deceased at the hospital. Although the Chevrolet was equipped with frontal air bags, they did not deploy in the crash.

**Figure 1:** Northwest-facing view of the deformed ET-Plus guardrail end treatment and crash site.

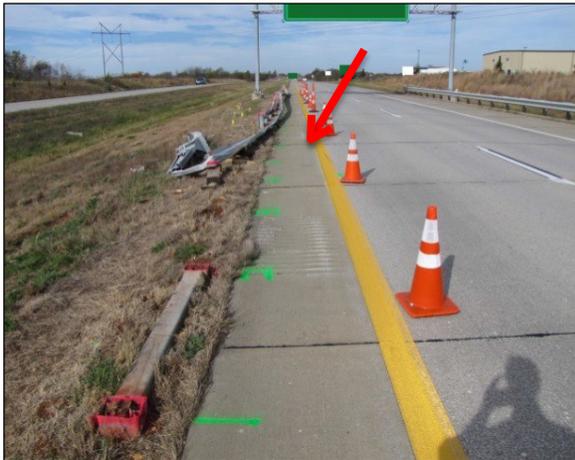
The front plane/left aspect of the Chevrolet struck the ET-Plus end terminal (Event 1) and displaced it along the rail (**Figure 4**). The frontal air bags in the vehicle did not deploy. Displacement of the end terminal extruded 3.7 m (12.0 ft) of the W-beam. The wooden support posts (Post 1 to 3) fractured and were displaced into the median. The Chevrolet began to rotate counterclockwise in response to the left bias of the impact force. A tire scuff mark attributed to the right rear tire was identified on the roadway straddling the yellow line and directed along the vehicle's path of travel. The tire mark measured 3.9 m (12.8 ft) in length and is identified by the arrow in **Figure 4**.

**Figure 4 :** Northwest trajectory view at the end terminal impact. The location of the right rear tire mark is denoted by the red arrow.

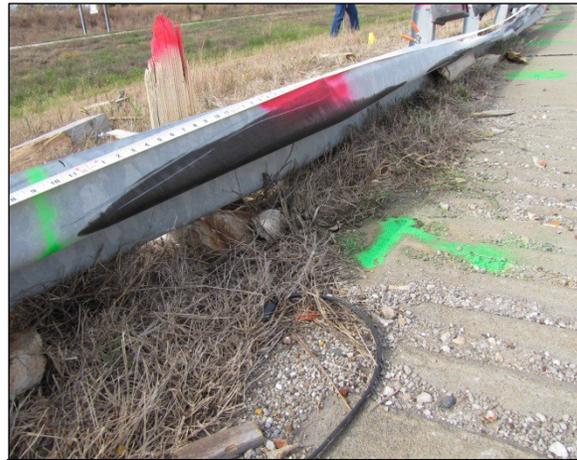
**Figure 5:** Northwest-facing view of the W-beam in the vicinity of Post 7 and the black transfer of the Chevrolet's right front tire.

Due to the off-road impact trajectory of the vehicle, its momentum and the resultant lateral loading of the W-beam, a bending moment was created between Posts 3 and 4. The W-beam deformed by bending approximately 180 degrees along the Chevrolet's travel path, located approximately 6.1 m (20 ft) from Post 1. The left side and center of mass of the Chevrolet overrode the deformed guardrail; however, the right front wheel and tire became captured on the road side of the W-beam as the Chevrolet traveled into the median. A rubber transfer was observed on the W-beam (**Figure 5**). This transfer began in the area of Post 7 (approximately 10.9 m (35.8 ft) from Post 1) and ended at Post 15 (approximately 26.8 m [88.0 ft] from Post 1).

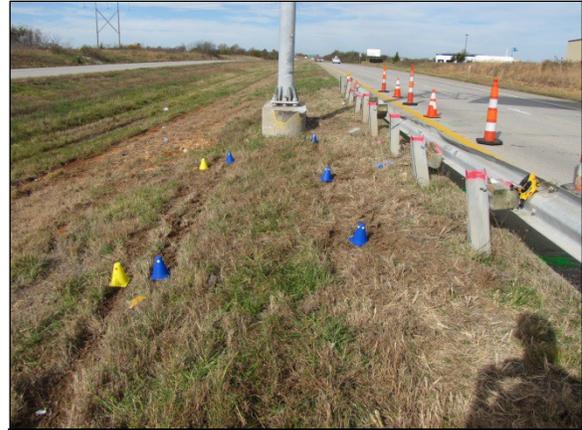
With the vehicle straddling the deformed guardrail and its right front tire/wheel captured on the road side of the guardrail, the Chevrolet initiated a clockwise rotation. Furrow marks attributed to the left side tires were observed in the median and are highlighted by the traffic cones in **Figure 6**. The length of the left front tire furrow (blue cones) measured 6.1 m (20.0 ft). The left rear dual marks (yellow and blue cones) measured 18.3 m (60.0 ft) in length. The Chevrolet's right front tire ultimately climbed over and separated from the W-beam at Post 15. The vehicle had rotated approximately 20 degrees clockwise relative to the heading of the roadway. Its momentum was directed toward the concrete base and pole.

**Figure 6:** Northwest trajectory view toward the concrete base/pole and the furrow marks of the left side tires.

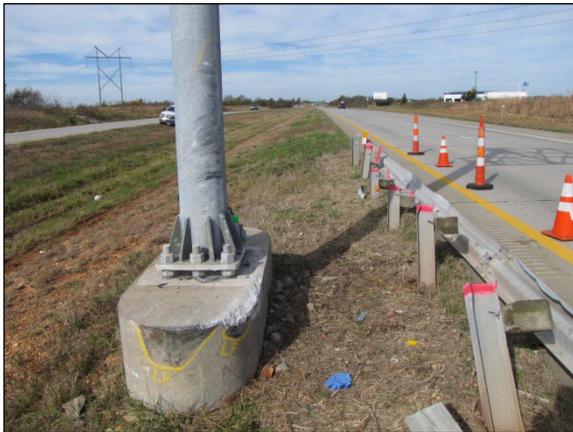
The left front tire/wheel struck the concrete base, and the left doors of the Chevrolet struck the pole (Event 2). A 38 cm x 138 cm (15 in x 66 in) pattern of abrasions and paint transfer extended to a height of 229 cm (90.0 in) above the ground on the pole. The unbelted driver was partially ejected through the left front glazing opening and contacted the pole with his head during the vehicle's engagement with the pole. The left rear dually tires/wheels then struck and engaged the concrete base (Event 3). A pair of distinct black transfer patterns and fractures to the top edge of the base (**Figure 7**) evidenced the contact of the left side tires with the base. The associated forces induced a rapid counterclockwise rotation to the Chevrolet.

**Figure 7:** Northwest-facing view of the impact damage and physical evidence on the concrete base and pole.

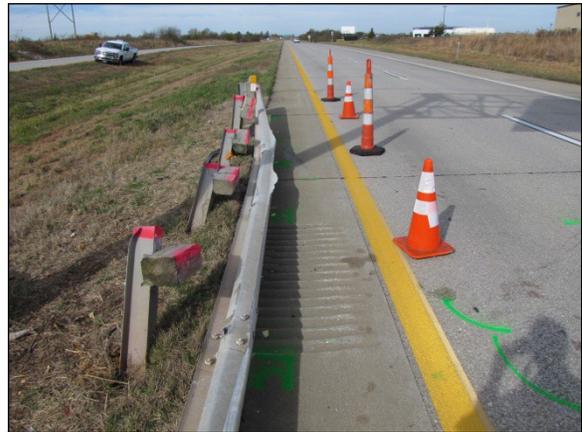
**Figure 8:** Northwest-facing view of the deformed guardrail at Posts 21-25.

The Chevrolet again contacted and then overrode the guardrail from Post 20 to 24 (**Figure 8**). These guardrail posts were deformed in the vehicle's direction of travel and the W-beam was deformed downward, contacting and abrading the road shoulder. Direct contact was observed on

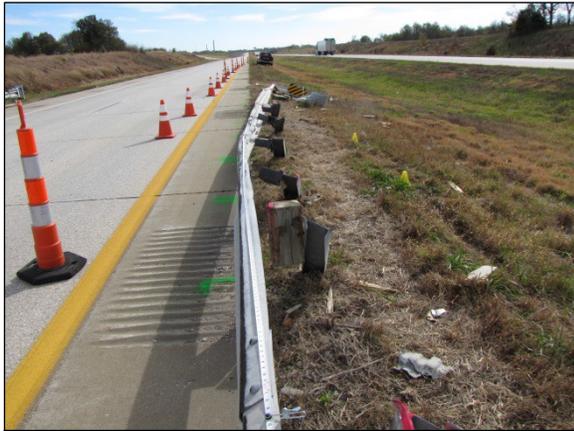
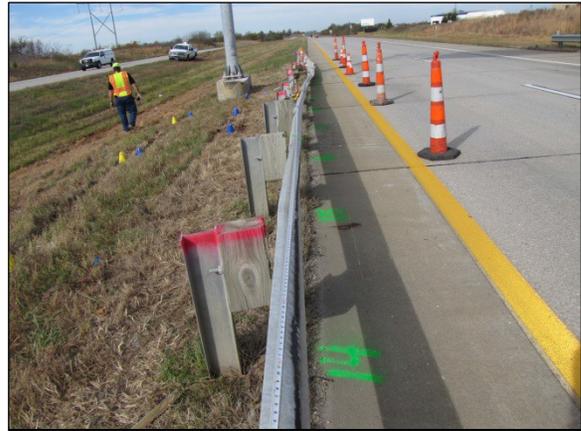
**Figures 10 and 11** depict the overall damaged guardrail system at the time of the SCI inspection.

**Figure 10:** Southeast-facing image along the deformed guardrail from Post 13.

**Figure 11:** Northwest-facing image along the deformed guardrail from Post 13.

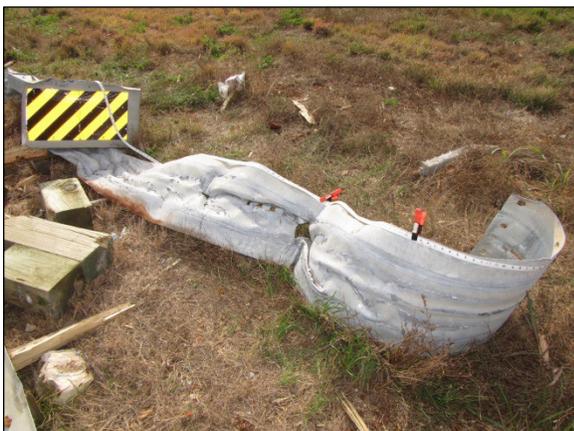
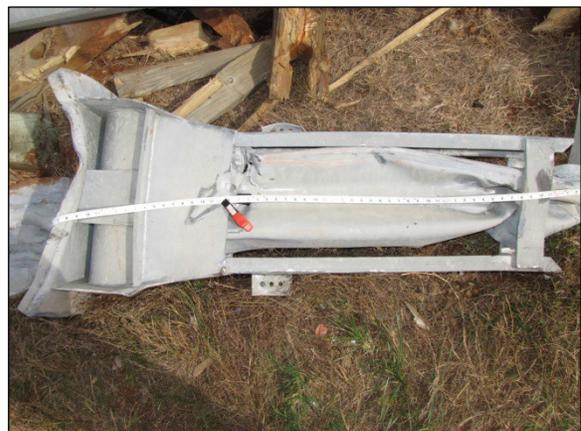
Pre-impact, the end terminal was fastened to Post 1 by two lag screws through hanger brackets welded to the terminal. The left front corner of the Chevrolet struck the impact face of the end terminal. The width and height of the end terminal's impact face measured 38 cm x 71 cm (15.0 in x 28.0 in), respectively. Examination revealed a 14 cm x 57 cm (5.5 in x 22.5 in) area of direct contact damage to the face with an 8 cm (3.0 in) deflection of the traffic side edge. At impact the lag screws released and the displaced end terminal extruded approximately 3.7 m (12 ft) of W-beam. As the W-beam deformed to the field side by bending in the area of Post 3 and 4, the Chevrolet's bumper contacted the traffic side of the end terminal. Deformation and abrasive

**Figure 12:** South-facing image of the extruded W-beam and the impact face of the end terminal.

**Figure 13:** Overhead image of the end terminal depicting its deformation.

contact damage were noted to the weldment. All welds remained intact. **Figures 12 and 13** are images of the end terminal and extruded rail.

The wooden posts at locations 1 to 7 were fractured by the force of the impact and the subsequent off-road trajectory of the Chevrolet. The W-beam deformed into a U-shape by bending with the vertex between Post 3 and 4. This deformation was not considered a kink.

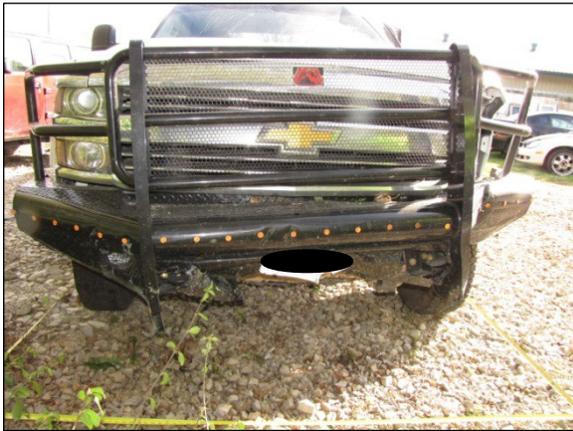
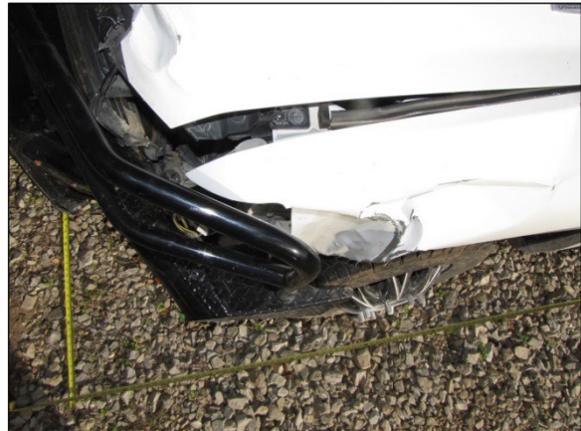
The exterior damage to the Chevrolet consisted of crush deformation on the front and left planes which was consistent with the events of the crash. Two distinct regions of direct damage contact were present on the front plane (**Figure 15**). The direct damage related to contact with the impact face of the end terminal began at the left corner and extended to the right 14 cm (5.5 in). This bumper corner deflected rearward approximately 13 cm (5 in) and contacted the body structure at the leading aspect of the left fender and forward left aspect of the hood (**Figure 16**). The damage profile at the fender and hood, caused by the dynamic deflection of the end terminal impact, matched the shape of the bumper guard. The bumper then rebounded through restitution.

**Figure 15:** Front view of the Chevrolet and the deformation of the aftermarket bumper.

**Figure 16:** Overhead view of the front left corner of the Chevrolet depicting the impact deformation.

The second region of front damage extended from the end terminal damage across the left and center aspect of the bumper and ended 46 cm (18.0 in) right of center. This second region was related to contact with the side of the end terminal and W-beam as the guardrail deformed by bending. The Chevrolet then overrode the guardrail evidenced by the damage to the lower aspect of the replacement bumper and abrasions to the undercarriage. The collision deformation classification (CDC) of the overall frontal damage pattern was 12FDEW1.

A residual crush profile of the bumper measured with the Nikon total station and accounting for freespace produced the following measurements: C1 = 18 cm (7.1 in), C2 = 13 cm (5.2 in), C3 = 5 cm (2.0 in), and C4 – C6 = 0. The untested properties of the replacement bumper and yielding properties of the guardrail impact were beyond the scope of analysis by the WinSMASH program. However, for comparative purposes, a borderline analysis of the crash severity (delta-V) was calculated using the barrier algorithm. The calculated total delta-V was 16 km/h (10 mph), with longitudinal and lateral components of -16 km/h (-10 mph) and 0 km/h, respectively.

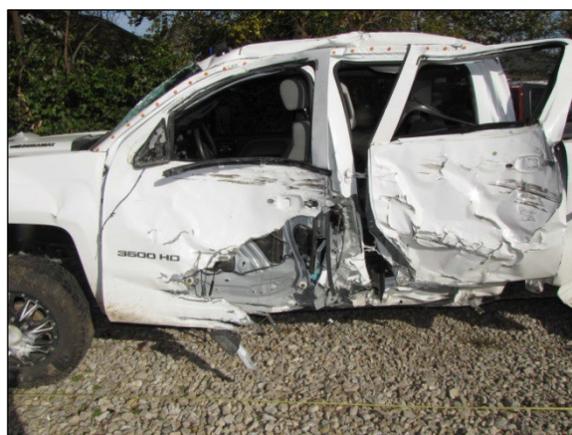
Damage on the left plane associated with contact from the pole itself began at the A-pillar, 77 cm (30.3 in) aft of the front axle, and extended rearward 184 cm (72.4 in) to the left C-pillar area. The most significant lateral deformation was sustained above the beltline. The most representative crush was observed to the left roof side rail. A residual crush documented to this profile produced the following resultant measurements: C1 = 15 cm (5.9 in), C2 = 26 cm (10.2 in), C3 = 27 cm (10.6 in), C4 = 21 cm (8.3 in), C5 = 15 cm (5.9 in), C6 = 0. The left rear door was shifted rearward 38 cm (15.0 in) and overlapped the C-pillar. The forward left corner of the cargo bed was deformed rearward 6 cm (2.5 in). The CDC assigned to the Chevrolet for the impact with the pole was 10LDEW3. A borderline analysis of the delta-V was calculated using the Barrier Algorithm of the WinSMASH model. The calculated total delta-V was 19 km/h (12 mph), with longitudinal and lateral components of -10 km/h (-6 mph) and 16 km/h (10 mph), respectively.

**Figure 17:** Left side of the Chevrolet depicting the Event 2 pole impact damage.

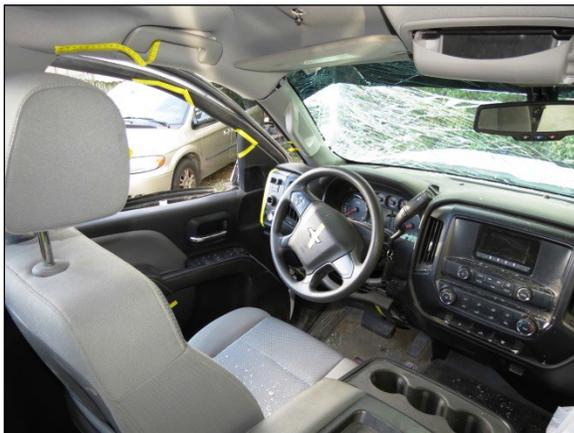
The interior damage to the Chevrolet consisted of the component-intrusion of the left plane and driver contacts to the interior. There was no deployment of the front air bags. The lateral intrusion of the left front and rear doors measured 10 cm (4.0 in) and 15 cm (6.0 in), respectively. The left B-pillar intruded 8 cm (3.1 in). The lateral intrusion of the left roof side rail measured 8 cm (3.1 in) at row 1 and 17 cm (6.7 in) at row 2. At impact, the driver contacted components forward and left of his position (**Figure 18**). Occupant contact was identified on the knee bolster, left instrument panel, center hub (driver air bag module) of the steering wheel evidenced by scuffs to the components. The driver contacted these components with his lower extremities, his left upper extremity, and chest, respectively. His left upper extremity also contacted the door at the A-pillar. The driver's head scuffed the upper door frame evidenced by a 13 cm x 3 cm (4.1 in x 1.1 in) contact area on the weather stripping. His head was partially ejected through the window opening and struck the pole. Rebound contacts were observed at the left roof side rail, B-pillar door frame, and head restraint. Hair and tissue were embedded in the scuffed areas of contact (**Figure 19**).

**Figure 18:** Left interior view depicting the driver contact evidence.

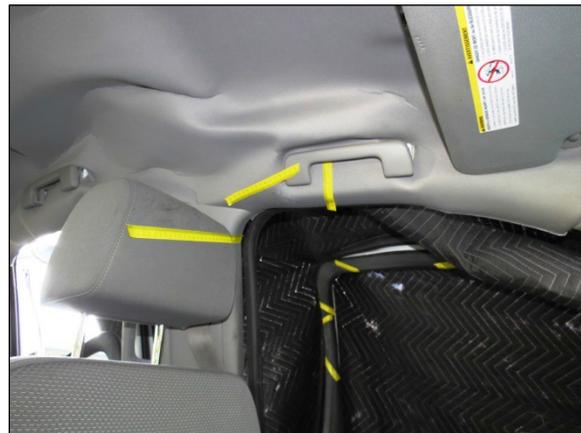
**Figure 19:** Interior view of the driver's rebound contact evidence.
