DOT HS 812 693

# **Special Crash Investigations Remote Vehicle Fire Child Restraint System Investigation Vehicle: 2000 Buick LeSabre Location: Indiana Crash Date: June 2012**

**Indiana University Transportation Research Center  
Special Crash Investigations  
Remote Vehicle Fire  
Child Restraint System Investigation  
Case Number - IN17005  
Vehicle: 2000 Buick LeSabre  
Location: Indiana  
Crash Date: June 2012**

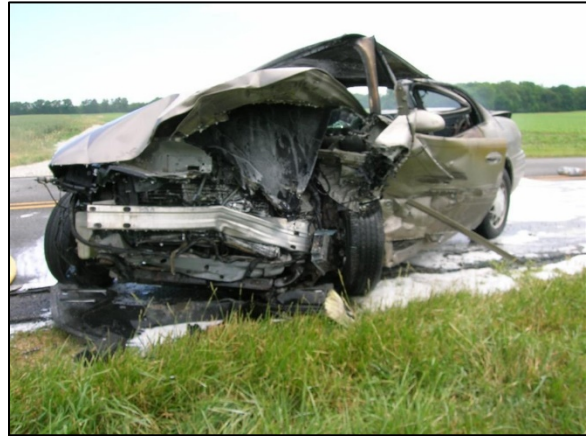
**Figure 1:** Police photo of the damaged 2000 Buick LeSabre, view east

*Exterior Damage Crash Event 1:* The Buick sustained direct and induced damage to the front plane during the impact with the Dodge. The left fender and left front door were also directly damaged. The impact was of sufficient severity to displace the left A-pillar rearward to nearly a vertical orientation, which also displaced the roof structure vertically. The vehicle's damage measurements were determined by scaling off one of the police on-scene photographs using known vehicle specifications to establish a scale. The direct damage to the front plane began at the left corner of the front bumper and extended approximately 82 cm (32 in) to the right across the front plane. The crush profile was approximately triangular-shaped based on the police on-scene photographs of the vehicle. Therefore, two crush measurements, one at each bumper

corner, were measured based on scaling off one of the police photographs and determined to be approximately 121 cm (48 in) and 20 cm (8 in) at C1 and C2, respectively.

*Damage Classification Crash Event 1:* The Collision Deformation Classification (CDC) was 12FYEW5 (0 degrees).

*Exterior Damage Crash Event 3:* The vehicle sustained fire damage primarily to the occupant compartment. The right-side doors, upper quarter panel, and trunk lid were also burned. Neither the hood or the engine compartment were burned, indicating that the fire likely started in the instrument panel and that the ignition source was related to damage to the electrical system.

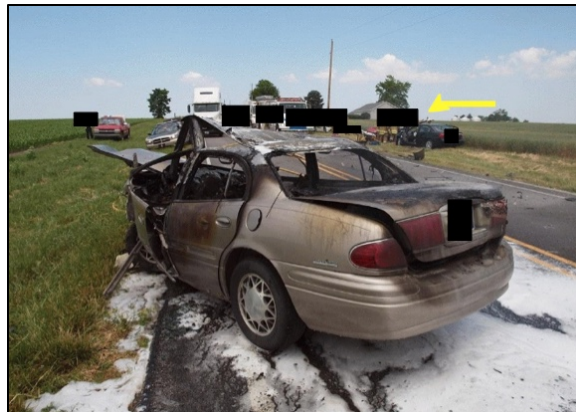
The impact caused both vehicles to rotate counterclockwise and the Dodge departed the right side of the road. The driver of the Chevrolet initiated a right steering maneuver and applied the brakes to avoid the crash and also departed the right side of the road. The front plane of the Chevrolet then struck the left plane of the Dodge (Event 2) and both vehicles came to final rest in a field with the Dodge heading west and the Chevrolet heading northeast. The Buick rotated approximately 210 degrees following the impact with the Dodge, coming to final rest in the southbound lane heading northwest (**Figure 2**), where it caught fire (Event 3).

**Figure 2:** Police photo of Buick’s final rest position, arrow shows final rest positions of Dodge and Chevrolet, view north

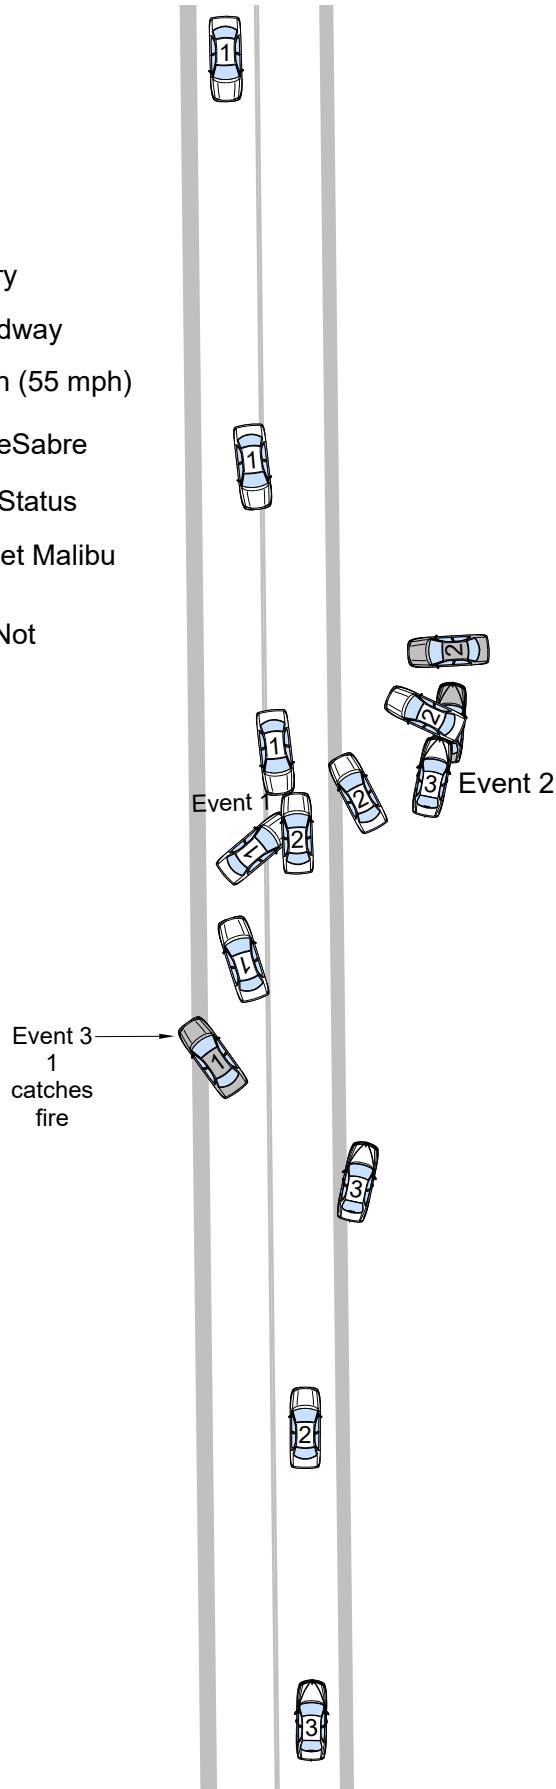
# CRASH DIAGRAM

Crash  
Schematic, Not  
to Scale
