DOT HS 812 697

# **Special Crash Investigations Remote Child Restraint System Investigation Vehicle: 2007 Lexus GX470 Location: Colorado Crash Date: September 2016**

**Special Crash Investigations  
Remote Child Restraint System Investigation  
Case Number DS16024  
Vehicle: 2007 Lexus GX470  
Location: Colorado  
Crash Date: September 2016**

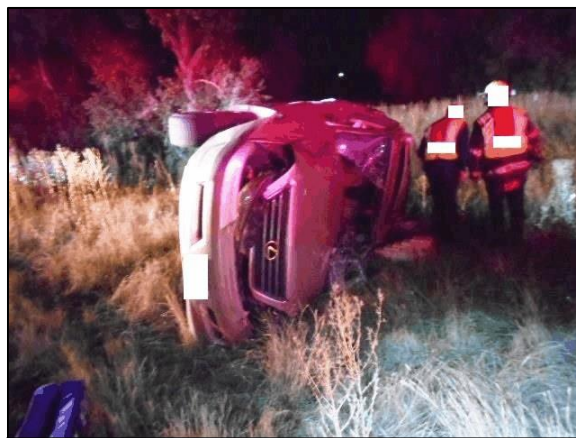
Following the rollover, the Lexus came to rest on its left side facing east (**Figure 3**). Three witnesses traveling in a non-contact vehicle were the first to respond to the crash and give assistance. They arrived immediately following the crash and called 911. While waiting for responders, the witnesses stayed in contact with the 2-year-old female occupant of the Lexus. The fire department arrived approximately 5 minutes after the crash and police arrived approximately 12 minutes after the crash. Responders removed the child occupant from the CRS and vehicle and transported her by ambulance to a local hospital, where she was treated for minor injuries and released. The driver and front right occupant were declared deceased on-scene and transported to a local morgue. The Lexus was towed due to damage and placed on a police hold pending vehicle inspection and imaging of the EDR. The vehicle was later released and salvaged. The insurance company indicated they gave approval for the vehicle to be destroyed.

**Figure 3:** Final rest orientation looking west, 2007 Lexus GX470 (police image).

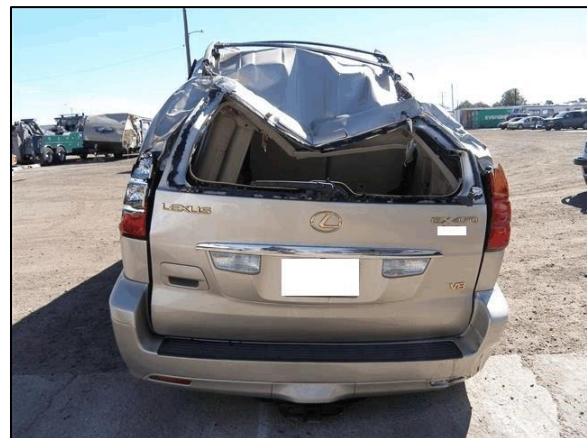
Exterior images of the Lexus taken by police were used to conduct a partial exterior vehicle inspection. The Lexus sustained direct contact damage to the left, top and right planes during the rollover. Direct damage to the top plane appeared in the images to extend laterally from roof side rail to roof side rail and longitudinally from the leading edge of the hood to the backlight header. Three tires were flattened and de-beaded. The front bumper fascia was fractured and displaced, and the rear bumper fascia was fractured. The vehicle sustained crush to the top plane during the rollover. The maximum vertical crush was located on the roof and backlight header above the rear cargo area. The maximum lateral crush was located at the upper aspect of the right D-pillar (**Figure 4**). The estimated Collision Deformation Classification (CDC) for the Lexus in Event 1 was 00TDDO4.

**Figure 4:** Maximum vertical and lateral crush areas, 2007 Lexus GX470 (police image).

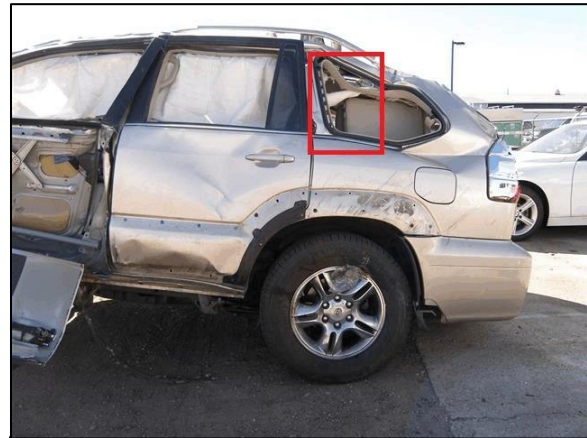
The right IC air bag deployed from the roof side rails above the front, second and third rows. The left IC air bag deployed above the front and second row but appears to not have deployed completely above the third row (**Figure 5**).

The IC air bags were configured with tethers at the forward aspect. In their deflated state, the IC air bags appeared to have fully covered the second row side windows and covered the majority of the front row windows for the front row with the exception of a small triangle of exposure at the forward aspect. Coverage for the third row side glass was not determined. Police images of the deployed IC air bags did not reveal any damage.

**Figure 5:** Deployed left IC air bag, 2007 Lexus GX470 (police image).

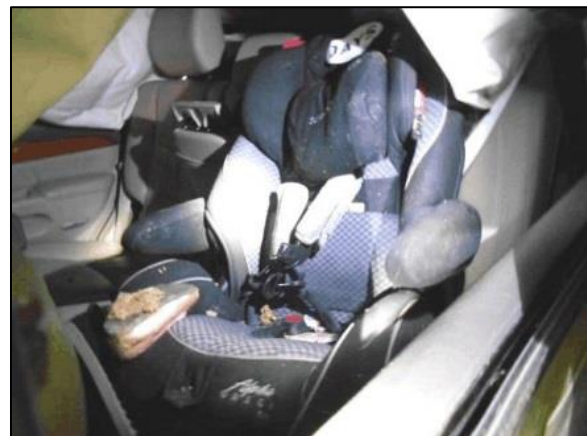
The Safety 1st Alpha Omega Elite CRS was a convertible safety seat (**Figure 6**). Data for this CRS and its installation was obtained from the police report and images. Specifications were obtained from the owner's manual. The Model Number, date of manufacture and history of the CRS is unknown.

**Figure 6:** Safety 1st Alpha Omega CRS (police image).

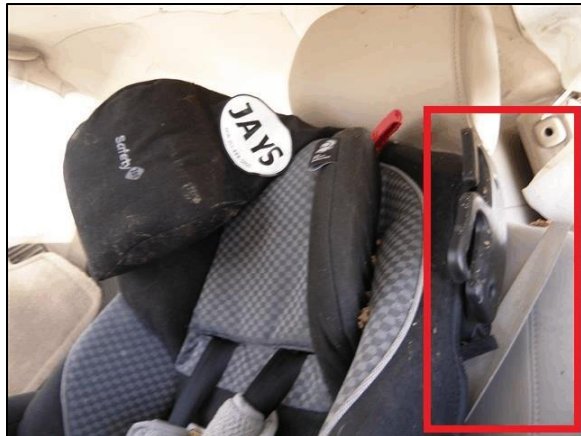
At the time of the crash, the CRS was installed in a forward-facing orientation in the second row left position using the vehicle's lap and shoulder seat belt routed through the forward-facing belt path (**Figure 7**) and with the LATCH system upper tether strap routed over the seat back and attached to the anchor located on the seat back (**Figure 8**). The police report indicated the CRS was properly installed. The manual indicates it is proper to use the upper tether in combination with the lap and shoulder belt to install this CRS.

**Figure 7:** Lap and shoulder seat belt used to install Safety 1st CRS, 2007 Lexus GX470 (police image).

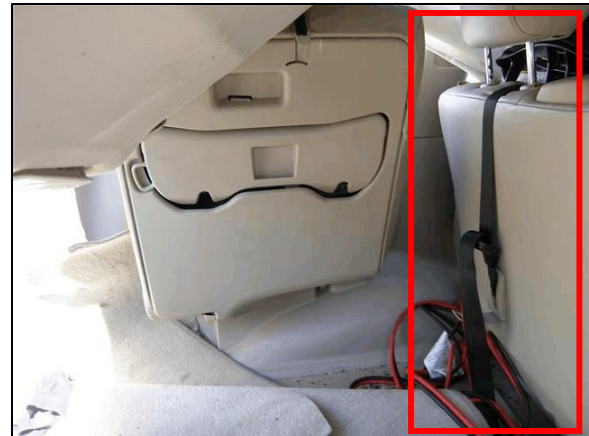
The second row seat belts were equipped with ELR/ALR and sliding latch plates. The left and right position belts were configured with non-adjustable D-rings and the center belt was configured with an integrated retractor. The second row was configured with Lower Anchors and Tethers for Children (LATCH). Lower anchors were present at the left and right seat positions and tether anchors were present at all three seat positions. The 2-year-old female occupant was seated in the second row left position. The police report indicated the lap and shoulder seat belt in that position was used to install the forward-facing CRS. Photos showed the tether anchor at

the second row left seat position was used to secure the CRS.

**Figure 8:** CRS tether strap to anchor connection, 2007 Lexus GX470 (police image).
