DOT HS 812 699

**Special Crash Investigations
On-Site Frontal Air Bag
Non-Deployment Investigation
Vehicle: 2008 Honda Accord
Location: Florida
Crash Date: March 2015**

SPECIAL CRASH INVESTIGATIONS
CASE NO.: CR15009
OFFICE OF DEFECTS INVESTIGATION
ON-SITE FRONTAL AIR BAG NON-DEPLOYMENT INVESTIGATION
VEHICLE: 2008 HONDA ACCORD
LOCATION: FLORIDA
CRASH DATE: MARCH 2015

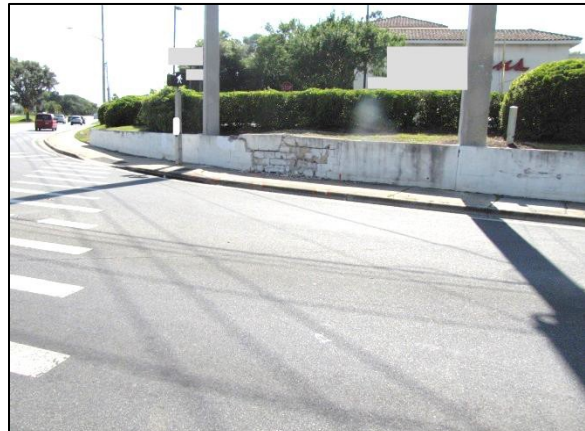
Figure 3: Image showing the point of impact in the southwest intersection quadrant.

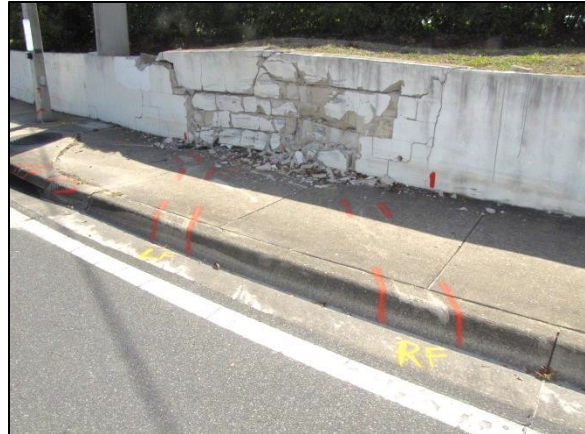
The crash sequence began with the right front tire/wheel (Event 1) and then the left front tire/wheel (Event 2) impacting the curb (**Figure 4**). Based on the observations and measurements of the SCI scene inspection, the relative angle between the front axle of the approaching Honda and the curb was approximately 30 degrees. The force of these impacts probably resulted in an air-out of both tires.

Figure 4: Image showing the Honda's impacts with the curb and concrete block wall.

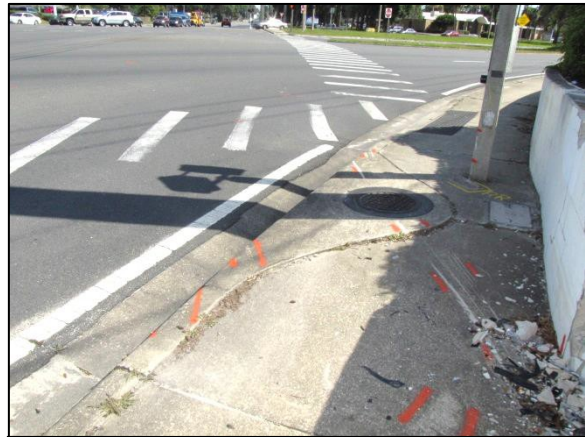
The Honda was redirected southward with a counterclockwise rotation due to its impact-orientation coupled with the curvature of the wall. The Honda separated from the block wall and travelled 7.4 m (24.3) ft at which time the right rear wheel and quarter panel of the vehicle struck the 20 cm (8 in) square concrete post (Event 4). This impact stopped the vehicle's counterclockwise rotation. The Honda separated from the post with a clockwise rotation and slid to its final rest position facing southward. **Figure 5** is a south looking view of the concrete post and the final rest location of the Honda. At rest, the vehicle was in the roadway 9.3 m (30.5 ft) from its impact with the block wall.

Figure 5: Image showing the Event 4 impact with the concrete post and the Honda's final rest location.

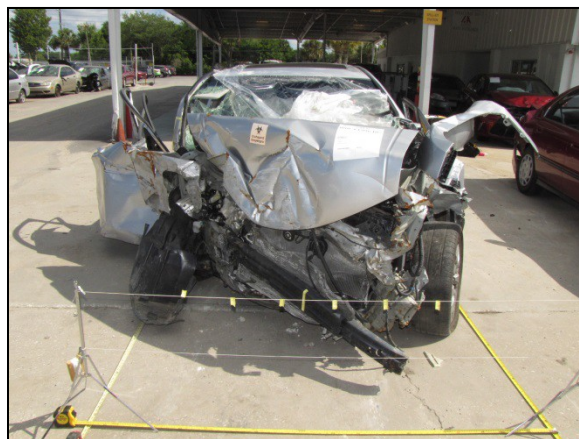
The right and center aspects of the Honda's front plane struck the concrete block wall (Event 3). The extent of the damage is shown in **Figures 7 and 8**. The direct contact damage began 25 cm (10.0 in) left of center and extended 102 cm (40.0 in) to the right front bumper corner. The front bumper fascia was separated and missing at inspection. The force of the impact coupled with the angled orientation of the block wall relative to

Figure 7: Front view of the Honda showing the Event 3 damage.

the Honda's trajectory resulted in the deformation pattern and subsequent compression of the engine compartment. The right front wheel assembly was displaced rearward under the right A-pillar. The right wheelbase was reduced 50 cm (19.5 in). The left wheelbase was unchanged. The A-pillar buckled and deformed rearward 8 cm (3.0 in) to a near-vertical orientation. The A-pillar sustained direct contact 20 cm (8 in) above the beltline. The right front door compressed 10 cm (4.0 in) and buckled outward 15 cm (6.0 in). Direct contact damage was noted on the right door panel extending 61 cm (24.0 in) from its leading edge. The windshield completely fractured across its width and height due to contact with the deformed hood. Over the time between the crash date and the SCI inspection, the windshield sagged and separated around the perimeter and fell onto the instrument panel. The frontal crush was measured along the deformed front bumper reinforcement bar. The residual crush was as follows: C1 = 14 cm (5.5 in), C2 = 48 cm (19.0 in), C3 = 70 cm (27.5 in), C4 = 74 cm (29.0 in), C5 = 78 cm (30.5 in), C6 = 79 cm (31.0 in). The maximum crush was located at right corner. The left front door was forced open and removed by the emergency responders. The left rear door was operational at inspection. The right front door was forced open and could not be closed due to deformation. The right rear door was removed and missing. The assigned CDC was 01FZAW6. The total delta V calculated by the WinSMASH program was 71 km/h (44 mph). The longitudinal and lateral components of the delta-V were -62 km/h (-39 mph) and -36 km/h (-22 mph), respectively.

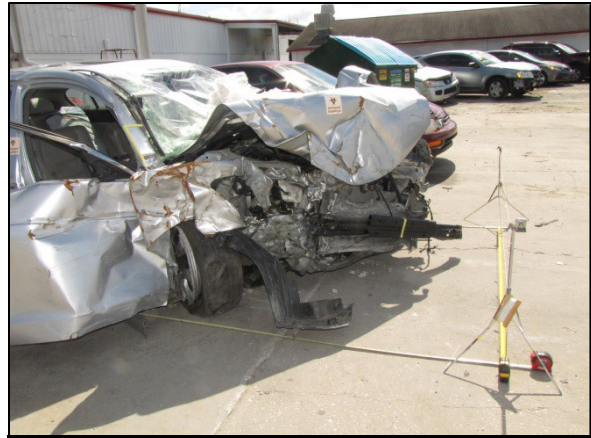
Figure 8: Right lateral view of the Honda at the front plane showing the extent of damage.

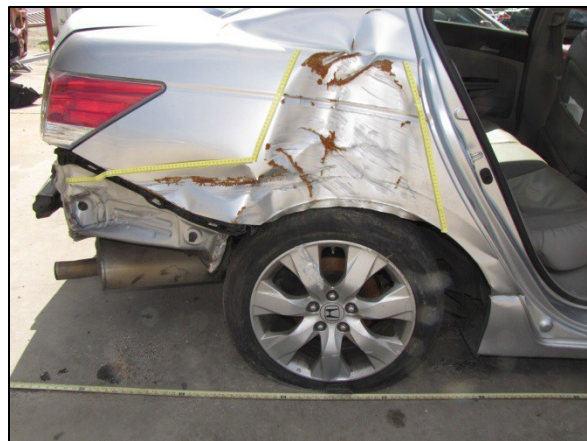
The right rear wheel and right quarter panel struck the concrete post that was located on the sidewalk. The axle position was deformed 6 cm (2.5 in) rearward and the face of the wheel rim was abraded. The quarter panel exhibited a damage pattern at the wheelhouse indicative of the impact that measured 43 cm (17.0 in) in length. It extended vertically to the beltline (**Figure 9**). This pattern began 127 cm (50.0 in) forward of the rear bumper reference line [22 cm (8.5 in) forward of the deformed axle location]. The maximum crush measured 6 cm (2.3 in). As the Honda then separated from the post, this pattern extended rearward to the right rear corner along the lower aspect of the body panel. The total length of the contact measured 102 cm (40.1 in). The rear bumper fascia had separated in this contact and was missing. The CDC of this damage pattern was 03RBEW2.

Figure 9: Image showing the Event 4 damage to the Honda.

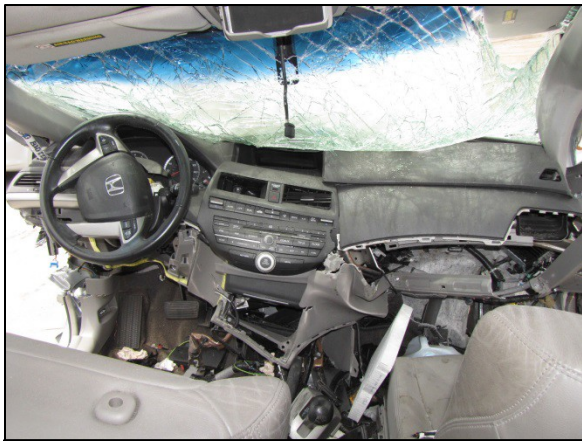
The interior damage to the Honda consisted of longitudinal intrusion that was biased to the front right, floor pan deformation and driver contacts to the knee bolster area (**Figures 10 and 11**). The right toe pan intruded 28 cm (11 in). The intrusion of the right corner of the instrument panel was 16 cm (6.5 in). The floor pan deformation completely disrupted the center console. The leather upholstered, 8-way powered driver seat was adjusted in a mid-to-rear track position that measured 5 cm (2.0 in) forward of full rear. The seatback was reclined 10 degrees. The horizontal distance from the seatback to the driver air bag module in the center hub of the steering wheel measured 60 cm (23.5 in). This horizontal distance was measured 46 cm (18.0 in) above the seat bight. The floor pan forward of the second row seat was buckled vertically. This deformation caused both first row seats to roll to the right. The gap between the left B-pillar and the outer aspect of the driver seat measured 15 cm (6.0 in). The outer aspect of the front right seat was in contact with the right B-pillar.

Figure 10: Image showing the instrument panel deformation in the Honda.

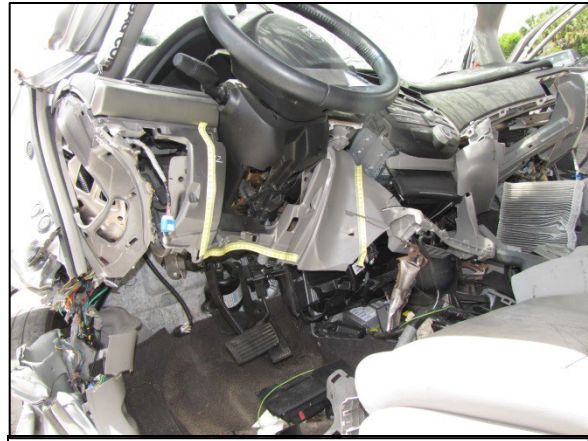
Figure 11: Oblique view of the driver's position in the Honda and the knee bolster contacts.

Two areas of contact from the driver's lower extremities were identified on the knee bolster of the lower left instrument panel. The left lower extremity contact was located 5 cm (2.0 in) left of the steering column and 48 cm (19.0 in) above the floor. The right lower extremity contact was located 18 cm (7.0 in) right of the steering column at the bolster's intersection with the center instrument panel. This contact extended 51 cm (20.0 in) above the floor.

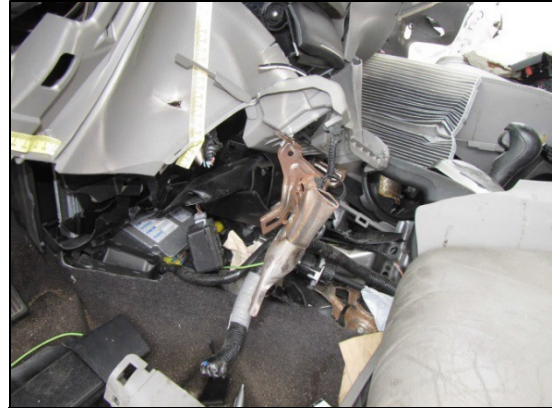
The disrupted/fractured components of the center console exposed the ACM. It was accessible (**Figure 12**). The module was secured to the vehicle by three fasteners. It was observed that two of the module's cast-mounting locations fractured due to floor pan deformation. Loosening the third fastener allowed the module to be removed. The SCI investigator forwarded the ACM to NHTSA, which forwarded the module to Honda for imaging.

Figure 12: Image showing the ACM location in the 2008 Honda Accord.

During its examination, the module would not fully boot and no crash data was recoverable from the unit. This examination took place as part of NHTSA Action PE15-0029.

The supplier of the air bag control module determined that there was a fault with the module during testing. The module would not fully boot. Crash data could not be recovered. It was subsequently determined that a faulty module resulted in the supplemental restraint system to become inoperative.

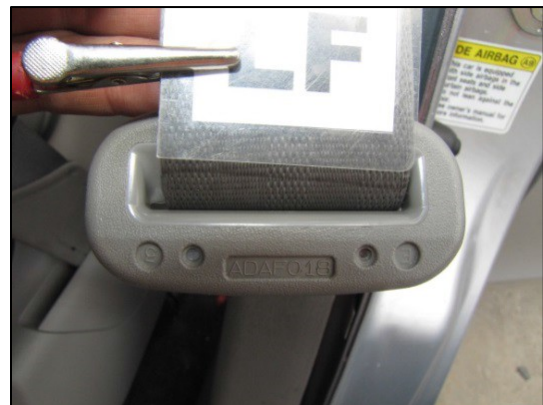
At inspection the driver's safety belt webbing was stowed and freely extended from the retractor. Visual and tactile inspection of the webbing was unremarkable; no crash related evidence was identified. Examination of the latch plate revealed minimal indicators of historical use. The friction surface of the latch plate was smooth and absent of crash related evidence (**Figure 13**). Based on the observations of the inspection, the driver was not restrained by the manual safety belt at the time of the crash. This determination was consistent with the observations of the police investigation.

Figure 13: Image showing the Honda driver's latch plate.

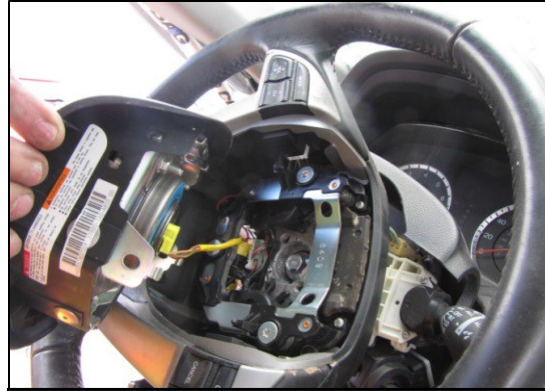
This air bag module was removed and examined. It was secured to the steering wheel by two fasteners. Removal of these fasteners allowed for examination of the wiring and the manufacturer's labeling on the back side of the module. All the wiring appeared intact and connected. The following alpha-numeric sequence identified the driver air bag assembly: *H0VS51BD2U 77800-TA0-A810 00*. The following alpha-numeric sequence identified the inflator: *Z35M8074978*.

Figure 14: Image showing the driver air bag module in the Honda.
