DOT HS 812 707

Special Crash Investigations On-Site Guardrail End Treatment Crash Investigation Vehicle: 2004 Pontiac Sunfire Location: Missouri Crash Date: May 2017

Special Crash Investigations
Case No.: CR17010
On-Site Guardrail End Treatment Crash Investigation
2004 Pontiac Sunfire
Location: Missouri
Crash Date: May 2017

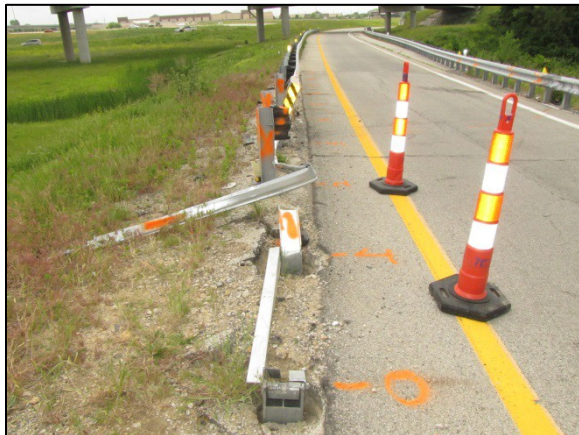
The left corner aspect of the Pontiac's front plane struck the SoftStop end terminal of the guardrail installation (**Figure 4**). The force of the impact caused the deployment of the Pontiac's frontal air bags. The impact-momentum of the vehicle displaced the end terminal 4.9 m (16.0 ft) along the W-beam. The displacement of the end terminal crushed the rail and forced the deformed beam to the ground absorbing energy in the process. The left bias of the impact caused the Pontiac to initiate a counterclockwise rotation as the terminal was displaced.

Figure 4: South-looking image of the guardrail impact (Event 1).

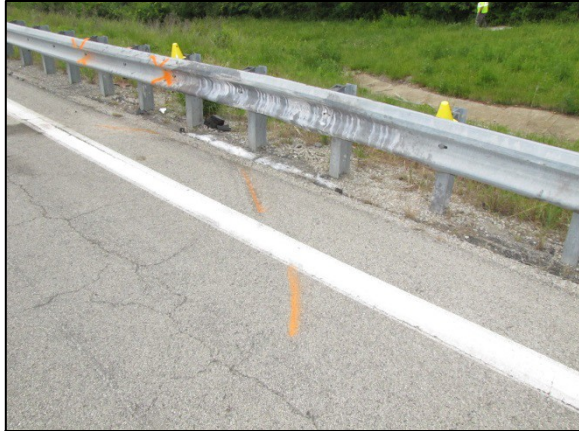
The Pontiac rotated approximately 45 degrees and separated from the end terminal along a westerly trajectory. The Pontiac continued to rotate clockwise as it traveled 8.4 m (27.6 ft) across the exit ramp (**Figure 5**). As the vehicle reached approximately 230 degrees of rotation relative to its original heading, the left plane/front corner area of the vehicle struck the face of the W-beam on the west side of the road. This impact deformed the guardrail approximately 15 cm (6 in) laterally over a 3.0 m (9.8 ft) distance (**Figure 6**). The force of the impact stopped the

Figure 6: Southwest-looking image depicting the guardrail impact of the opposite road side.

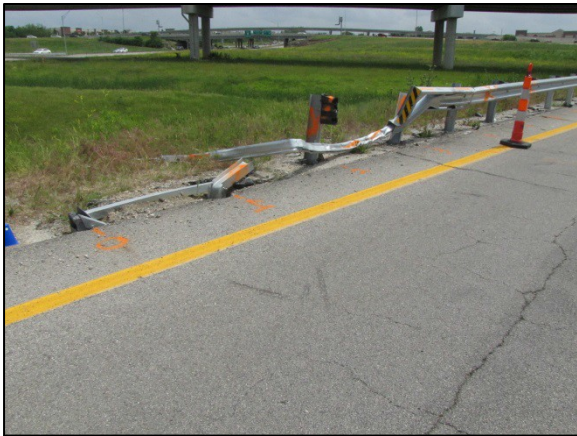
The struck guardrail (**Figure 9**) was a tangent system with a measured W-beam height of 79 cm (31.0 in). This height was measured at an undamaged section at Post 6. The Pontiac struck the impact face of the end terminal (originally located at Post 1) and displaced it along the W-beam. The impact face measured 18 x 51 cm (7 x 20 in), width x height. Due to its design, the terminal crushed and flattened the W-beam during its movement, thus absorbing energy of the impact. The posts numbered 0 to 4 of the installation were damaged. The total length of damaged W-beam measured 8.8 m (29 ft). This length included the 4.9 m (16 ft) of extrusion plus a 3.9 m (13 ft) of rail section that included a small wrinkle in the top W-beam flange near Post 5. Due to the splice locations, this wrinkled section of rail required replacement to the splice located between Posts 8 and 9.

Figure 9: South-looking oblique view of the deformed guardrail system at the SCI inspection.

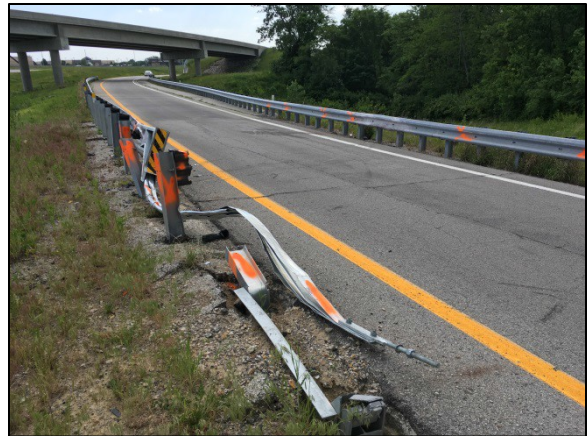
Figure 10: West-looking image of the guardrail at its initial inspection by the MoDOT inspector. Image supplied by MoDOT.

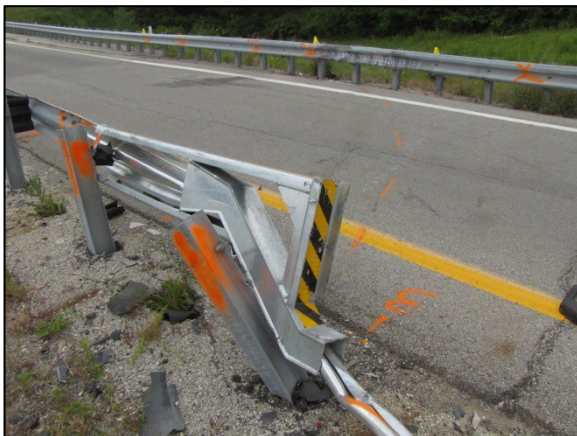
The end terminal (**Figures 11 and 12**) was displaced 9.8 m (16 ft) by the Pontiac. The downstream end of the terminal was captured at the carriage bolt of Post 4. Inspection of the end terminal was unremarkable. No welds were broken and it was relatively undeformed.

Figure 11: Northwest-looking oblique view of the displaced end terminal.

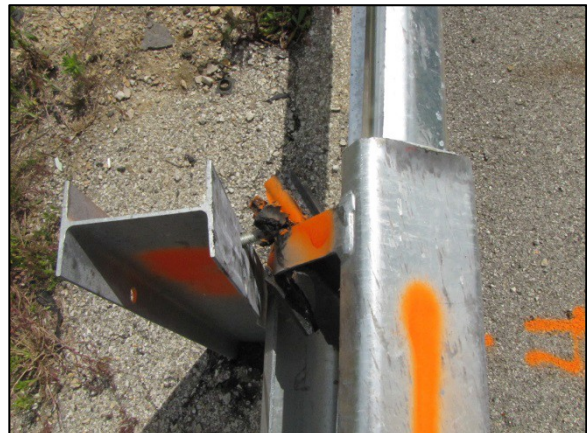
Figure 12: Overhead view of the downstream aspect of the end terminal depicting its capture on the Post 4 carriage bolt.

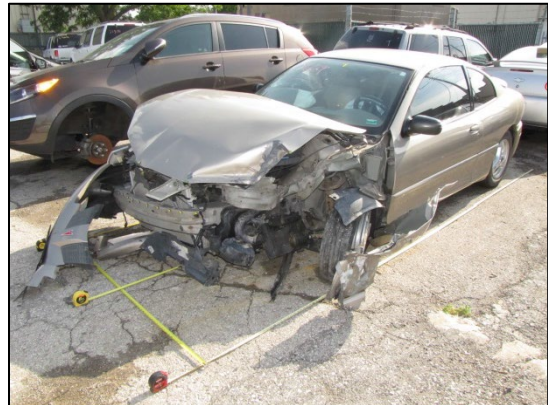
The 2004 Pontiac Sunfire, two-door coupe (**Figure 13**), was identified by Vehicle Identification Number 1G2JB12F847xxxxxx. Its date of manufacture was unknown. The Pontiac was equipped with the base-level trim package. The vehicle was configured on a 264 cm (104.0 in) wheelbase with an overall length of 470 cm (185.2 in). The powertrain consisted of a 2.2-liter, transverse-mounted, 4-cylinder, gasoline engine linked to a 3-speed automatic transmission. Standard equipment included power-assisted front disc/rear drum brakes with ABS, traction control, and power-steering. The gross vehicle weight rating for this vehicle was 1,664 kg (3,669 lb) with gross axle weight ratings of 907 kg (2,000 lb) front and 757 kg (1,669 lb) rear. At the time of the crash, the Pontiac was configured with Headway tires at the left front, left rear, and right front axle. The tire at the right rear axle location was a Goodyear Viva 2. All tires were the manufacturer-recommended size of P195/65R15. The specific tire data at the time of the SCI inspection was as follows:

Figure 13: Front left oblique view of the Pontiac depicting its deformation.

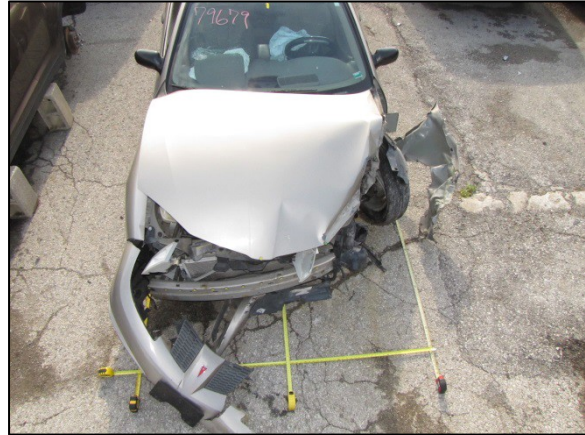
The exterior damage of the Pontiac (**Figure 14**) was present on the left aspect of the front plane and the forward aspect of the left plane. Due to the vehicle dynamics and the physical locations of the crash events, the two damage patterns overlapped each other. The exact locations of the

direct contact damage and crush attributable to each crash event was masked due to the overlap. The resultant frontal crush was a composite profile attributable to both impacts. For reference purposes only, the profile (after adjustment for freespace) was as follows: C1 = 3 cm (1.2 in), C2 = 3 cm (1.2 in), C3 = 2 cm (0.8 in), C4 = 1 cm (0.4 in), C5 = 1 cm (0.4 in), C6=0. The crush profile could not be used for analysis due to the overlapping properties.

Figure 14: Overhead view of the Pontiac depicting its deformation.

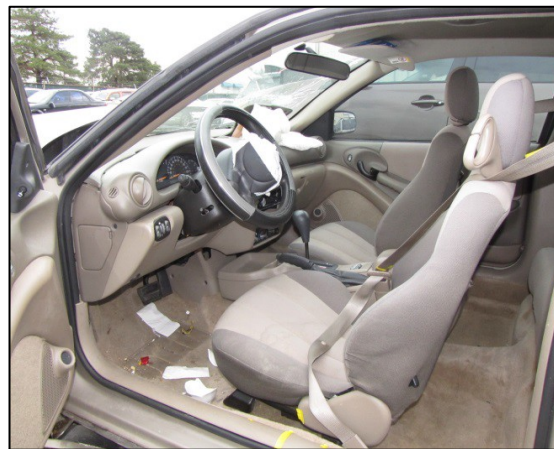
The interior damage to the Pontiac (**Figure 15**) consisted of the deployment of the frontal air bags. There was no intrusion of the interior components or identified occupant contacts to the interior. The right aspect of the windshield was fractured by the contact from the cover flap of the passenger's frontal air bag module during its deployment.

Figure 15: Left interior view of the Pontiac.
