DOT HS 812 716

# **Special Crash Investigations On-Site End Terminal Guardrail Investigation Vehicle: 2003 GMC Yukon Location: Missouri Crash Date: January 2017**

**Indiana University  
Transportation Research Center  
On-Site End Terminal Guardrail Investigation  
Case Number: IN17009  
Vehicle: 2003 GMC Yukon  
Location: Missouri  
Crash Date: January 2017**

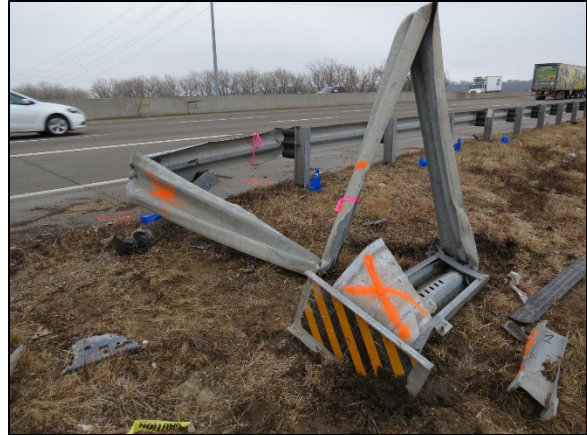
This report documents the on-site investigation of an SUV impact to an ET-Plus 10 cm (4 in) model end terminal guardrail (**Figure 1**) that is of interest to the Federal Highway Administration (FHWA). This crash was identified by an engineer with the Missouri Department of Transportation (MoDOT), who submitted photographs of the vehicle and the damaged guardrail end terminal to the FHWA. The FHWA determined that the end terminal and crash type were of interest. This crash investigation was then initiated by the National Highway Traffic Safety Administration in January 2017 and assigned to the Special Crash Investigation team at the Indiana University Transportation Research Center. This single-vehicle crash involved a 2003 GMC Yukon (**Figure 2**). The crash occurred in Missouri in January 2017 at night and was investigated by a local police agency. The vehicle, guardrail, and crash scene were inspected in January 2017. A telephone interview was conducted with the driver in June 2017.

**Figure 1:** The damaged ET-Plus and guardrail.

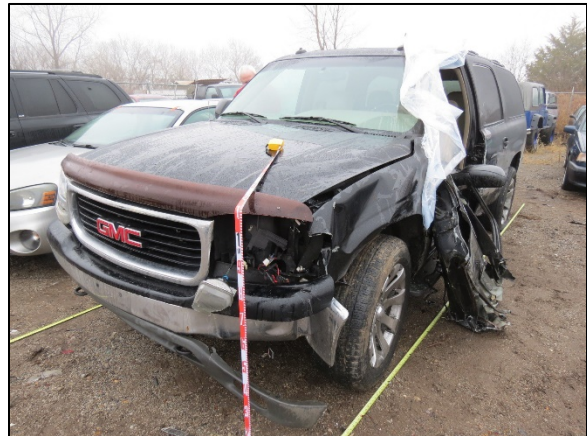
**Figure 2:** The damaged 2003 GMC Yukon.

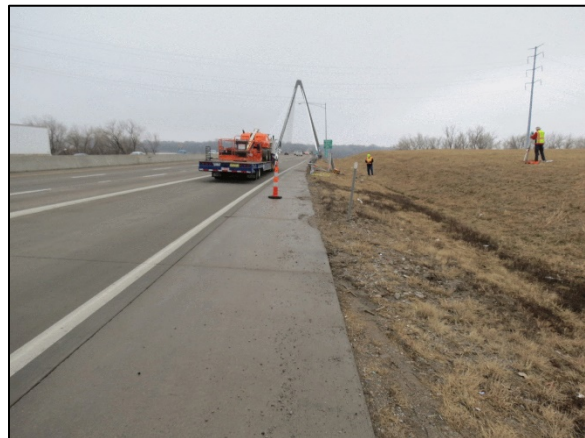
The brake application by the driver of the GMC and possible right steering input to avoid the non-contact vehicle resulted in a loss of vehicle control, and the GMC began to rotate clockwise, traveling toward the west roadside and the guardrail (**Figure 3**).

**Figure 3:** View southeast to GMC's approach from approximately 30 m (100 ft) from impact with ET- Plus.

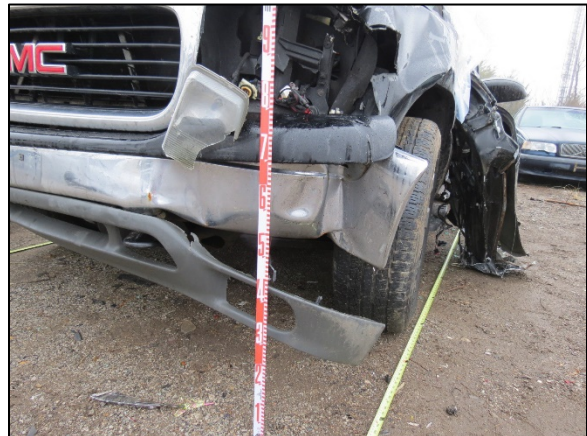
The left corner of the GMC's front plane (**Figure 4**) struck the end terminal (**Figure 5**, event 1). The impact speed is not known. The impact extruded 1.0 m (3.3 ft) of guardrail from the end terminal as the guardrail was deformed and displaced toward the field side of the guardrail. The vehicle's EDR reported the maximum longitudinal velocity change as -14.4 km/h (-9.35 mph) occurring at 485 msec following AE. The WinSMASH program could not be used to calculate delta-V since an impact with a yielding object is out of scope for the program. However, the barrier algorithm of WinSMASH was used to calculate a barrier equivalent speed (BES) based on the crush to the front plane. The calculated BES was 17 km/h (11 mph).

**Figure 4:** Damage to the front left corner of the GMC from impact with the ET-Plus.

***Exterior Damage Event 1:*** The GMC sustained direct and induced damage to the front plane during the impact with the end terminal. The direct damage began and the left corner of the front bumper and extended 33 cm (13.0 in) to the right involving the bumper, left headlamp/turn signal assembly, and left fender. The Field L was 182 cm (71.7 in). Crush measurements were taken on the bumper and the maximum residual crush was 20 cm (7.9 in) occurring at C<sub>1</sub>. The crush values were: C<sub>1</sub> = 20 cm (7.9 in), C<sub>2</sub> = 11 cm (4.3 in), C<sub>3</sub> = 0 cm, C<sub>4</sub> = 0 cm, C<sub>5</sub> = 0 cm, C<sub>6</sub> = 0 cm.

***Damage Classification Event 1:*** The Collision Deformation Classification (CDC) was 12FLEE2 (350 degrees). The severity of the damage was moderate.

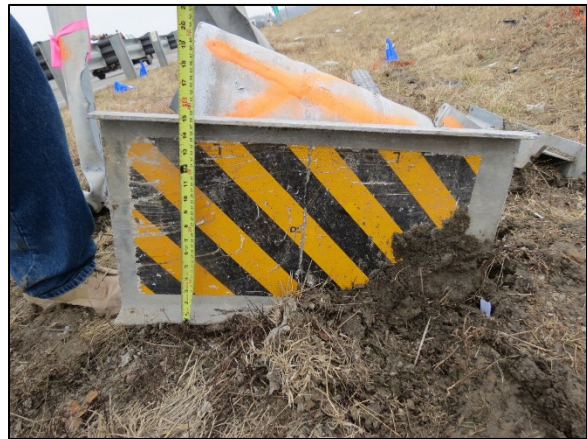
**Figure 5:** The damaged ET-Plus.

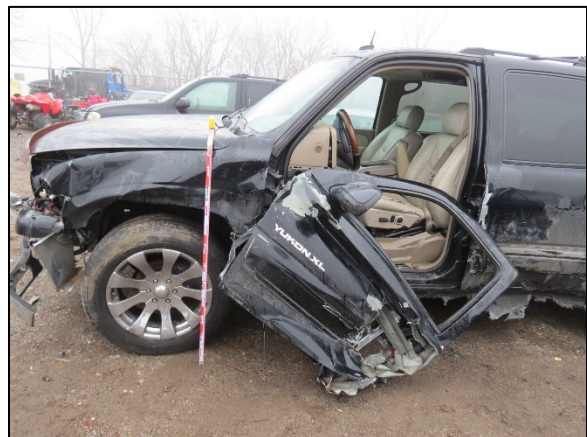
The impact damaged and displaced the guardrail, resulting in five kinks in the guardrail. One of these kinks (probably the kink at the entrance to the guide chute on the end terminal) struck the vehicle's left front door (**Figure 6**, Event 2) creating an approximate 42 cm (17 in) long tear in the sheet metal and damaged the door's latch mechanism, which caused a separation of the latch and striker. The door remained partially attached to the vehicle by the lower hinge. The vehicle then came to final rest heading southeast after traveling 13.2 m (43.3 ft) from the initial impact with the end terminal.

**Figure 6:** Damage to GMC's left front door from impact with kink in guardrail.

***Exterior Damage Event 2:*** The left plane sustained direct and induced damage when the vehicle struck a kink in the guardrail as the guardrail deformed during the first impact. The direct damage involved the fender, both doors, running board, sill, and quarter panel. The sheet metal of the left front door was torn during this impact and door latch assembly damaged resulting in the latch releasing from the striker. The direct damage to the left plane began 42 cm (16.5 in) forward of the left rear axle and extended 229 cm (90.2 in) rearward. No crush measurements were taken since the left front door was partially displaced from the vehicle.

***Damage Classification Event 2:*** The CDC was 10LDEW2. The severity of the damage was moderate.

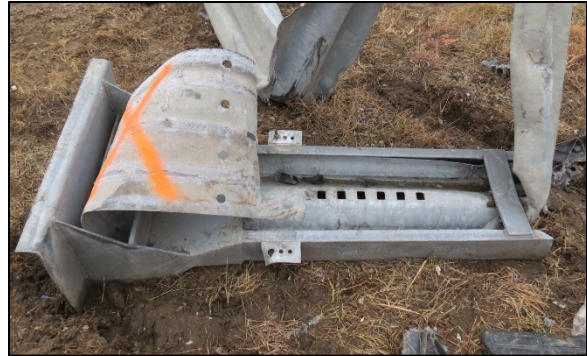
The GMC's front plane impact to the end terminal extruded 1.0 m (3.3 ft) of guardrail (**Figure 7**) to the field side and damaged five posts and 9.5 m (31.3 ft) of guardrail (**Figure 8**) resulting in five kinks in the guardrail. The direct damage to the face of the end terminal involved its full width (38 cm [15.0 in]) and height (71 cm [28.0 in]). The guardrail was displaced from posts 1 to 6; however, post 6 was not damaged or displaced. Post 1 pivoted downstream and separated from its base. It was found 8.5 m (27.9 ft) downstream of its base. Post 2 was bent downstream approximately 75 degrees off vertical. Post 3 was bent downstream approximately 70 degrees off vertical. The bolt pulled through the guardrail and remained attached to the post, while the composite offset block separated and was found near post 13. Post 4 was bent downstream approximately 40 degrees off vertical. The bolt pulled through the guardrail and the offset block was damaged but remained attached to the post. Post 5 was bent downstream approximately 60 degrees from vertical. The bolt was separated from the post and the offset block was damaged. Post 6 was not damaged or displaced but the bolt was pulled through the guardrail. Posts 7 and 8 were undamaged. The offset block for post 9 was cracked and the offset block for post 10 was cracked and displaced slightly downstream. This damage appeared to be unrelated to this crash and may have occurred during installation. There was no damage on the face of the guardrail near or at either of these posts. The FHWA guardrail form is attached to the end of this report as **Appendix A**.

**Figure 7:** Extruded guardrail from the end terminal.

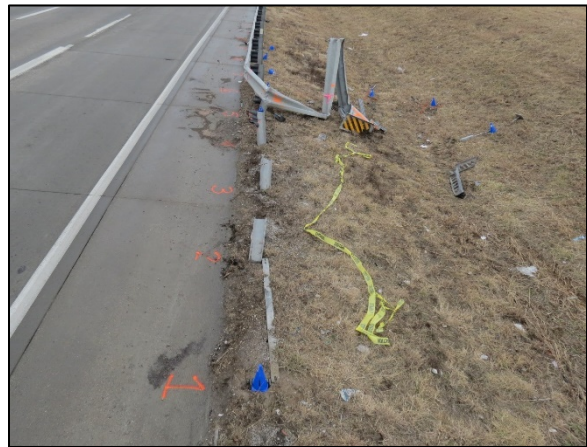
**Figure 8:** Damaged and displaced posts and guardrail, view southeast.
