Special Crash Investigations Remote Child Restraint System Investigation Vehicle: 2004 GMC Yukon Location: Montana Crash Date: July 2018

Special Crash Investigations
Remote Child Restraint System Investigation
Case Number: DS18019
Vehicle: 2004 GMC Yukon
Location: Montana
Crash Date: July 2018

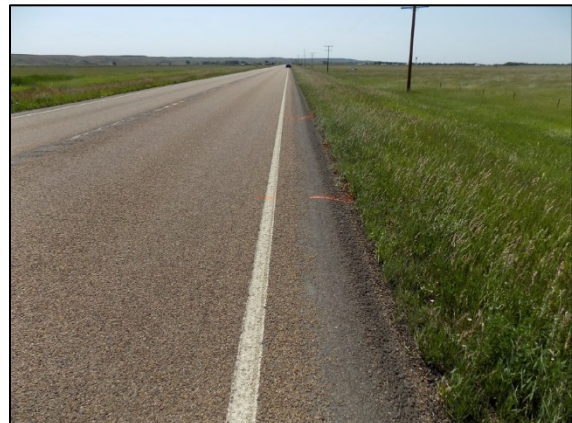
The GMC was traveling westbound in the first lane at a minimum speed of 111 km/h (69 mph).¹ The driver had a history of seizures and was using multiple anticonvulsants. The coroner indicated that the driver probably had a seizure prior to the crash. The vehicle initially drifted off the right side of the roadway (**Figure 2**). The driver corrected to the left and the vehicle re-entered the roadway. The driver then over-corrected to the right and the vehicle departed the roadway a second time while beginning clockwise rotation (**Figure 3**).

Figure 2. Right side roadway departure, looking northwest (police photo)

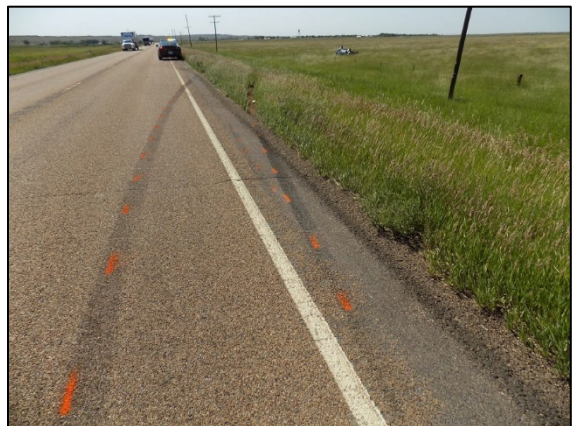
Figure 3. Second roadway departure, looking northwest (police photo)

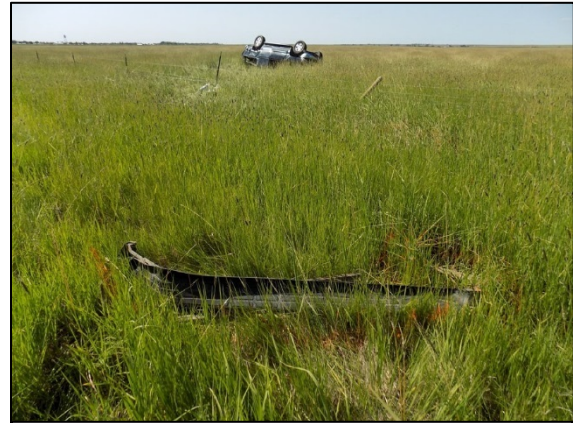
The vehicle traveled off the roadway a short distance before tripping and beginning a left side leading rollover (Event 1). The second row left passenger was ejected during the rollover. While rolling, the vehicle struck a barbed wire fence (Event 2). The vehicle rolled 10 quarter turns, while traveling approximately 44 m (147 ft) before coming to rest on its roof facing east (**Figure 4**).

Figure 4. Final rest position, looking north (police photo)

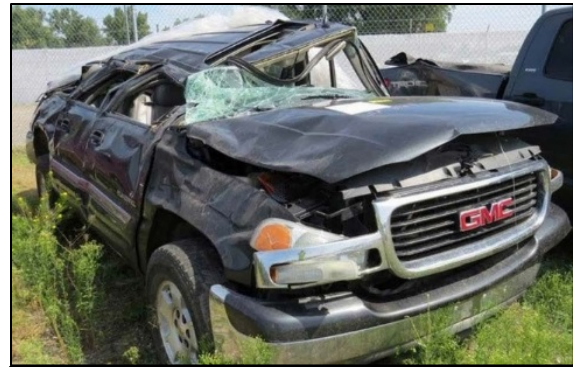
The GMC sustained moderate top plane damage as a result of the rollover (**Figure 5**). The damage extended from roof side rail to roof side rail. The maximum crush was located at the right A-pillar with an estimated measurement of 22 cm (8.6 in). The Collision Deformation Classification (CDC) was 00TDDO3. The damage from the impact with the barb wire fence could not be separated from the rollover damage.

Figure 5. Rollover damage, 2004 GMC Yukon

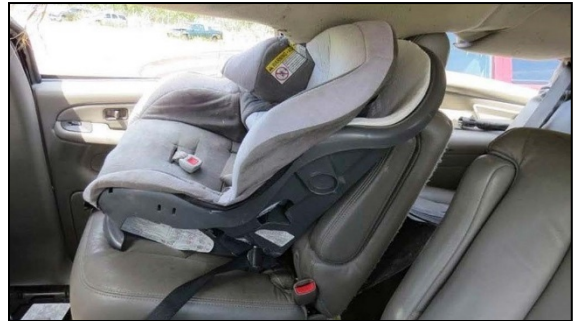
Graco ComfortSport Convertible Safety Seat The 16-month-old male was seated in a Graco ComfortSport CRS (**Figure 6**) identified by the model number 1747504 and manufacture date of January 12, 2009. This CRS was being used in a forward-facing orientation. The child weighed 13 kg (30 lbs) and met the CRS weight range of 9 to 18 kg (20 to 40 lbs). It was configured with an adjustable 5-point harness system, adjustable harness slots, and Lower Anchors and Tethers for Children (LATCH). The CRS was intended to be using either LATCH or the vehicle's seat belt. In this case the seat was installed using LATCH on the second row right seat cushion. The LATCH strap connectors were attached to the left and right LATCH anchors. It is not known if the seat was anchored correctly. The tether was not used. The harness shoulder straps were positioned through the top set of harness slots.

Figure 6. Graco ComfortSport CRS

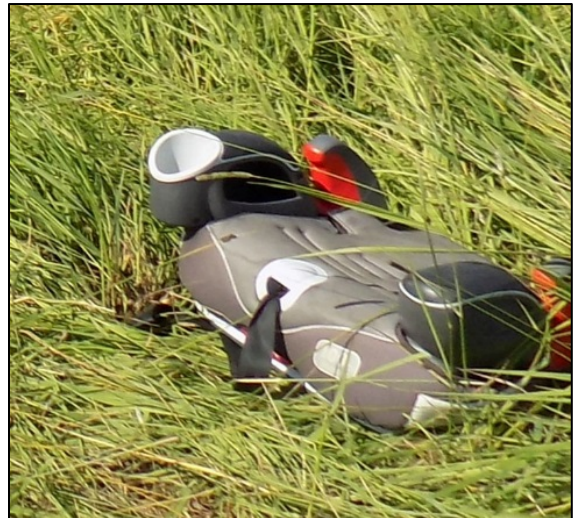
The 6-year-old was seated in a Graco Nautilus 3-in-1 CRS booster seat (**Figure 7**). The child was not using the lap and shoulder seat belt.

Figure 7. Graco Nautilus 3-in-1 CRS (police image)

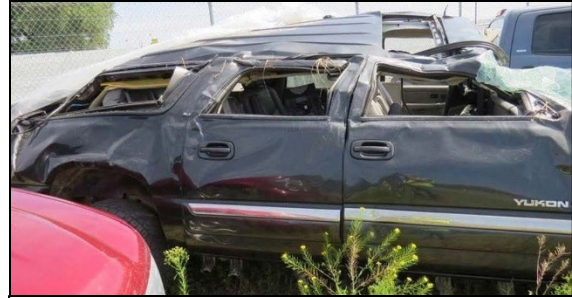
The GMC sustained moderate interior damage as a result of intrusion and integrity loss (**Figure 8**).

There were vertical and lateral intrusions to the right pillars (A, B, and C), the right roof, and the right roof side rail. The intrusions extended into both the front and second rows. The tempered

glazing was disintegrated on both sides and on the roof. The laminated glazing to the windshield was cracked and displaced. Both right side doors were jammed shut.

Figure 8. Right side intrusion, 2004 GMC Yukon

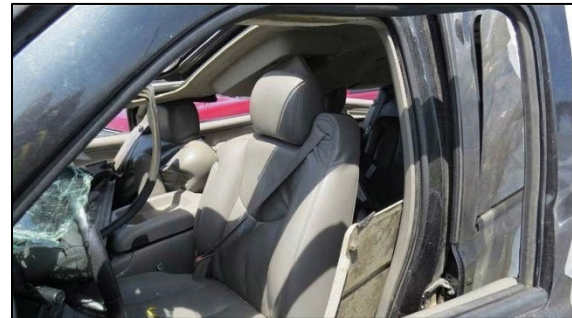
The front row was equipped with integral driver and front right passenger lap and shoulder seat belts. The driver's belt was equipped with continuous loop belt webbing, a sliding latch plate, and an emergency locking retractor (ELR). The driver of the GMC had been using the lap belt only prior to the crash. The lap portion of the driver's seat belt was cut during her extrication (**Figure 9**). The second row seats were equipped with lap and shoulder seat belts.

Figure 9. Driver seat belt, 2004 GMC Yukon

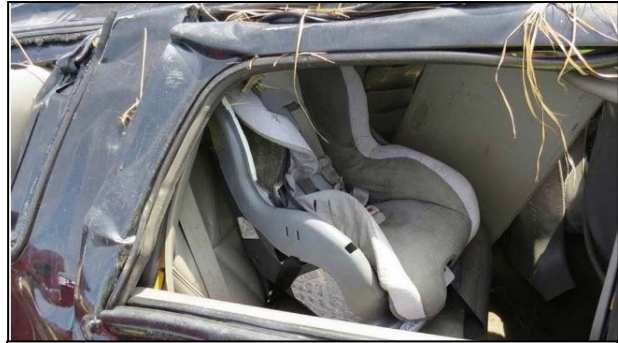
The 16-month-old male child was seated in a Graco ComfortSport CRS that was anchored to the bucket seat. The seat was installed using LATCH on the second row right seat cushion. The LATCH strap connectors were attached to the left and right LATCH anchors. It is not known if the seat was anchored correctly. The child was restrained by the CRS’s internal harness. The harness shoulder straps were positioned through the top set of harness slots. During the rollover sequence he remained in the CRS. There was intrusion damage in this seating area and he likely contacted the right roof rail with his head, causing the neck injury.

Figure 10. ComfortSport CRS (police photo)
