DOT HS 812 726

# **Special Crash Investigations Ambulance Crash Investigation**

**Vehicle: 2009 Ford E-350  
Type II Ambulance**

**On-Site Ambulance Crash Investigation Case Number DS16014**  
**Vehicle: 2009 Ford E-350 Type II Ambulance**  
**Ambulance Body: Medtec Ambulance Corporation**  
**Location: New Mexico**  
**Crash Date: July 2016**

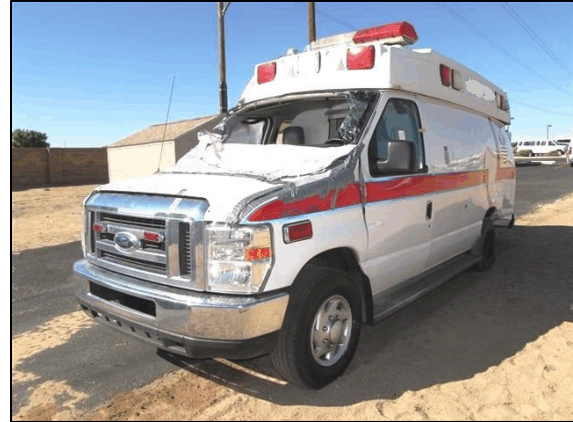
**Figure 1.** 2009 Ford E-350 Type II Ambulance

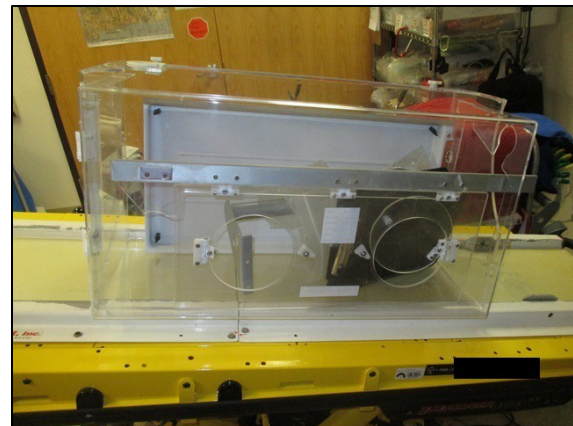
**Figure 2.** Drager Isolette 8000 Incubator (insurance company photo)

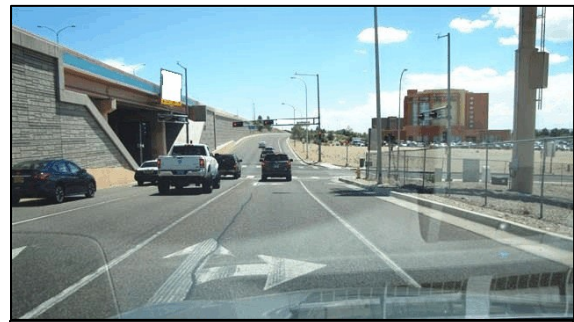
The southbound roadway consisted of three lanes each measuring 3.7 m (12.0 ft) in width and a paved shoulder on the right edge measuring 2.1 m (7.0 ft) in width (**Figure 3**). The first lane from the right was configured for through or right-turning traffic, the center lane was for through traffic only and the third lane from the right was configured for through or left turning traffic. The left edge of the roadway was bordered by a concrete barrier and wall configured in an elevated interstate highway structure. The lanes were separated by solid white painted stripes. This roadway was straight and had variable slopes in the area of the crash. The profile was a negative 4.0 percent slope approaching the intersection, level in the intersection, and a positive 4.0 slope beyond the intersection. The posted speed limit for this roadway was 56 km/h (35 mph).

**Figure 3.** Approach to intersection, looking south

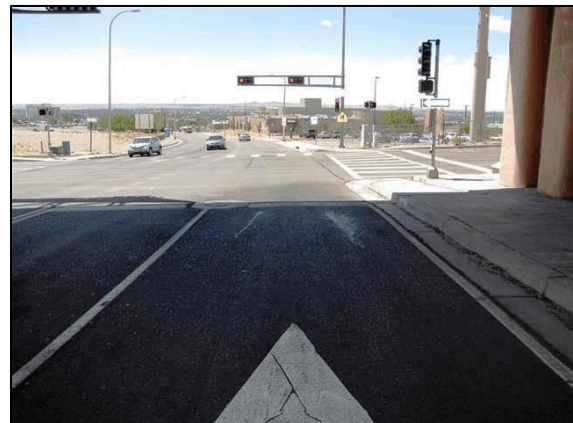
**Figure 4.** Approach to intersection, looking west

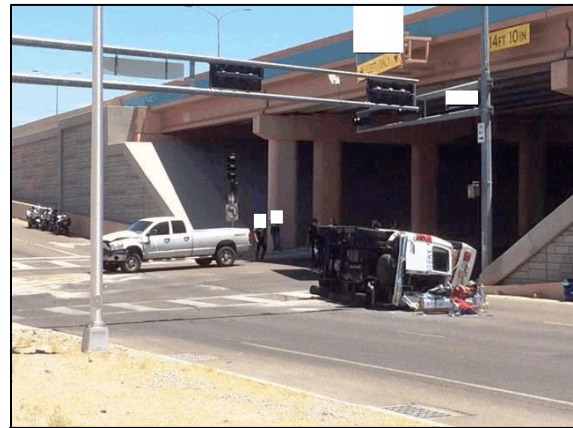
During the crash, the top-mounted access door of the incubator came open and the 6-week-old female patient was displaced from the incubator through the opening. The incubator was displaced from the cot and overturned. The patient came to rest in an area between the overturned incubator and Occupant 7, who was attending the patient. Following the crash, the nurse found the child in the patient compartment and resumed efforts to perform emergency breathing procedures on the patient until responders arrived. Police were dispatched 5 minutes after the crash and arrived on-scene 6 minutes after. The Ford was at rest on its right side (**Figure 5**). Another ambulance was dispatched 6 minutes after the crash and arrived on-scene 9 minutes after. A witness traveling behind the ambulance stopped and reportedly kicked out the windshield and assisted the front row occupants from the vehicle through the opening. The occupants in the patient compartment were assisted through the back doors by responders. All occupants of the Ford were transported by ambulance to local hospitals.

**Figure 5.** Crash site looking north, final rest positions Dodge on left, Ford on right (news photo)

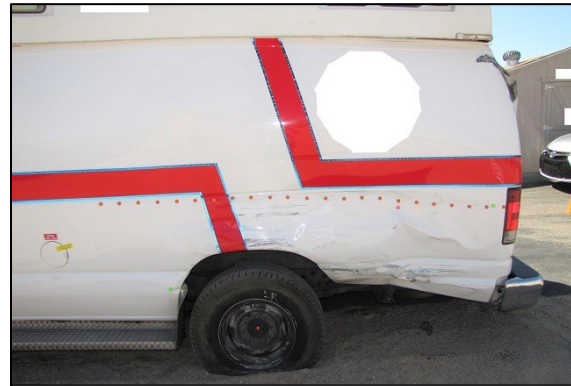
The Ford sustained minor severity damage to the left plane caused during the impact with the Dodge in Event 1. The direct damage was distributed across the rear and middle aspects of the left plane beginning 12 cm (4.7 in) forward of the left rear bumper corner and extending 180 cm (70.9 in) forward ending 45 cm (17.7 in) forward of the rear axle. The Field L was distributed across the rear and middle aspects of the left plane beginning 5 cm forward of the left rear bumper corner and extending 216 cm (85.0 in) forward ending 85 cm (33.5 in) forward of the rear axle. Twenty-three measurements were taken at mid-door level (**Figure 6**) by the Nikon Total Station and the Faro Blitz program computed crush measurement in six increments as follows:  $C_1 = 6$  cm (2.4 in),  $C_2 = 10$  cm (3.9 in),  $C_3 = 9$  cm (3.5 in),  $C_4 = 7$  cm (2.8 in),  $C_5 = 3$  cm (1.2 in),  $C_6 = 0$  cm.

Maximum crush was located 80 cm (31.5 in) aft of the left rear axle and the CDC for the Ford in Event 1 was 10LZEW2. The Ford sustained moderate severity damage to the right plane and roof caused during the rollover event. Direct damage extended from the right rear bumper corner to the right front bumper corner and measured 570 cm (224.4 in). Vertically, direct damage extended from the sill to the roof and measured 218 cm (85.8 in). Maximum lateral crush was located at the top of the right A-pillar and measured 10 cm

**Figure 6.** Left plane crush, 2009 Ford E-350 Type II Ambulance

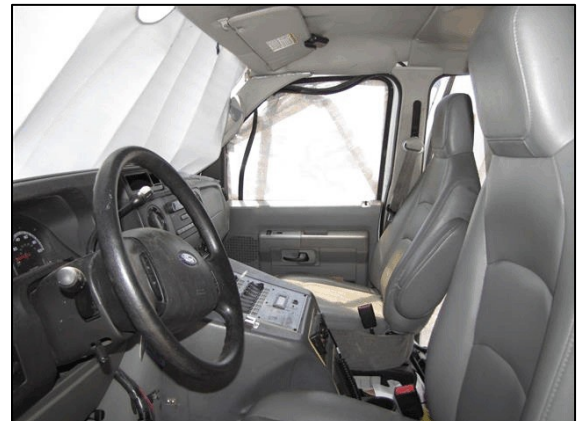
The Ford's front row and patient compartment interior revealed damage from impact forces and post-crash activities (**Figure 7**). The windshield was fractured and displaced from the frame, the front row right side glass, patient compartment rear side door glass and left backlight glass were disintegrated. Cabinets and trim in the patient compartment revealed fractures from impact forces and shifting of the greenhouse. Police had removed the EDR and a GPS-based data collector from the front row. Lateral intrusion reduced the front row of the occupant compartment in the following areas: right side door, rear upper quadrant (11 cm [5.1 in]), right roof side rail (8 cm [3.1 in]) and right B-pillar (5 cm [2.0 in]).

**Figure 7.** Front row interior, 2009 Ford E-350 Type II Ambulance

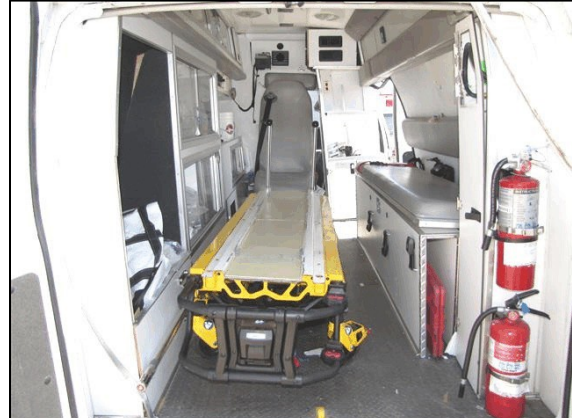
The Type II van-based patient compartment was an Endeavor model manufactured by Medtec Ambulance Corporation in October 2009. The standard layout of the interior featured a rear-facing attendant's seat, an inward-facing squadbench along the right wall, a backboard, and multiple storage shelving and cabinetry consisting of Formica surfaces, sliding plexiglass access doors and fixed aluminum shelving (**Figure 8**). At the time of the SCI inspection, the patient cot was secured in place along the left wall using a Stryker 6371 antler design floor-mount cot fastener system. The serial number placard for the fastener system was missing.

**Figure 8.** Patient compartment, 2009 Ford E-350 Type II Ambulance

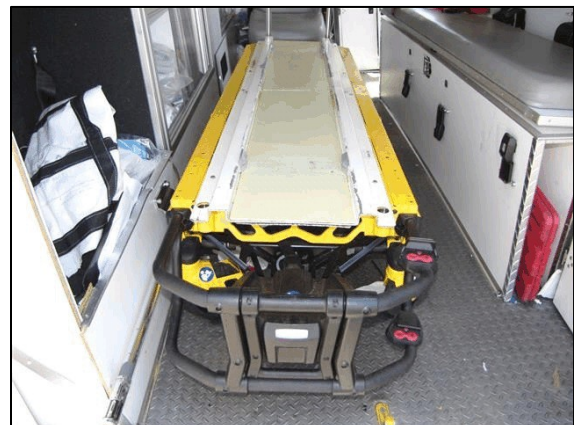
The patient cot was a Stryker 6516 Power-Pro IT manufactured in October 2014 (**Figure 9**). The Stryker was configured specifically as a powered incubator transport unit. It was configured with a hydraulic lift system for raising and lowering the incubator during transport and transfers. The height mechanism used infinite settings from 36 cm (14.0 in) to 105 cm (41.5 in). The manufacturer tech sheet indicated the incubator should be transported in the lowest, most stable setting. At the time of the SCI inspection, the cot height was 41 cm (16.1 in).

**Figure 9.** Stryker 6516 Power-Pro IT patient cot

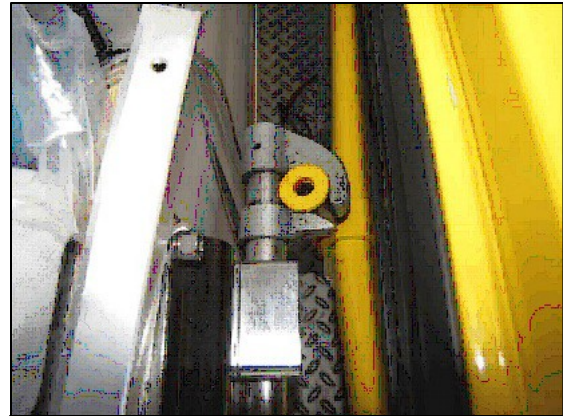
when occupied. Labeling declared that the maximum load capacity was 318 kg (700.0 lb). It was configured with four tie-down brackets used to attach the incubator to the mounting surface. The cot was secured in place in the passenger compartment using a Stryker model 6371 antler design floor-mount cot fastener system. The system consisted of a forward antler bracket and rearward side mounted locking-clamp mechanism. The antler bracket cradled the forward portion (location of the patient's head area) of the cot's frame, while the vertically-oriented locking mechanism clamped around a pin protruding from the cot's lower frame rail. At the time of the SCI inspection, the ambulance cot was secured in place by the fastening system (**Figure 10**). The investigator released the mechanism for inspection and it was determined to be functional and undamaged. An ambulance company representative stated the cot remained secured to the vehicle during the crash. There was no visible damage to the cot's metal frame or fastening system.

**Figure 10.** Stryker patient cot locking clamp, 2009 Ford E-350 Type II Ambulance

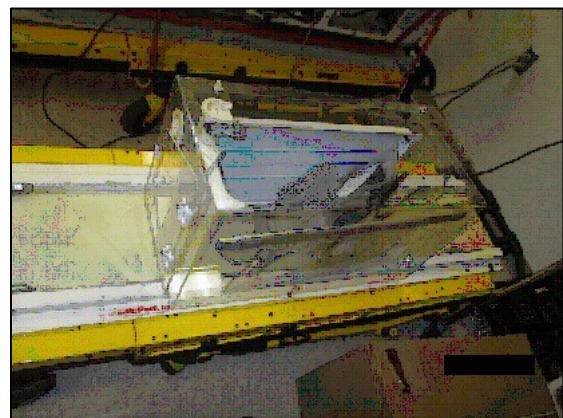
The 6-week-old female patient was being transported to an emergency surgery in a Drager Isolette 8000 incubator (**Figure 11**) that was secured to the Stryker Power-Pro patient cot. The Isolette is a self-contained incubator unit that provides a controlled heat, humidity, and oxygen micro-environment for the isolation and care of premature and low-birth weight infants. The apparatus is made of a clear plastic material and has a large door and portholes for access to the infant with a minimum of heat and oxygen loss. A servocontrol mechanism constantly monitors the infant's temperature and controls the heat in the unit. The Isolette measured 153 cm (60.1 in) high, 104 cm (41.0 in) wide and 75 cm (29.5 in) long. Weight without options and accessories was 93 kg (205 lb). The unit was equipped with a standard hood configured with front and rear access panels and six access ports. The access panel opening height measured 28 cm (11.0 in). The unit was configured with a hinged door that opened to 90 degrees. The Isolette was owned by the hospital. It was removed from the Ford at the crash scene and, according to an insurance company representative who was interviewed, it was not returned to service due to damage.

**Figure 11.** Drager Isolette 8000 incubator, fractured and displaced top was exit medium for patient (insurance company photo)

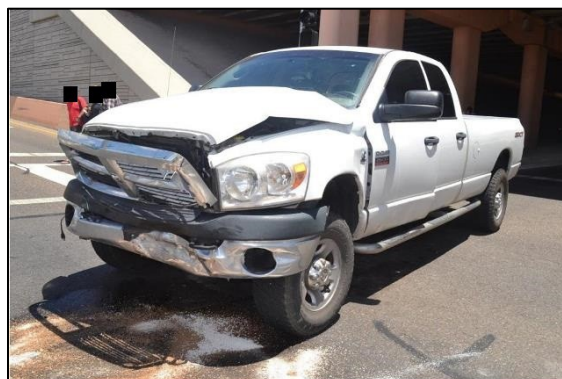
**Figure 12.** 2009 Dodge Ram 2500 (attorney photo)

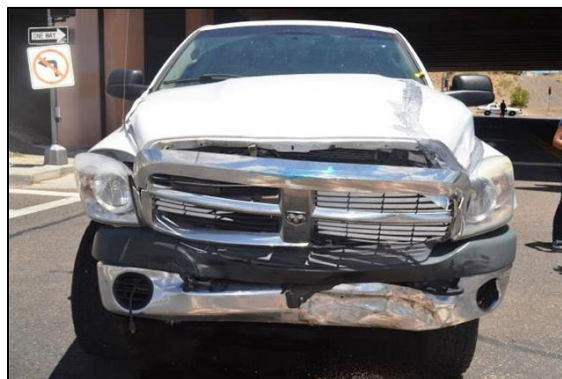
Images provided to SCI by an attorney indicate the Dodge sustained damage distributed across the front plane and minor to moderate severity crush (**Figure 13**). The estimated CDC for the Dodge in Event 1 was 01FDEW1.

**Figure 13.** 2009 Dodge Ram 2500, front end damage (attorney photo)
