# **Special Crash Investigations On-Site Guardrail End Terminal Crash Investigation Vehicle: 2002 Hyundai Sonata Location: Pennsylvania Crash Date: November 2016**

**Special Crash Investigations**  
**Case No.: CR16038**  
**On-Site Guardrail End Terminal Crash Investigation**  
**Vehicle: 2002 Hyundai Sonata**  
**Location: Pennsylvania**  
**Crash Date: November 2016**

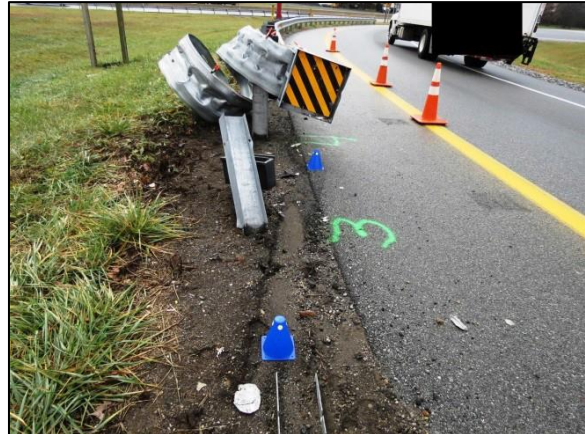
**Figure 1:** East-looking trajectory view of the Hyundai showing the struck guardrail end-treatment.

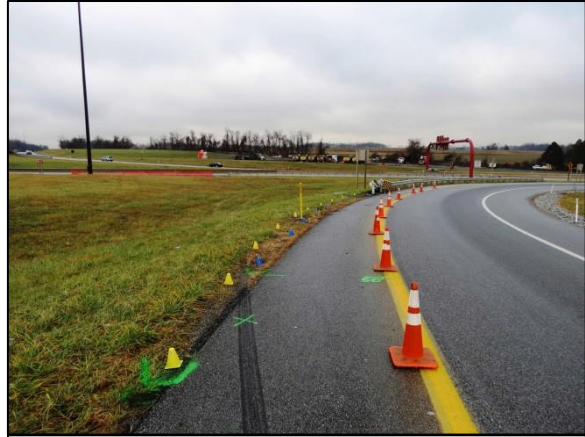
The SCI Investigator observed during the SCI scene inspection that the location of the vehicle's left roadside departure was 19.6 m (64.3 ft) from the end terminal. The tire marks indicated that the driver counter-steered to the right and applied the brakes. As a result of this maneuver, the Hyundai initiated a clockwise yaw. **Figure 4** is an east-facing view along the trajectory of the Hyundai at the road departure. The yaw trajectory is denoted by the cones in the image. The blue and yellow cones denote the left front tire mark and the left rear tire mark, respectively. The dark straight skid mark in the foreground of the image was not related to this crash.

**Figure 4:** East-facing image showing the yaw marks along the Hyundai's trajectory.

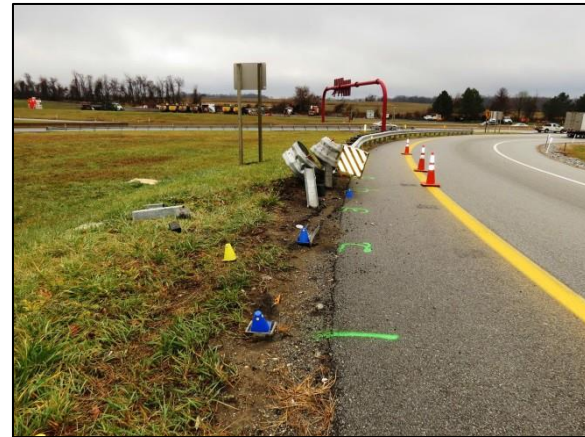
The front plane/left aspect of the Hyundai then struck the SKT end terminal (Event 2, **Figure 5**). Forces associated with the impact caused the vehicle's seat belt pretensioner to actuate and the front air bag to deploy. The Hyundai's engagement with the end terminal displaced the SKT impact head along the guardrail and extruded 6.0 m (19.8 ft) of the W-beam. During the engagement, the Hyundai initiated a counterclockwise rotation due to the offset of the impact force. The vehicle slid to final rest in the roadway, facing eastward.

**Figure 5:** East-facing trajectory view of the Hyundai at the point of impact with the end treatment.

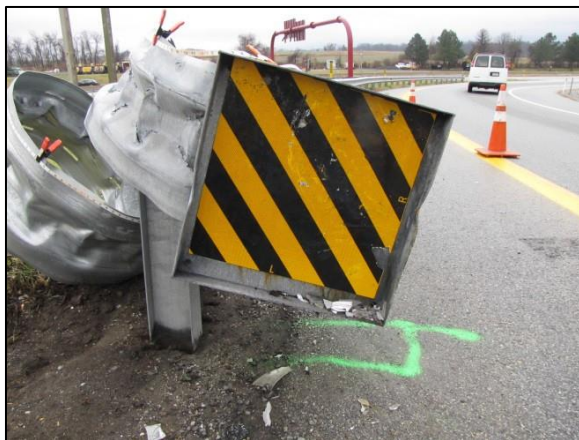
The struck guardrail was a tangent system installed in the 82 m (269 ft) radius curve of the ramp. The height of the W-beam measured 72 cm (28.8 in) at an undamaged section of the beam between Post 5 and 6. The Hyundai struck the 51 x 51 cm (20.0 x 20.0 in) impact face of the end terminal (**Figure 7**) originally located at Post 1. Direct contact damage to the impact face measured 33 x 51 cm (13.0 x 20.0 in), width by height, referenced to its lower left corner. The force of the impact displaced the end terminal east to between Posts 4 and 5 (**Figure 8**), which extruded 6.0 m (19.8 ft) of the W-beam. The extruded W-beam curled toward the field side, away from the roadway.

**Figure 7:** Image showing the struck end terminal and the extruded W-beam.

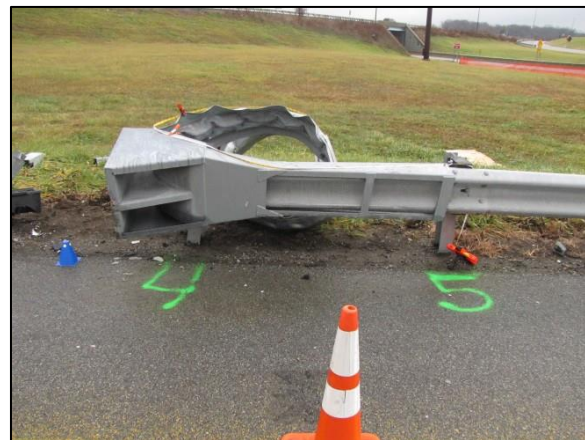
**Figure 8:** Side view of the location of the displaced end terminal.

Posts 1 to 4 of the installation were damaged during the crash along with 7.4 m (25.4 ft) of W-beam. Damage to the installation required replacement of the W-beam to the splice at Post 5. The deformed guardrail was inspected and documented through measurements and photographs. A diagram showing the deformed guardrail is included at the end of this report. The FHWA Guardrail Form documenting the crash and installation is included at the end of this report as **Appendix A**.

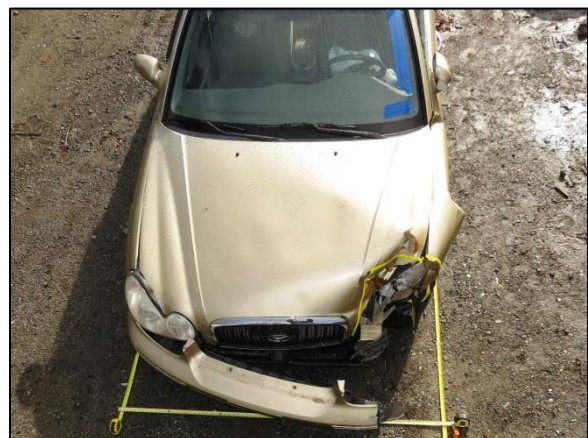
The exterior damage to the Hyundai (**Figure 10**) was located on the vehicle's front plane, consistent with Events 1 and 2 of the crash sequence. Any damage potentially associated with contact to the delineator was considered negligible due to the yielding properties of the object and was masked by the overlapping impact damage related to the end terminal. The estimated collision deformation classification (CDC) for Event 1 was 12FLLN1.

Damage from the end terminal began at the extreme left end of the front bumper reinforcement. Direct contact began 51 cm (20.0 in) left of center and extended 35 cm (13.8 in) to the left front corner. The impact force was absorbed by the deformation of the soft unsupported structures at the corner. The bumper fascia fractured and separated. There was no crush to the left frame rail, but the left front fender was crushed and shifted rearward. Although the left front tire was cut and aired out, there was no change in the left wheelbase dimension.

**Figure 10:** Overhead view showing the Hyundai's frontal damage.

A residual crush profile along the elevation of the bumper reinforcement produced the following resultant measurements: C1 = 43 cm (17.0 in), C2 = 42 cm (16.5 in), C3 = 0, C4 = 0, C5 = 0, C6 = 0. The Collision Deformation Classification (CDC) assigned to this damage pattern was 12FLEE2.

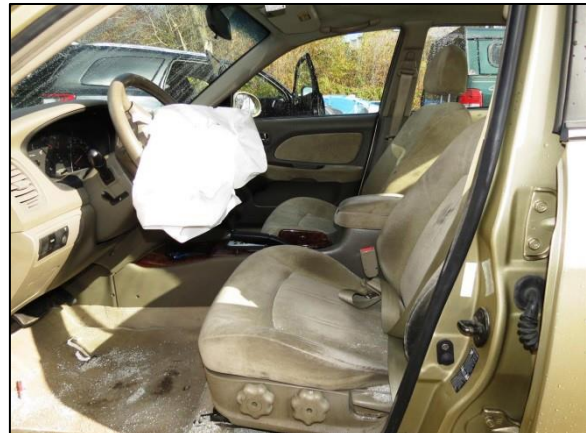
Damage to the interior of the Hyundai consisted of the deployment of the driver air bag. There was no other damage or intrusion associated to the exterior forces of the crash (**Figure 11**). There were no contacts to the components of the interior that could be attributed to the kinematics of the belted driver. At the time of the SCI inspection, the driver's seat was adjusted to the full-rear track position with the seatback slightly reclined. The horizontal distance from the seatback to the center hub of the seat wheel measured 67 cm (26.3 in). There was no discernable deformation to the steering wheel rim, nor was there any apparent loading of the shear capsules.

**Figure 11:** Left interior view of the Hyundai's front row.

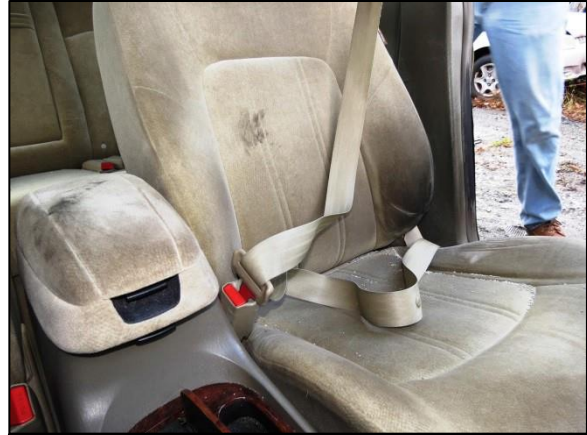
The driver's pretensioner actuated during the crash, which locked the webbing in the used position (**Figure 12**). The extended length of the webbing measured 187 cm (73.8 in).

**Figure 12:** Interior image of the Hyundai showing the driver seat belt.

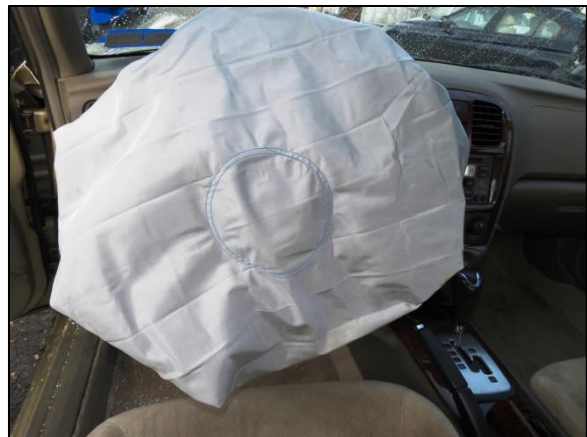
At the time of the SCI inspection, the driver air bag was observed to have deployed as a result of the crash. It had deployed from its module located in the center hub of the steering wheel rim without damage. In its deflated state, the air bag measured 61 cm (24.0 in) in diameter (**Figure 13**). The air bag was tethered internally and was vented by two ports located on the back side of the air bag in the 10 o'clock and 2 o'clock sectors. There was no discernable occupant contact evidence on the Hyundai's deployed driver air bag.

**Figure 13:** Interior image of the Hyundai showing the deployed driver air bag.
