DOT HS 812 771

**Special Crash Investigations
On-Site Office of Defects
Investigation
Air Bag Non-Deployment
Investigation
Vehicle: 2008 Kia Optima
Location: Texas
Crash Date: July 2015**

**Indiana University
Transportation Research Center
On-Site Office of Defects Investigation
Air Bag Non-Deployment Investigation
Case Number: IN15031
Vehicle: 2008 Kia Optima
Location: Texas
Crash Date: July 2015**

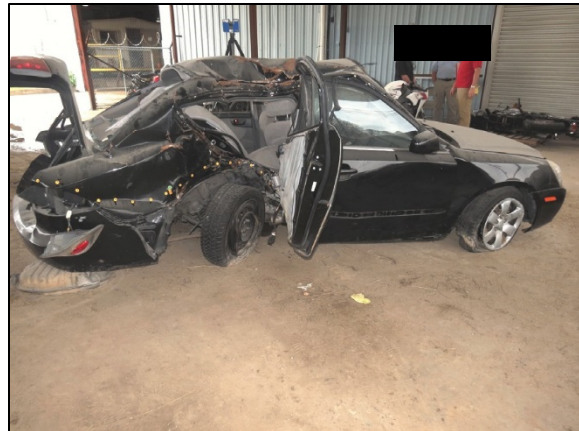
This report documents the on-site investigation in the non-deployment of the front right seat-mounted side impact air bag and the right side impact inflatable curtain (IC) air bag in a 2008 Kia Optima (**Figure 1**), which was involved in a single-vehicle crash. This crash was reported to the National Highway Traffic Safety Administration in November 2015 by the family of the front right passenger. The investigation of this crash was initiated in December 2015 through the Office of Defects Investigation (ODI) in Washington, DC, and was assigned to the Special Crash Investigation (SCI) Team at the Indiana University Transportation Research Center. The crash occurred in July 2015 in the evening in Texas and was investigated by local police. Cooperation with the investigating police agency was established in December 2015, and clearance to inspect the vehicle was authorized in March 2016. The scene inspection was completed in March 2016, and the vehicle inspection was completed in March 2015. The driver was incarcerated and could not be interviewed.

Figure 1: 2008 Kia Optima

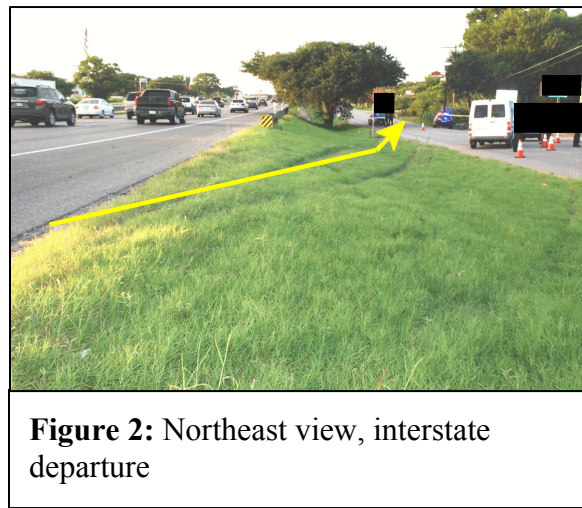
The driver lost control of the vehicle and it departed the right edge of the roadway while rotating counterclockwise (**Figure 2**). The vehicle traveled down the 7 percent grade of the embankment approximately 18 m (59 ft) to the lowest part of the roadside where the right rear door

Figure 2: Northeast view, interstate departure

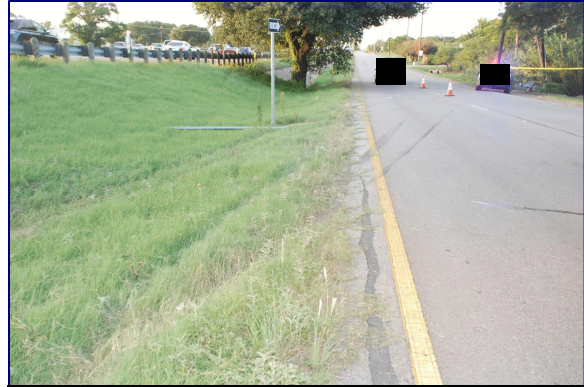
struck a breakaway sign post (Event 1, **Figure 3**). The impact resulted in the right rear door opening, due to a latch/striker separation. The Kia then traveled up the 4 percent grade toward the northeast-bound service road, and crossed both northeast-bound lanes. Traveling approximately 57 m (187 ft) from the interstate departure, with the back plane leading, the Kia's back wheels struck the service road's east curb (Events 2 and 3, **Figure 4**), followed by the front wheels impacting the same curb (Events 4 and 5). The vehicle then became airborne. With the right plane leading and the left side tilting downward, the sill and undercarriage at the right rear door area struck a 26 cm (10.2 in) diameter wooden utility pole (Event 6, **Figure 5**), shearing it 1 m (3.3 ft) above ground. The undercarriage of the Kia also struck a metal utility box (Event 7), which was adjacent to the pole. The WinSMASH program could not be used to calculate delta V for Events 1 to 7, since impacts with curbs, yielding objects, and non-horizontal directions of force are out of scope for the program. The severity of the damage from the utility pole impact was severe. The severity of the damage from the remaining impacts was moderate. As a result of the utility pole impact, a guy wire securing it to the ground became detached and struck the left plane (Event 8) causing minor damage to the left front door. The vehicle came to final rest approximately 2 m (6.6 ft) northeast of the utility pole impact, heading northwest, with the top portion of the utility pole against the right side of the vehicle.

Figure 3: Northeast view, impact with breakaway pole

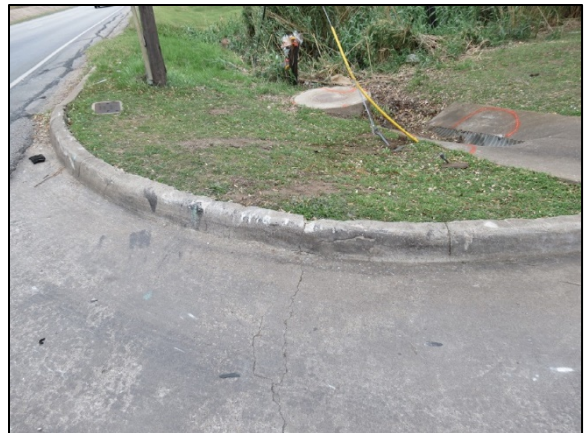
Figure 4: Curb impacts

Exterior Damage Events 2, 3, 4, and 5: All four wheels struck the curb as the vehicle departed the service roadway. All four tires were deflated and each rim was dented.

Damage Classification Event 2, 3, 4, and 5: The CDCs were 06BLWN3, 06BRWN3, 06BLWN9, and 06BRWN9, respectively. The severity of the damage was moderate.

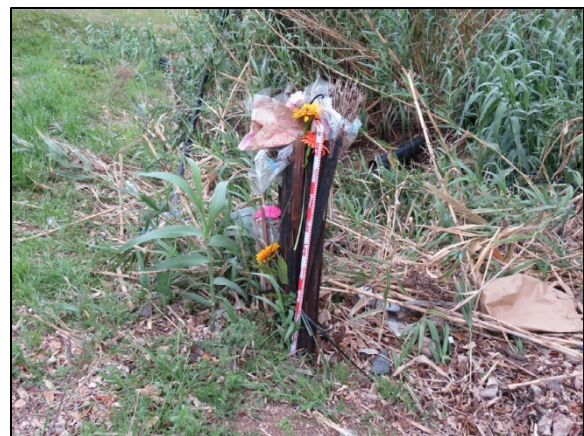
Figure 5: Utility pole impact/remains

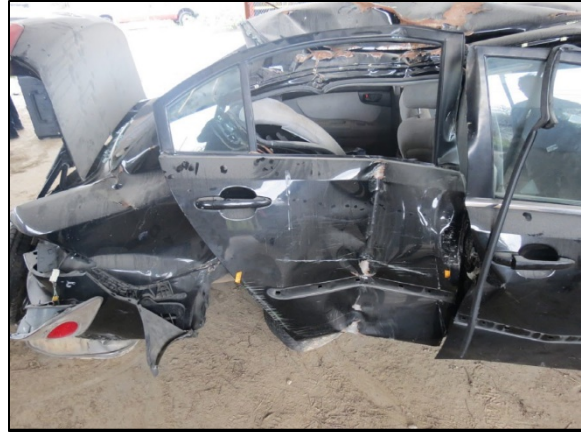
Exterior Damage Event 1: The Kia sustained damage to the right plane during the impact with the breakaway sign post (**Figure 6**). There was direct damage to the right rear door, window

frame, and roof side rail and the door opened due to a latch and striker separation. Direct damage began 200 cm (78.7 in) rear of the right front axle and was 5 cm (2 in) wide.

Damage Classification Event 1: The Collision Deformation Classification (CDC) was 03RPAN3 (90 degrees). The severity of the damage was considered moderate based on damage to the door and the roof side rail.

Figure 6: Breakaway sign post-impact.

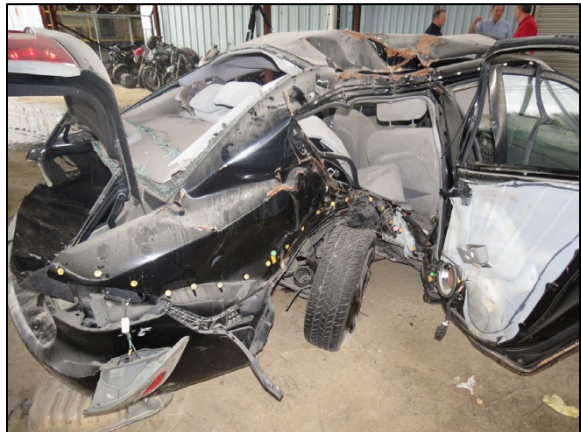
Exterior Damage Event 6: The Kia sustained damage to the undercarriage and right plane during the impact with the utility pole (**Figure 7**). The undercarriage, right rear wheel, and right sill were directly damaged. Direct damage to the bottom of the sill was located at the right door beginning 170 cm (66.9 in) rear of the right front axle and extended rearward 83 cm (32.7 in). The sill was fractured and displaced vertically 60 cm (23.6 in) and the seat cushion at the middle and right rear seat positions was intruded vertically 28 cm (11 in) and 40 cm (15.7 in), respectively.

Damage Classification Event 6: The CDC for the impact with the utility pole was 00UPRW3. The damage severity was considered severe due to the fracture and vertical displacement of the sill at the right rear door.

Figure 7: Right rear undercarriage/sill impact area.

The SCI investigation determined that the undercarriage impact to the utility pole resulted in a non-horizontal force direction to the vehicle. The direction of the crush to the vehicle's undercarriage and right sill was primarily along the vertical axis suggesting that there was probably insufficient lateral impact forces for the air bag sensing system to command deployment of the right IC and front right occupant's seat-mounted side impact air bags. In addition, these air bags did not deploy during the right plane impact with the breakaway sign post since it was a yielding object and the impact was probably not of sufficient severity to require their deployment. The frontal air bags did not deploy during the crash since there was no frontal impact. The left IC and driver's seat-mounted side impact air bags did not deploy since the guy wire impact to the driver's door was not of sufficient severity to require their deployment.

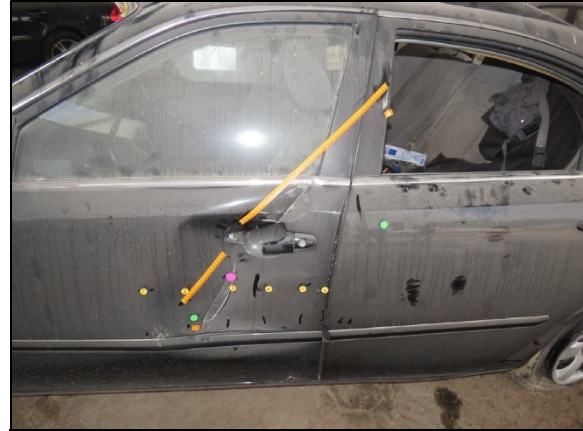
Exterior Damage Event 8: The Kia sustained damage to the left plane (**Figure 8**) from the impact with a guy wire that snapped under tension during the utility pole impact. The left front door and B-pillar were directly damaged. Direct damage began 130 cm (51.2 in) rear of the left front axle and extended 48 cm (18.9 in) on the front door and B-pillar.

Damage Classification Event 8: The CDC for the impact with the guy wire was 09LPAN02. The damage severity was minor.

Figure 8: Left front door/B-pillar damage from guy wire impact

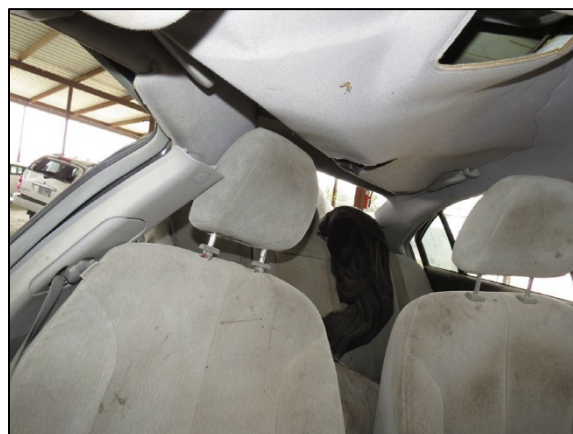
There were 12 intrusions and the most severe intrusions to front right occupant's seating positions involved the roof side rail and B-pillar, which intruded laterally 30 cm (11.8 in) and 22 cm (8.7 in), respectively. The roof intruded vertically 12 cm (4.7 in). The vehicle was extremely dirty and unkempt at the time of SCI inspection, which was completed approximately eight months after the crash. No discernable occupant contacts were noted. All of the non-fixed glazing was closed at the time of the crash. The windshield was cracked from impact forces, but remained in place. The right and left rear glazings and the backlight were disintegrated from impact forces. The remaining glazing was undamaged. The left side doors remained closed and operational. The right front door was jammed shut and was pried open by rescue personnel. The right rear door came open during the impact with the median road sign post (Event 1), due to separation of the latch and striker.

The front right occupant was restrained by the lap and shoulder seat belt. The seat track was adjusted to the middle position and the seat back recline position is unknown. The top of the head restraint was located 26 cm (11.4 in) above the top of the seat back. The front right occupant was displaced to the right in her seat belt during the counter-clockwise rotation and further displaced to the right as a result of the right plane impact with the breakaway sign post. The wheel impacts displaced the occupant rearward into the seat back and the undercarriage impact also displaced her rearward and to the right. As a result of the impact to the utility pole, her head contacted the intruded B-pillar (**Figure 9**) and she sustained an open basilar skull fracture, cerebral contusions, and a subarachnoid hemorrhage.

Figure 9: Right B-pillar intrusion
