DOT HS 812 790

Special Crash Investigations On-Site Guardrail End Terminal Crash Investigation Vehicle: 2001 Isuzu Trooper Location: Missouri Crash Date: July 2018

Special Crash Investigations
On-Site Guardrail End Terminal Crash Investigation
Case Number DS18020
Vehicle: 2001 Isuzu Trooper
Location: Missouri
Crash Date: July 2018

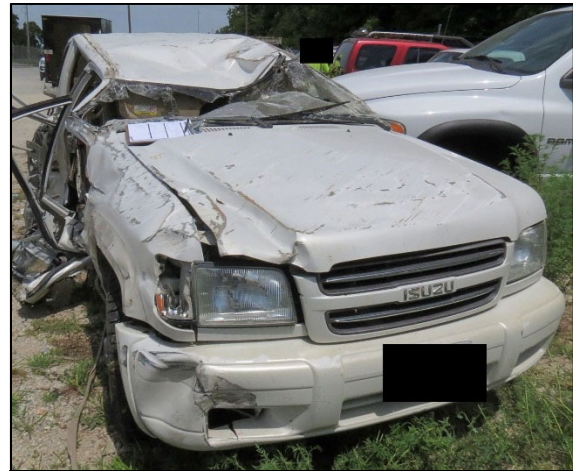
This report documents the on-site guardrail end terminal investigation of the Trinity SoftStop guardrail end terminal struck by a 2001 Isuzu Trooper during a crash and the injuries sustained by the driver (**Figure 1**). The investigation is intended to determine what role the guardrail may have played in causing injuries to the driver. This case was initiated by the state transportation agency who notified the Federal Highway Administration (FHWA) of the crash. After reviewing the case and determining the guardrail end terminal qualified and the case was of interest, the FHWA forwarded the notification along with on-scene images to the Special Crash Investigations (SCI) group of the National Highway Traffic Safety Administration with instructions to deploy the SCI team. SCI assigned the case to Dynamic Science, Inc. in August 2018.

Figure 1. 2001 Isuzu Trooper

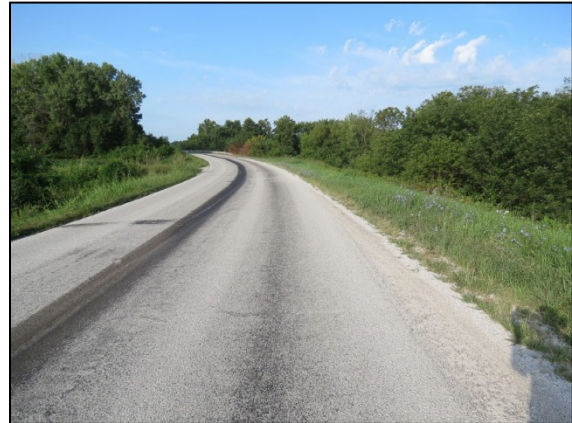
The crash site was the westbound lane of a two-lane undivided state highway in a rural area of Missouri (**Figure 2**). The asphalt roadway was 7.6 m (25 ft) wide, curved to the left with a radius of 193.2 m (634 ft), had a positive two percent grade, and had a positive six percent superelevation. The travel lanes were unmarked but did have several reflector markers at irregular intervals. The roadway was bordered by unmarked aggregate/earth shoulders and W- beam guardrails with Trinity SoftStop end terminals. The roadway was dry and it was dark at the time of the crash. The posted speed limit was 89 km/h (55 mph). The weather at the nearest report station was 19 degrees C (66 degrees F), 90 percent humidity, clear visibility and the wind direction was southwest at 5 km/h (3 mph). A crash diagram is attached at the end of this technical report.

Figure 2. Westbound approach

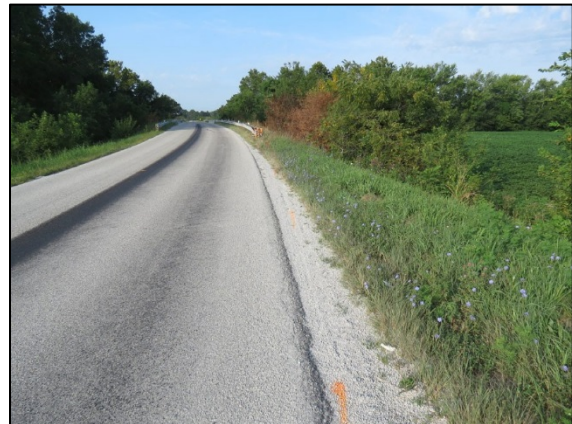
The Isuzu was traveling westbound in the first lane at an unknown speed while negotiating a left curve. For unknown reasons, the driver lost control of the vehicle and began a slight counterclockwise yaw. The vehicle partially departed the roadway approximately 15 m (49 ft) prior to the terminal end (**Figure 3**).

Figure 3. Westbound approach, right road edge departure

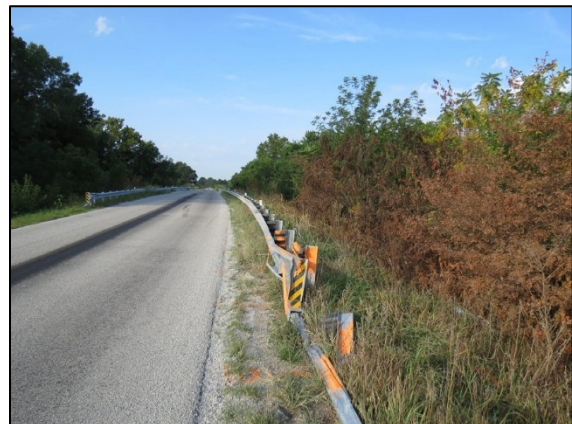
As the vehicle departed the shoulder on the right, the right plane struck the SoftStop end terminal treatment (**Figure 4**). The WinSMASH program calculated a barrier equivalent speed (BES) of 16 km/h (10 mph). The driver's and passenger's frontal air bags deployed during this impact. The results are borderline because the end terminal yielded and the damage to the vehicle was primarily longitudinal. As the guardrail engaged the side of the vehicle, including the B-pillar and right rear door, the vehicle began a clockwise rotation. Portions of the vehicle remained in contact to the guardrail face at posts 4-6.

Figure 4. Guardrail end treatment impact

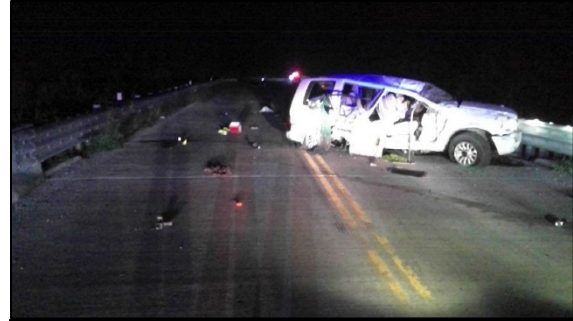
In the area between guardrail posts 10-12, approximately 18 m (60 ft) west of the terminal end, the vehicle struck the guardrail face with its front right bumper and possibly front right tire. The vehicle continued rotating clockwise before tripping and beginning a left side leading rollover. The vehicle continued rotating while rolling eight quarter turns before coming to rest on its wheels in an upright orientation facing south (**Figure 5**). The distance from the trip point to final rest was 47 m (154 ft).

Figure 5. Final rest, looking east (police provided photo)

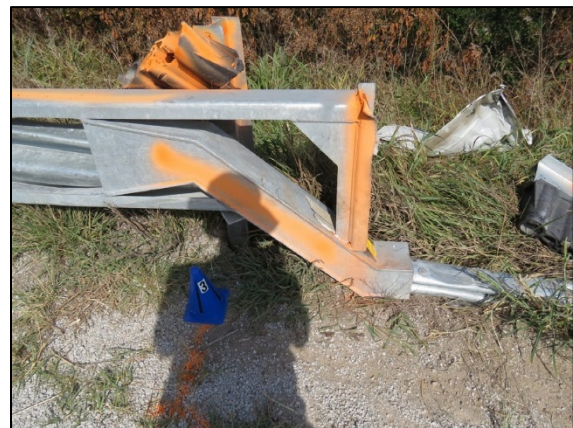
The guardrail end terminal in this crash was a Trinity SoftStop tangent single-side redirective and gating terminal (**Figure 6**). It uses a moveable impact head on a W-beam rail section. During an end impact, the head travels down the anchored rails which are extruded toward the ground. The head measured 18 x 53 cm (7 x 21 in). Portions of the vehicle remained in contact to the guardrail face at posts 4 to 6. In the area between guardrail posts 10 to 12, approximately 18 m (60 ft) west of the terminal end, the vehicle struck the guardrail face with its front right bumper and possibly tire. The system was designed with an anchor post (post 0) and an anchor panel between post 0 and post 1. The head was located in front of post 1. The distance between post 0 and the terminal head was 129 cm (51 in). Posts 1 and 2 were steel and designed to yield. Composite offset block were installed on all posts except for posts 0 and 1. The guardrail height as measured in the field was 78 cm (30.7 in). During the crash, the SoftStop impact head was displaced west with 3.6 m (12 ft) extrusion toward the ground and came to a stop in front of post 3 (**Figure 7**). The total length of rail damaged was approximately 7.6 m (25 ft). This end terminal had been involved in a previous

Figure 6. Trinity SoftStop guardrail end terminal, looking north

crash. The terminal face label had been replaced at some time in the past. The old label had been marked with orange paint. The completed FHWA guardrail forms are included at the end of this report as **Appendix A**.

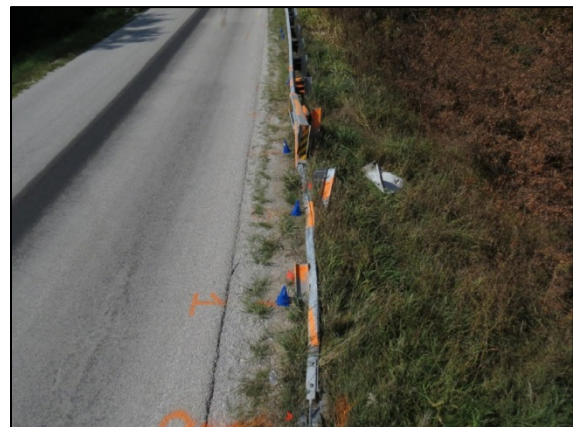
Figure 7. Trinity SoftStop guardrail end terminal, looking west

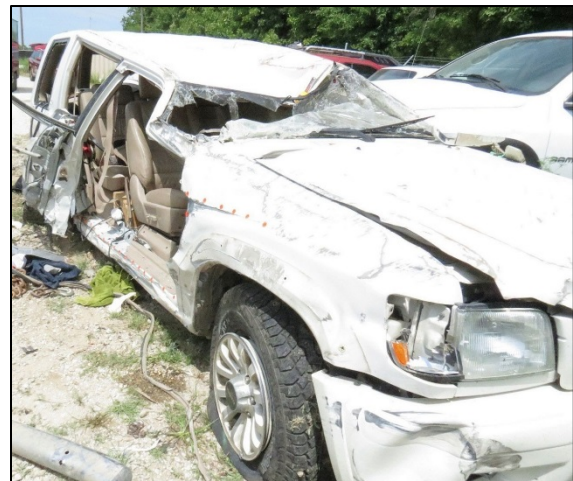
The Isuzu was involved in three damage producing events. The vehicle sustained moderate right plane damage from the impact with the end terminal (**Figures 8-9**). The damage began 1 cm (0.4 in) aft of front axle and extended 219 cm (86.2 in) rearward. The damage began 34 cm (13.3 in) above the ground at the right fender. The front right door was displaced from the vehicle. The second row right door and B-pillar were displaced rearward 38 cm (14.9 in). Twenty-four measurements were taken at the sill level by the Nikon Total Station and the Faro Blitz program computed crush measurement in six increments as follows: C1 = 13 cm (5.1 in), C2 = 12 cm (4.7in), C3 = 11 cm (4.3 in), C4 = 11 cm (4.3 in), C5 = 4 cm (1.5 in), C6 = 7 cm (2.7 in). The overall length of damage was adjusted to account for C

Figure 8. Right plane damage, 2001 Isuzu Trooper

values that were not accessible/visible for measurement. The Collision Deformation Classification (CDC) was 12RYEW2.

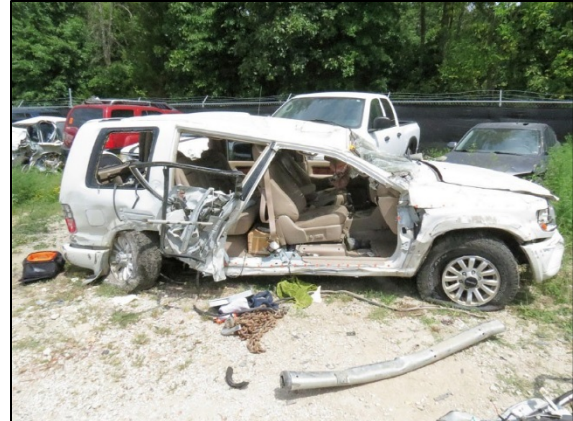
Figure 9. Right plane damage, 2001 Isuzu Trooper

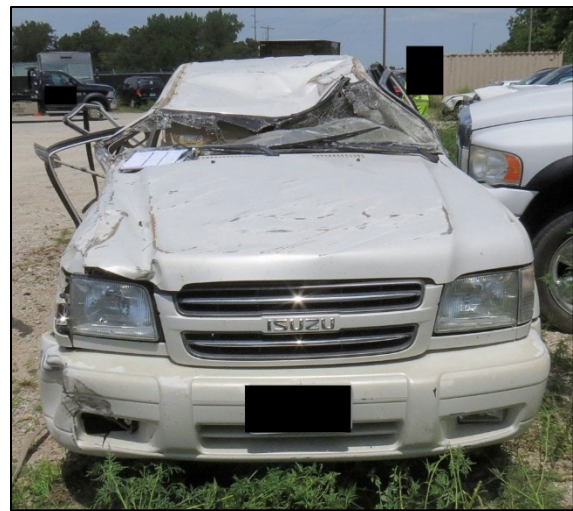
The Isuzu sustained moderate top plane damage from the rollover (**Figure 10**). The direct damage measured 118 cm (46.4 in) roof side rail to roof side rail.

The maximum vertical crush was located 35 cm (13.7 in) right front left roof side rail on the windshield header and measured 31 cm (12.2 in). The CDC was 00TDDO4.

Figure 10. Rollover damage, 2001 Isuzu Trooper

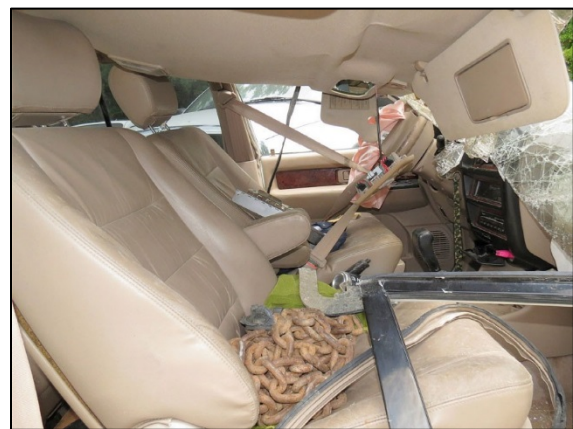
The Isuzu sustained moderate interior damage from intrusion and occupant contacts (**Figure 11**). There was vertical intrusion of the roof, windshield header, and roof side rails. The front right door was displaced from the vehicle and the right rear door was deformed rearward, exposing the second row seats. The B-pillar was deformed 38 cm (14.9 in) rearward. The windshield glazing was fractured and the glazing was disintegrated at the front row left, front row right, second row right, and backlight. The left front, second row left, and rear doors remained closed and operational.

Figure 11. Interior damage, 2001 Isuzu Trooper

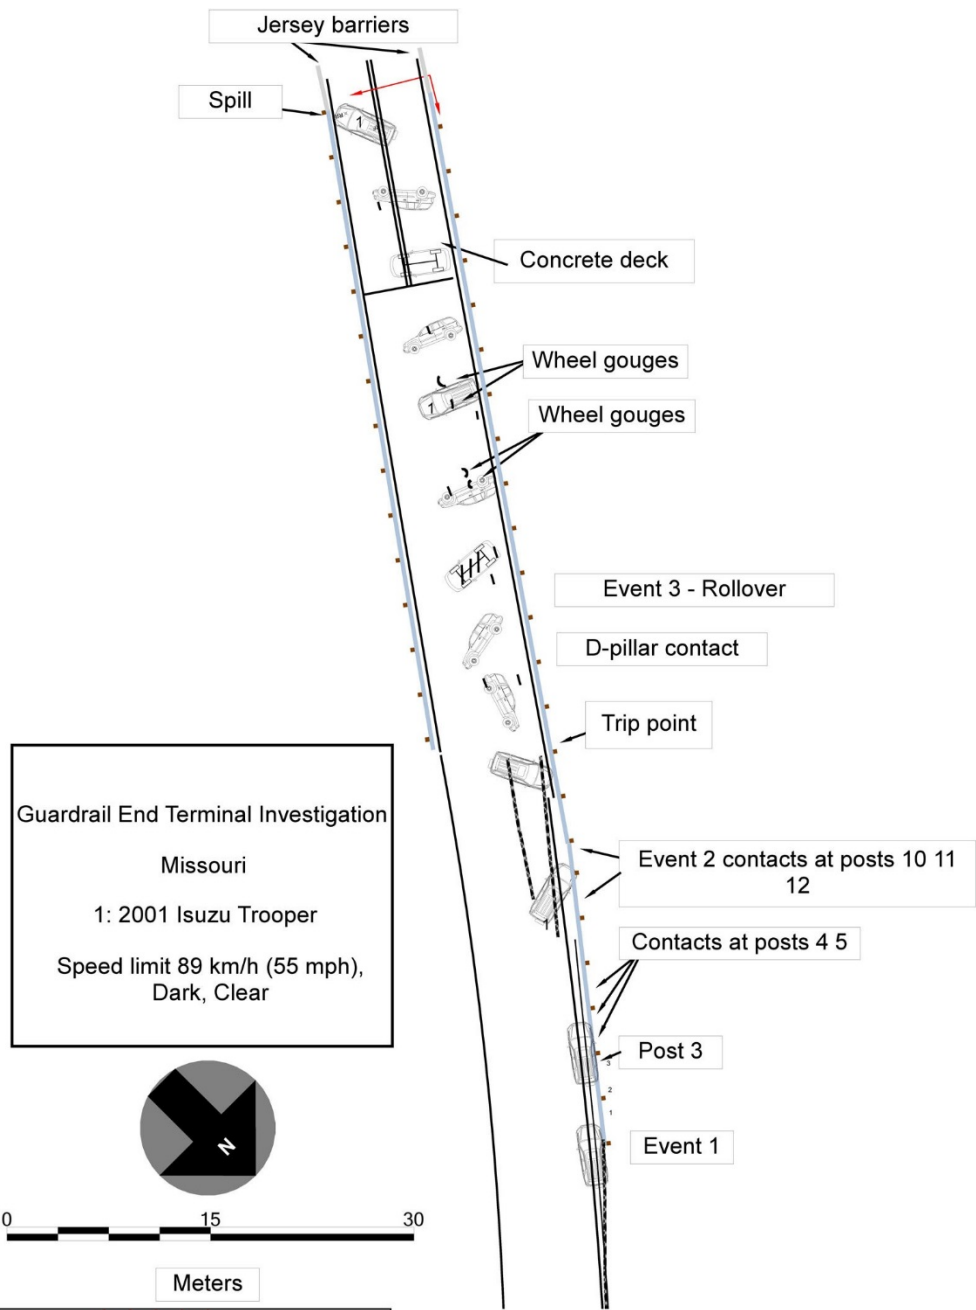
CRASH DIAGRAM

Guardrail End Terminal Investigation
 Missouri
 1: 2001 Isuzu Trooper
 Speed limit 89 km/h (55 mph),
 Dark, Clear
