DOT HS 812 797

# **Special Crash Investigations On-Site Rollaway/Backover Investigation Vehicle: 2002 Dodge Ram Location: Illinois Crash Date: May 2017**

**Special Crash Investigations**  
**Case No: CR17013**  
**Office of Defects Investigation**  
**On-Site Non-Traffic Surveillance Rollaway/Backover Investigation**  
**Vehicle: 2002 Dodge Ram 2500 Quad Cab**  
**Location: Illinois**  
**Crash Date: May 2017**

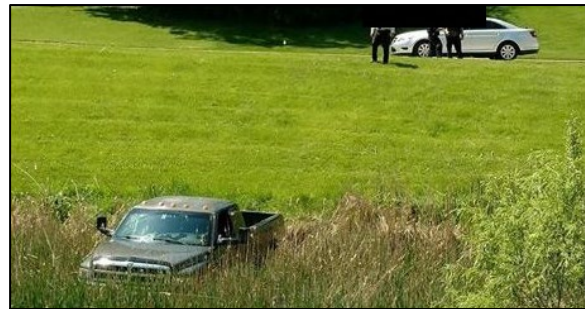
**Figure 1:** South-facing image depicting the Dodge at rest in the retention pond. Image obtained from an online news source.

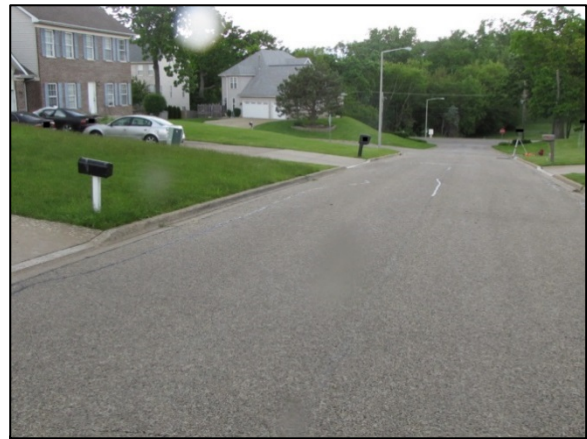
**Figure 2:** Lookback view in the northerly direction of the parked position of the (south-facing) Dodge and its rollaway trajectory.

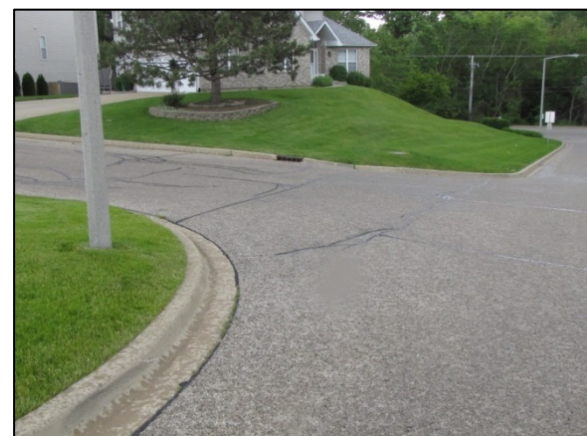
**Figure 3:** Northwesterly view of the struck landscape wall and the rollaway trajectory of the Dodge.

The Dodge rolled up the slope of the lawn approximately 8.8 m (29 ft). The back plane of the Dodge traveled over the 33 cm (13.0 in) tall landscape wall and its rear differential struck the concrete blocks (Event 3). The combination of rolling up the slope and the force of the impact caused the Dodge to come to a momentary stop. The landscape wall displaced by the force of the impact had been rebuilt at the time of the SCI inspection.

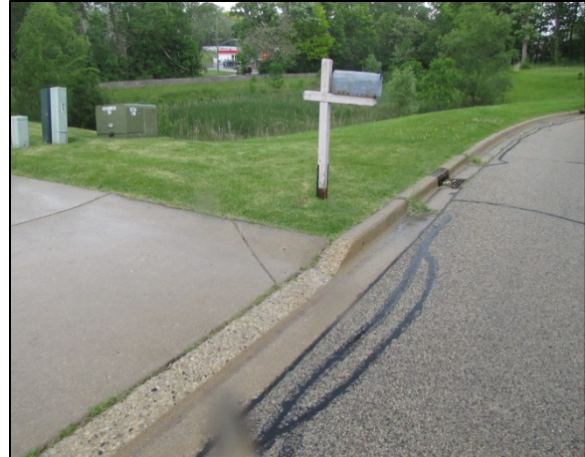
**Figure 5:** Eastward trajectory view of the Dodge from its road departure toward the retention pond.

The front plane of the Dodge struck and fractured a wooden mailbox post located at this residence (Event 4). This impact did not slow or alter the rollaway trajectory of the Dodge. Rotating tire prints on a lawn area evidenced the vehicle trajectory as it traversed the lawn for a distance of 29 m (95 ft). The grade of the lawn was 25 percent negative in the northeasterly direction. The Dodge entered a shallow retention pond located 12 m (39 ft) north of the north curb of the east intersection leg. The Dodge came to rest in the retention pond with its engine still running at idle.

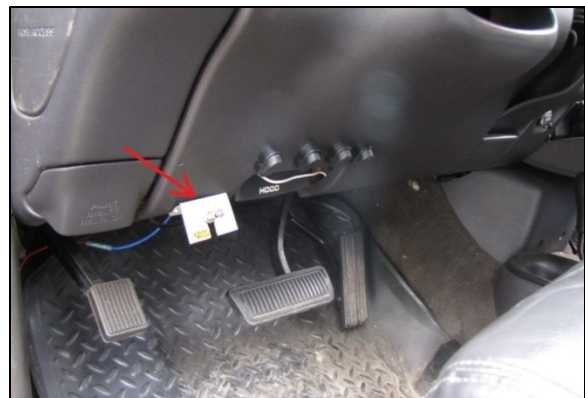
The Dodge was equipped with an aftermarket diesel fuel cut-off switch located on the left aspect of the lower left instrument panel (**Figure 7**). The cable-pull fuel shut-off was configured and installed to allow the Dodge to continue to run with the key in the off-position and removed from the vehicle. At the time of the SCI inspection, the fuel cut-off was the only method to stop the engine. Three aftermarket gauges were mounted to the left A-pillar that provided the driver with performance data of the vehicle's turbo-engine.

**Figure 7:** Aftermarket cable-pull fuel cut-off in the Dodge.

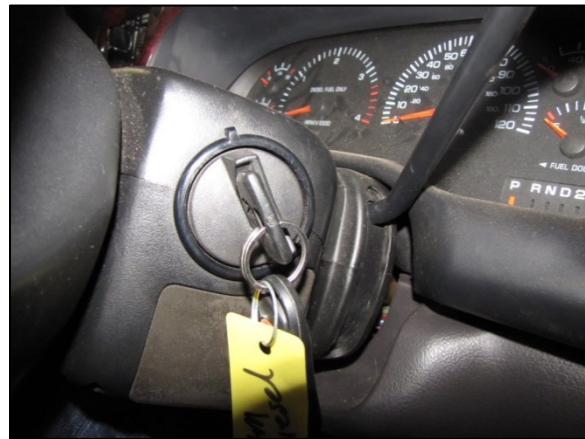
The 2002 Dodge was configured with a keyed ignition switch conventionally mounted to the right side of the steering column (**Figure 9**). At the time of the SCI inspection, the key was removed from the ignition and the transmission was placed in the park position with the column locked for both steering and transmission selection functions. On entry to the vehicle through the left front door, no audible warnings were provided. The dome light was illuminated.

**Figure 9:** Keyed ignition switch of the Dodge in the lock position.

with the door open and the dome light illuminated. The instrument panel lights did not illuminate. This position of the ignition switch was designed for towing the vehicle. It should be noted that the brake pedal did not need to be engaged prior to shifting the transmission from the park position.

The 2002 Dodge Ram was not equipped with a brake transmission shift interlock (BTSI). The brake pedal was not required to be engaged to shift the column-mounted transmission selector lever from the park position with the keyed ignition switch turned clockwise to the first detent or the run position after the engine was started. That part of FMVSS No. 114 regulating the BTSI did not become a requirement until the 2010 model year. The 2002 Dodge Ram was only equipped with a theft protection interlock.

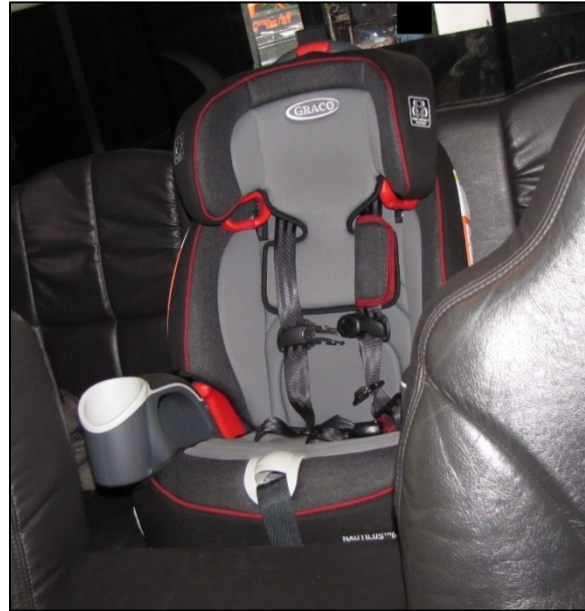
The 2-year-old male non-motorist was initially restrained in a Graco Nautilus 65 child restraint system. The Graco Nautilus 65 was designed as a 3-in-1 forward-facing-only CRS that could be used as 5-point harness system, a high-back booster, or a backless booster. During its use in this incident, the CRS was installed and used as a 5-point harness system. CRS manufacturer specifications listed the forward-facing CRS for use of children weighing 10 to 29 kg (22 to 65 lb). The CRS was installed in the second row center position and was secured to the vehicle by the manual lap belt routed through the forward-facing belt path (**Figure 10**).

**Figure 10:** The CRS installed in the second row center position of the Dodge.
