DOT HS 812 812

Special Crash Investigations On-Site Rollaway Crash Investigation Vehicle: 2014 RAM 1500 Location: Texas Crash Date: August 2018

**Special Crash Investigations (SCI)
On-Site Office of Defects Investigation
Rollaway Crash Investigation
Case Number: DS18024
Vehicle: 2014 Ram 1500
Location: Texas
Crash Date: August 2018**

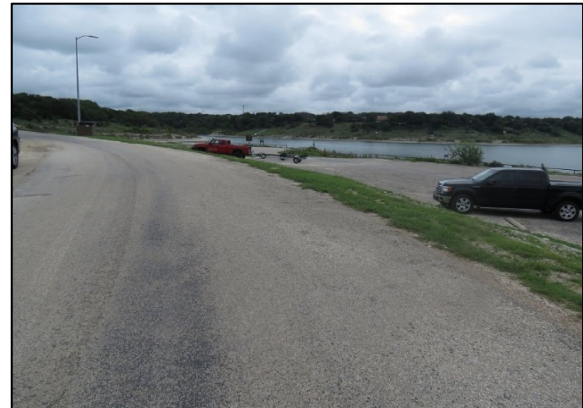
The crash site was the road and parking lot adjacent to a boat ramp in a public park. The asphalt roadway was oriented southwest/northeast and measured 5.8 m (19.0 ft) in width. A metal pipe gate was located at the west roadway entrance. The grade at this location was +2.6 percent. Adjacent to the roadway was a descending embankment that measured 7.5 m (24.6 ft) from top to bottom. The grade at the midpoint of the embankment was -18 percent. The total drop from the top of the embankment to the bottom was approximately 1.8 m (5.9 ft). An asphalt parking lot was located at the base of the embankment and measured 28.2 m (92.5 ft) from northwest to southeast. The entire perimeter of the roadway and parking lot was separated from the park by a metal guardrail. The height of the rail was 58 cm (22.8 in) and was constructed of 8 cm (3.0 in) metal pipe. There were concrete parking bumpers located on the parking lot at the base of the embankment and along the southeast edge. Southeast of the parking lot was a descending area covered by large rocks and vegetation.

Figure 2. Approximate parked position, looking southeast.

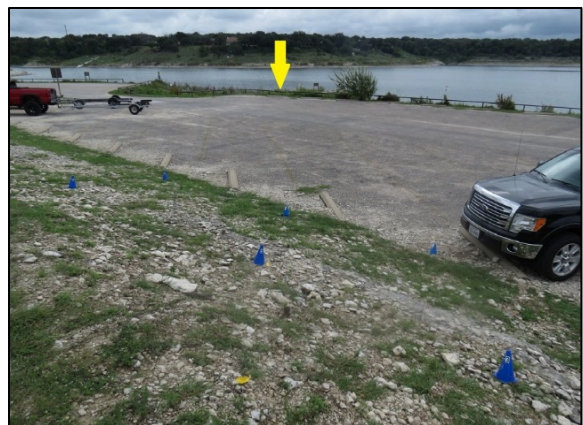
Figure 3. Path down embankment, looking southeast. Struck rail marked with yellow arrow.

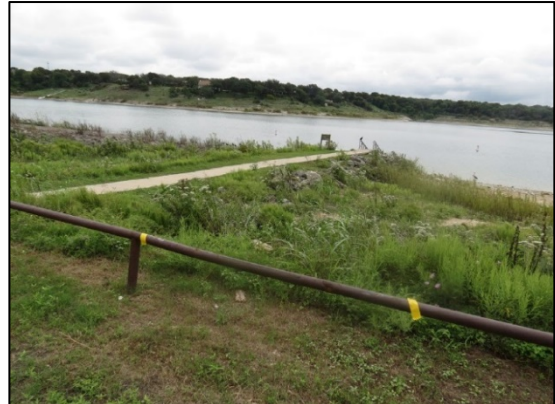
At the end of the parking lot, the Ram struck the pipe rail (**Figure 4**) with its front plane (Event 1). The barrier algorithm of the WinSMASH program calculated a barrier equivalent speed (BES) of 14 km/h (9 mph). The vehicle went over the rail and down a rock-covered embankment while sustaining undercarriage damage (Event 2).

Figure 4. Impact with pipe rail, looking southeast.

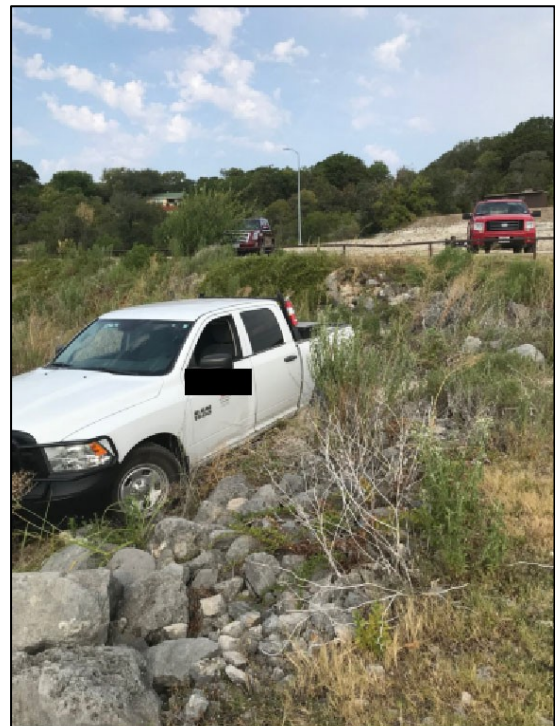
The Ram came to rest at an angle on a pile of rocks (**Figure 5**). The engine was still running. The driver opened the driver's door and reported that he looked at the gear shift knob and it showed the vehicle to still be in Park (**Figure 6**). The vehicle sustained undercarriage damage and the transmission could not be taken out of Park. The vehicle was towed from the scene to a Dodge dealership. According to the repair order, the transmission pan was damaged and needed to be replaced. The vehicle underwent a multi-point inspection in accordance with the vehicle's maintenance interval. The powertrain control module was reprogrammed/updated to satisfy NHTSA safety recall 18V- 332/U61 (see NHTSA Recalls and Investigations section of this report for additional details). Additional diagnostics were performed and there were no transmission-related issues identified.

Figure 5. Final rest, looking northwest (park agency photo).

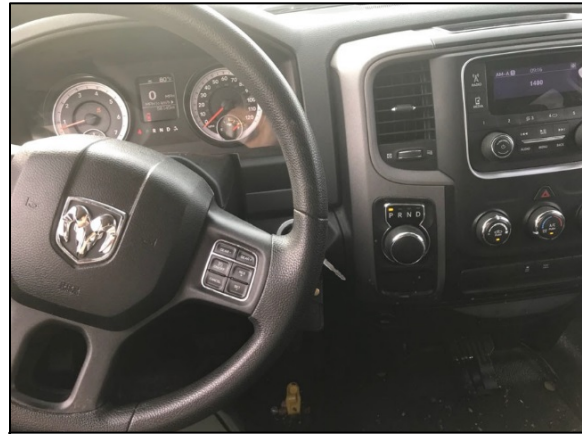
Figure 6. 2014 Ram 1500, controls at final rest (agency photo).

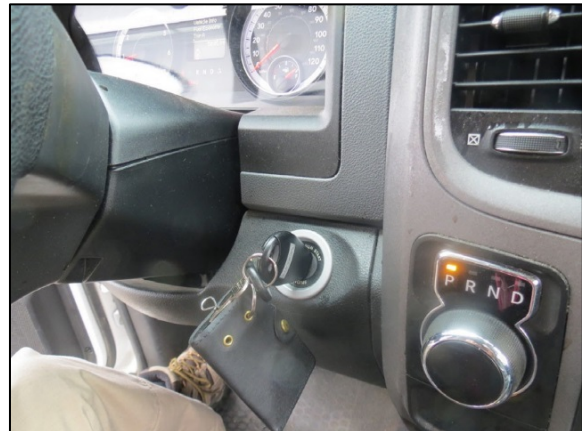
The transmission is controlled by a rotary electronic gear selector located on the instrument panel (**Figure 7**). The transmission gear range (PRND) is displayed both above the gear selector and in the electronic vehicle information center (EVIC). To select a gear range, rotate the gear selector. Press the brake pedal to shift the transmission out of Park, or to shift from Neutral into Drive or Reverse, when the vehicle is stopped or moving at low speeds. To shift past multiple gear ranges at once (such as Park to Drive), rotate the gear selector to the appropriate detent. Select Drive range for normal driving. This vehicle is equipped with a brake transmission shift interlock system (BTSI) that holds the transmission gear selector in Park unless the brakes are applied. To shift the transmission out of Park, the ignition switch must be turned to the On/Run position (engine running, for vehicles with 8-speed transmission) and the brake pedal must be pressed.

Figure 7. Ignition/transmission selection, 2014 Ram 1500.

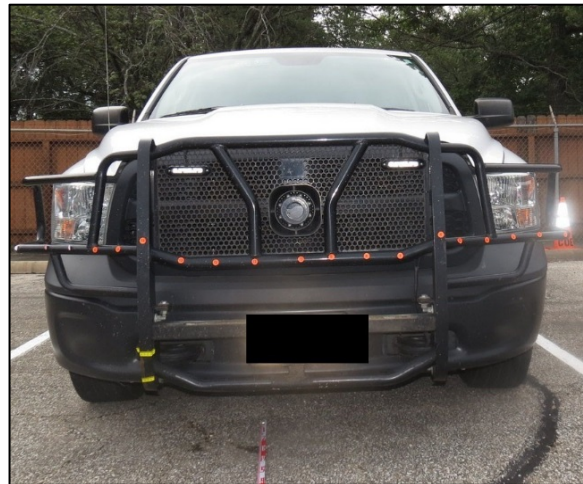
The Ram sustained minor surface damage to the grille guard (**Figure 8**) from the impact with the pipe rail. The direct damage was presumed to be across the vertical surfaces of the grille guard based on the height of the struck object. This measured 104 cm (40.9 in). There was an area of scraping located at the bottom of the right

Figure 8. Front plane damage, 2014 Ram 1500.

vertical surface that may have occurred as the vehicle traveled past the pipe rail. Sixteen measurements were taken at the bumper level along the grille guard by the Nikon Total Station and the Faro Blitz program computed crush measurement in six increments as follows: $C_1 = 0$ cm, $C_2 = 0$ cm, $C_3 = 0$ cm, $C_4 = 0$ cm, $C_5 = 4$ cm (1.5 in), $C_6 = 0$ cm. The collision deformation classification (CDC) was 12FDLW1.

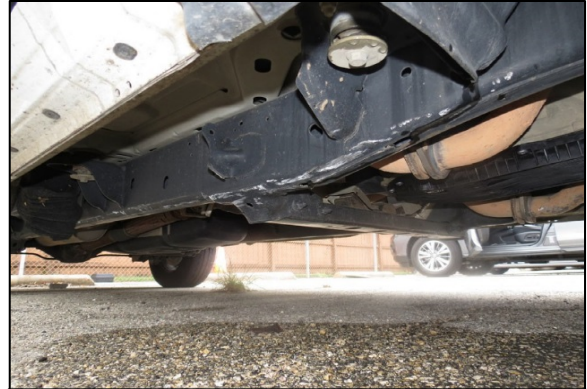
The vehicle sustained minor damage to the undercarriage (**Figures 9-10**) from impacts to the rocky surface beyond the pipe rail. The CDC was 00UDDW2.

Figure 9. Undercarriage damage (right frame rail), 2014 Ram 1500.

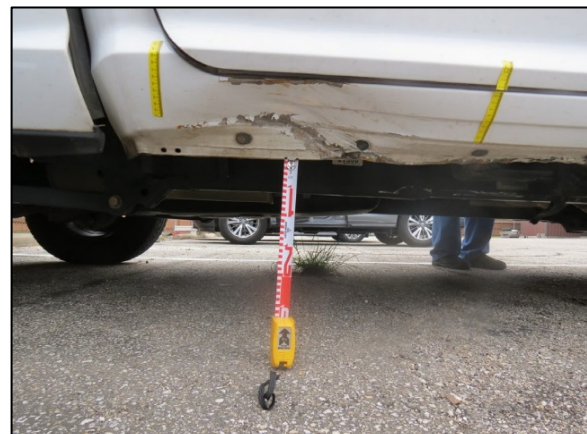
Figure 10. Undercarriage damage (right sill), 2014 Ram 1500.

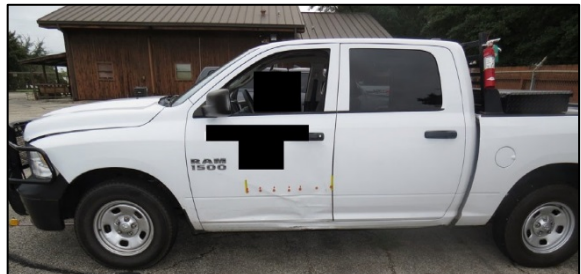
The driver of the Ram reported that he stopped the vehicle and placed it in Park with the engine running. This was a different driver than the driver involved in the second incident. He exited the vehicle to secure the gates. He first secured the exit gate (on left) and then crossed the road to secure the entrance gate (on right). At this time he observed the vehicle start rolling forward. It struck one of the wooden posts with its left side (**Figure 13**) and came to rest in that area. The direct damage was located 95 cm (37.4 in) aft of front axle and measured 53 cm (20.8 in). The CDC was 12LPES1. The driver entered the vehicle on the passenger side to make sure the vehicle was turned off and the vehicle placed in Park. The vehicle was then driven from the scene and a report of the incident was generated.

Figure 13. 2014 Ram 1500, left side damage.
