DOT HS 812 820

**Special Crash Investigations
On-Site Guardrail End Terminal
Crash Investigation
Vehicle: 2013 Toyota Avalon
Location: California
Crash Date: May 2017**

**Case Number: DS17009
Vehicle: 2013 Toyota Avalon
Location: California
Crash Date: May 2017**

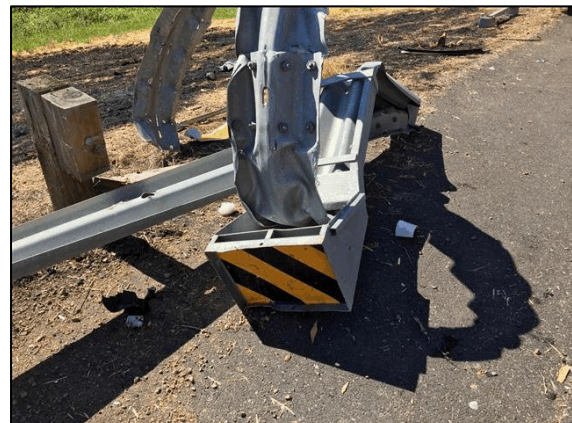
For unknown reasons, the Toyota traveled off the right edge of a southbound interstate highway and struck the guardrail end terminal. The first impact was followed by an impact with a sign pole, a second guardrail impact and a vehicle fire that spread to the occupant compartment of the Toyota. The fire prevented extrication of the driver by those who stopped to help and he sustained fatal injuries of an unknown nature. The investigation was intended to determine the dynamics of interaction between the guardrail and the vehicle, and what role the guardrail may have played in causing the driver's injuries. The scene, vehicle and guardrail inspections were completed in June 2017. A police officer was present during the vehicle inspection. The Toyota was supported by the Bosch Crash Data Retrieval (CDR) system but the vehicle's event data recorder (EDR) was not imaged. Fire damage prevented on-site imaging of EDR. It was located under the center console, which had melted, fallen, and hardened around the EDR module, making it inaccessible.

Figure 2. FLEAT guardrail end terminal struck by 2013 Toyota Avalon (Caltrans [California Department of Transportation] photo).

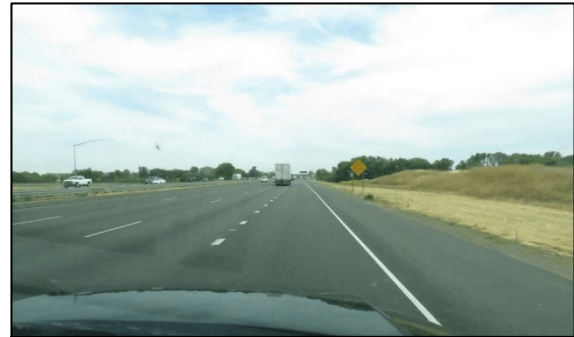
The crash site was the southbound lanes of a four-lane divided interstate highway in California (**Figure 3**). The asphalt roadway was straight, level and dry. The four travel lanes were separated by dashed white lines. The roadway was bordered on the right by a white fog line, a concrete shoulder, and a metal W-beam guardrail. It was bordered on the left by a yellow fog line, a concrete shoulder, a grass-covered median and a metal W-beam guardrail. The posted speed limit was 105 km/h (65 mph). Conditions were daylight and the weather at the nearest reporting station was 23.9 degrees C (75.0 degrees F), 53 percent humidity, 16 km (10 miles) visibility and calm winds. Crash diagrams are included at the end of this report.

Figure 3. Crash site, southbound approach.

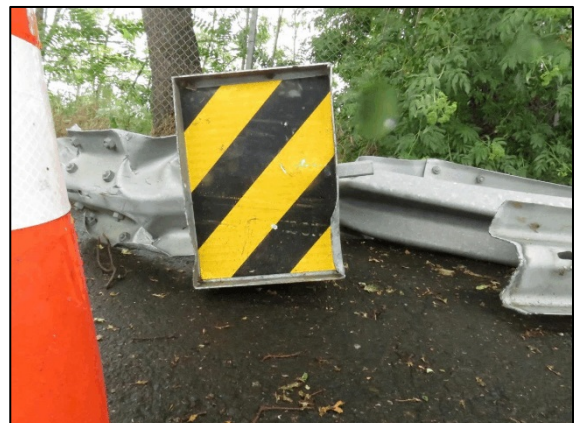
The Toyota's front plane struck the FLEAT guardrail end terminal (**Figure 4**) in a head-on configuration (Event 1). The barrier algorithm of the WinSMASH program calculated a barrier equivalent speed (BES) of 17 km/h (11 mph). The vehicle initiated a post-impact

Figure 4. FLEAT end terminal impact face.

The guardrail end terminal in this crash was a FLared Energy Absorbing Terminal (FLEAT) extruder-type end terminal. The rectangular impact face measured 52 x 35 cm (20.5 x 14.0 in) and the guide chute exit measured 48 cm (19.0 in) in height. The FLEAT was configured with a metal ground strut measuring 170 cm (67.0 in) in length located between posts 1 and 2, an anchor cable attached to post 1 and an anchor bracket attached to the W-beam between posts 1 and 2. The wooden guardrail posts measured 15 x 20 cm (6.0 x 8.0 in) and were assembled with composite offset blocks measuring 13 x 18 cm (5.0 x 7.0 in). Post spacing measured 190 cm (75.0 in) and W-beam height measured top to ground was 81 cm (32.0 in). At impact with the guardrail, a section of W-beam measuring 4.8 m (15.7 ft) in length (**Figure 6**) extruded on the traffic side of the guardrail. The total damaged length of W-beam measured 6.5 m (21.3 ft). The guardrail impact head, anchor cable and bracket were displaced. The first three wooden posts were fractured through (**Figure 7**) and the first five wooden posts were replaced. The guardrail kinked in two places, beginning at post 4 and ending at the post 5 (**Figure 8**). It appeared from the damage to the W-beam that it ceased to extrude through the FLEAT head at the area of the first kink. A straight section of W-beam measuring 4.1 m (13.5 ft) was replaced at the area of the second guardrail impact.

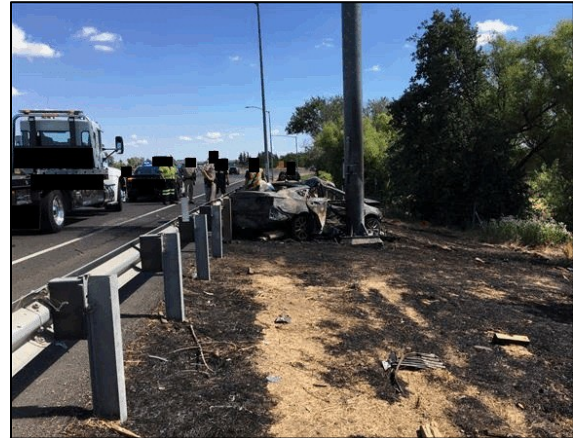
Following the pole impact, the Toyota rotated clockwise and the rearward aspect of its left plane struck the back side of the guardrail W- beam (Event 3). This was a minor impact. Direct damage and crush were unknown. The Toyota came to rest facing southwest near the pole and guardrail (**Figure 5**). Total distance traveled from the first impact to final rest measured 29.0 m (95.0 ft). At some point during or soon after the crash the vehicle caught fire which spread to the occupant compartment (Event 4).

Figure 5. Crash site, looking south at Toyota's final rest position (police photo).

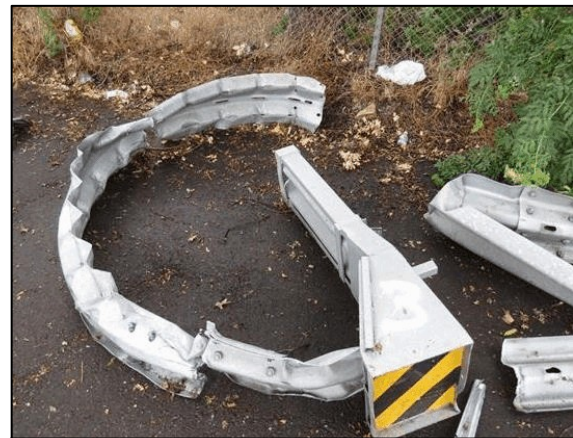
Figure 6. FLEAT end terminal and extruded W-beam.

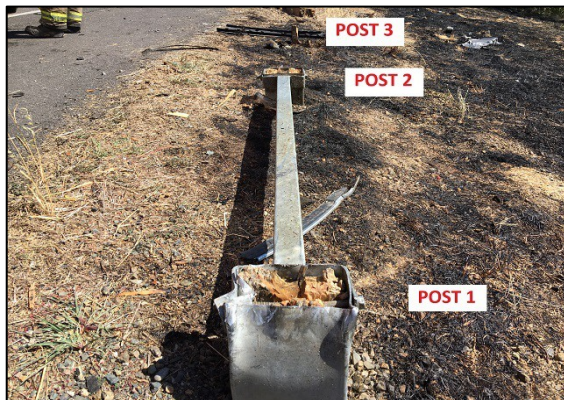
Figure 7. On-scene image, fractured posts 1-3 (police department photo).

Additional Comments: Posts 1 through 5 were replaced.

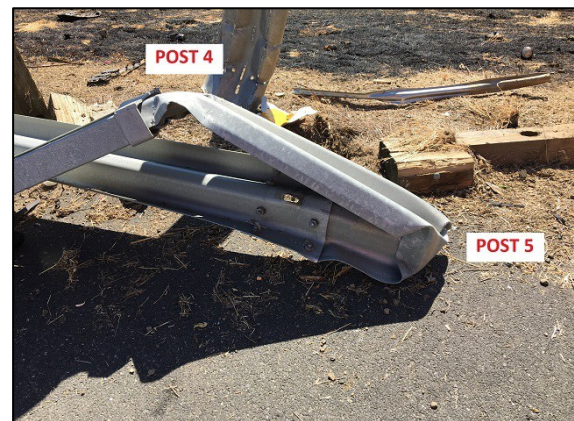
Figure 8. On-scene image, kinks in W-beam at posts 4-5 (police department photo).

ALL-SYSTEM PERFORMANCE			
Rail kinks Downstream of Head?	<input type="checkbox"/> No <input checked="" type="checkbox"/> Yes;	No. of Kinks in Rail: 2	
Was there intrusion into the Occupant Compartment by foreign object (guardrail)?	<input checked="" type="checkbox"/> No <input type="checkbox"/> Yes		
Did vehicle impact other objects after impact with terminal?	<input type="checkbox"/> No <input checked="" type="checkbox"/> Yes		
Object Contacted	1. Metal pole 2. Downstream section of W-beam

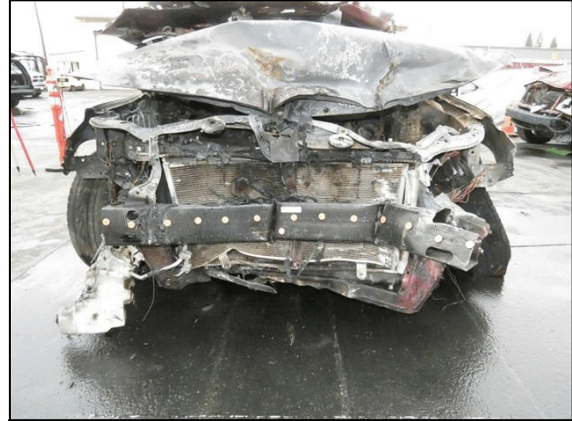
The Toyota sustained minor severity front plane damage from the impact with the guardrail end terminal (**Figure 9**). The front bumper fascia was displaced from the vehicle and not available for inspection; the bumper backing bar was used to measure crush. The direct damage began 29 cm (11.4 in) right of the front left bumper corner and extended 32 cm (12.5 in) to the right. The Field L extended from bumper corner to bumper corner. Maximum crush was located 64 cm (25.2 in) right of the left front bumper corner. Thirteen measurements were taken at bumper level by the Nikon Total Station and the Faro Blitz program computed crush measurement in six increments as follows: $C_1 = 0$ cm, $C_2 = 1$ cm (1.6 in), $C_3 = 9$ cm (3.1 in), $C_4 = 9$ cm (3.5 in), $C_5 = 2$ cm (1.6 in), $C_6 = 1$ cm (0.4 in). The principal direction of force was 0 degrees. The Collision Deformation Classification (CDC) for the Toyota in Event 1 was 12FCEN1.

Figure 9. Front plane crush measurement, 2013 Toyota Avalon.

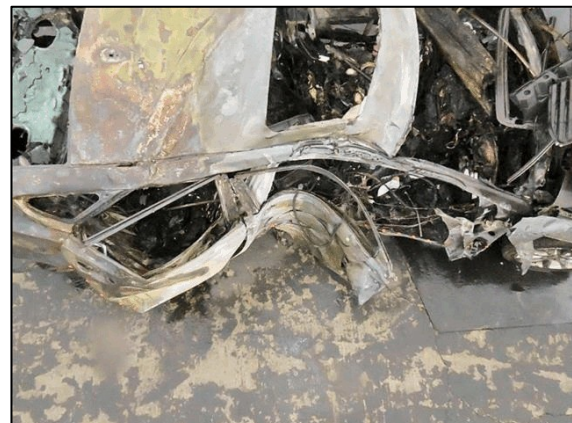
The vehicle sustained moderate severity right plane damage from the impact with the metal pole (**Figure 10**). Direct damage began 192 cm (75.6 in) aft of the front axle and extended 60 cm (23.6 in) forward. The Field L began 10 cm (3.9 in) aft of the rear axle and extended 244 cm (96.1 in) forward. Maximum crush was located 160 cm (63.0 in) aft of the left front axle. Twenty-four measurements were taken at sill level by the Nikon Total Station and the Faro Blitz program computed crush measurement in six increments as follows: $C_1 = 4$ cm (1.6 in), $C_2 = 14$ cm (5.5 in), $C_3 = 22$ cm (8.7 in), $C_4 = 21$ cm (8.3 in), $C_5 = 20$ cm (7.9 in), $C_6 = 7$ cm (2.8 in). The principal direction of force was 60 degrees. The CDC for the Toyota in Event 2 was 02RPAW3.

Figure 10. Right plane damage, 2013 Toyota Avalon.

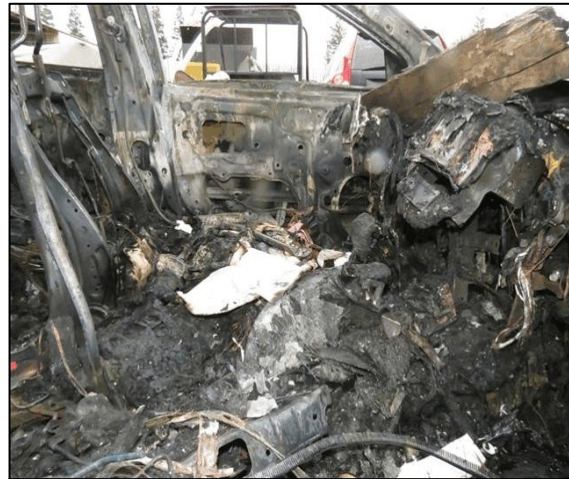
The Toyota's interior sustained severe thermal damage caused by the fire and post-crash activities including efforts to extinguish the fire (**Figure 11**). The instrument panel, controls, seats, roof header, trim, restraint systems, carpet and most other non-metallic components were burned or melted. All four doors appeared to have been jammed shut and later forced open. All glazing was fractured and missing. The vehicle sustained front row lateral intrusion of the right B-pillar (20 cm [7.9 in]), right sill (20 cm [7.9 in]), and right door, rear lower quadrant (16 cm [6.3 in]). Front row longitudinal intrusion was documented at the right seat back (28 cm [11.0 in]) and right seat cushion (14 cm [5.5 in]). Second row vertical intrusion was documented at the right roof side rail (19 cm [7.5 in]).

Figure 11. Interior view, front row looking right to left, 2013 Toyota Avalon.

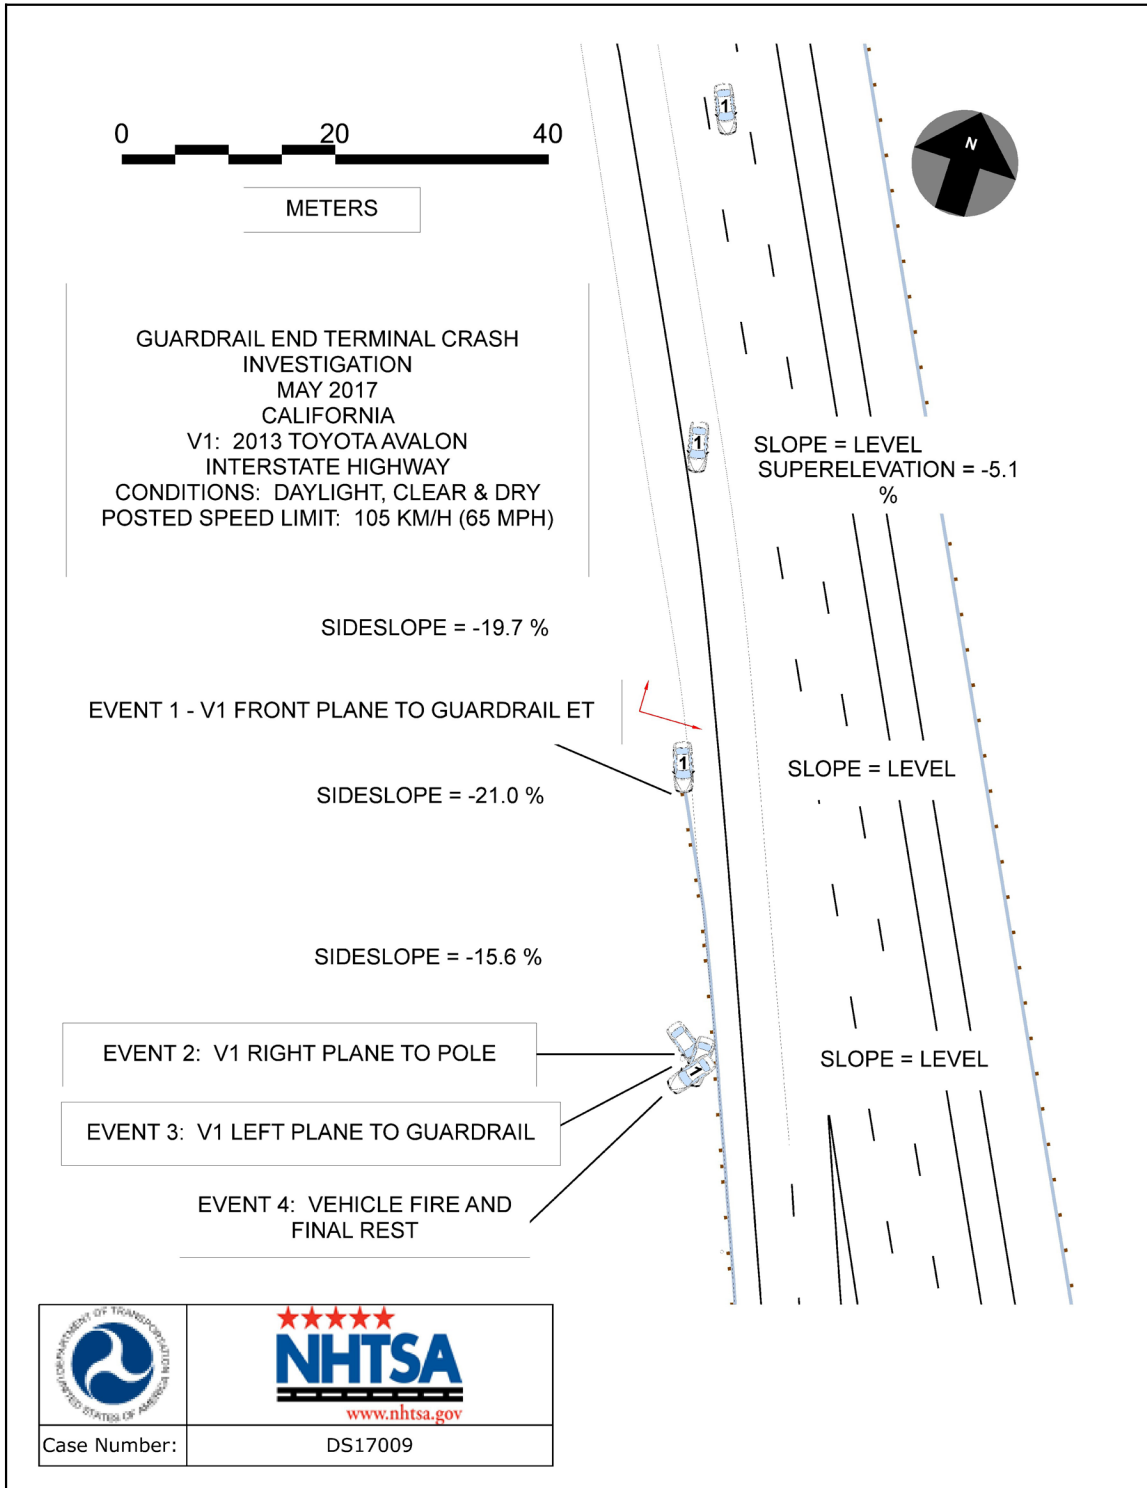
EVENT 1: V1 FRONT PLANE TO FLEAT
GUARDRAIL END TERMINAL

EVENT 2: V1 RIGHT PLANE TO POLE
(46cm [18 in] diameter at base)

EVENT 3: V1 LEFT PLANE TO
GUARDRAIL

EVENT 4: VEHICLE FIRE
