DOT HS 812 834

November 2019

**Special Crash Investigations
On-Site Alleged Air Bag Inflator
Rupture Crash Investigation
Vehicle: 2007 Honda CR-V
Location: Texas
Crash Date: October 2017**

**SPECIAL CRASH INVESTIGATIONS
ON-SITE ALLEGED AIR BAG INFLATOR RUPTURE
CRASH INVESTIGATION
CASE NUMBER: CR17031
VEHICLE: 2007 HONDA CR-V
LOCATION: TEXAS
CRASH DATE: OCTOBER 2017**

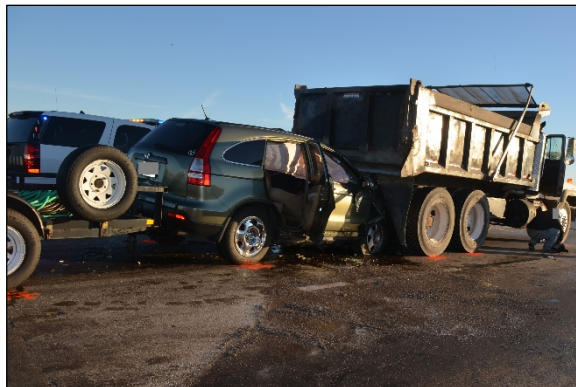
Due to the braking input by the Mack's driver, the Mack came to a controlled stop in its original travel lane on top of the overpass. The Honda remained engaged against the Mack, with its front plane under-riding the Mack's back plane. The respective vehicles' final rest positions were documented by the investigating law enforcement agency (**Figure 3**).

Figure 3. View of the Honda and Mack at final rest (on-scene image provided by the law enforcement agency).

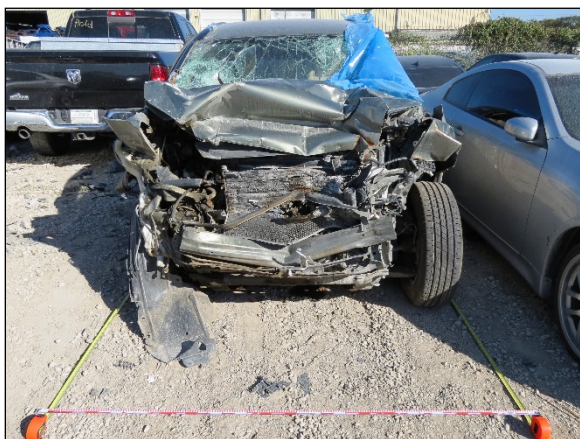
In the front plane damage pattern was moderate deformation and crush to frontal components. The bumper fascia, grille, and both headlight assemblies were fractured. The bumper fascia was completely separated from the Honda and no longer with the vehicle. The bumper beam, radiator support, hood, and frontal components were crushed rearward, with deflection of the forward aspect of the left front/right front fenders.

Direct contact damage associative to the front crash event spanned the entire width of the front plane. A residual crush profile was documented, with measurements taken to the leading edge of the deformed hood/upper radiator support and deformed bumper beam. The width of the direct and induced damage (Field-L) for the crush profile measured 105 cm (41.3 in). The averaged crush profile produced the following resultant measurements: C1 = 36 cm (14.2 in), C2 = 42 cm (16.5 in), C3 = 41 cm (16.1 in), C4 = 41 cm (16.1 in), C5 = 34 cm (13.4 in), and C6 = 35 cm (13.8 in). **Figure 5** depicts the front plane damage pattern, while **Figure 6** depicts the damage profile from an overhead perspective.

Figure 5. Frontal damage pattern and deformation to the 2007 Honda CR-V.

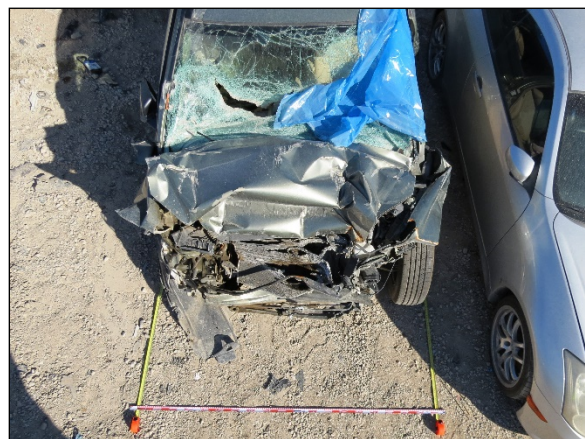
Figure 6. Overhead view of the frontal damage profile to the 2007 Honda CR-V.

Although the maximum crush in the profile observed at the center of the damage profile (C3/C4 locations) measured 48 cm (18.9 in), there was direct contact observed to both A-pillars from contact with the bottom of the Mack's dump body. A fracture pattern across the width of the windshield evidenced engagement of the glazing with the back plane of the Mack. Therefore, based on the observed visible damage to the Honda, the Collision Deformation Classification (CDC) assigned for the Event 1 impact with the Mack was 12FDAW6.

The barrier algorithm of the WinSMASH model was used to calculate the delta-V of the impact for the Honda. The total calculated delta-V was 52 km/h (32 mph). The longitudinal component of the calculated delta-V was -52 km/h (-32 mph), with a lateral component of 0 km/h (0 mph). Based on SCI expertise, these results fit the collision model but appeared underestimated, likely due to the underride characteristics of the crash.

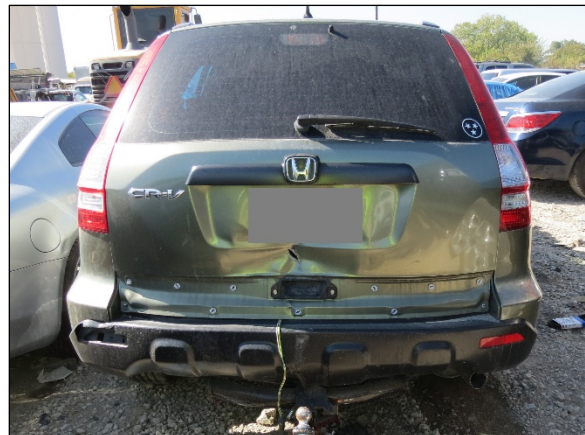
Intra-unit damage sustained by the Honda resulted from the forward vertical pitch of the small utility trailer during the frontal impact with the Mack, and consisted of minor deformation to the center aspect of the tailgate (**Figure 7**). The damage was attributed to contact with the trailer jack and tongue. Due to the nature of the damage and its minor severity, no residual crush profile was documented during the SCI inspection. It should be noted that the damage and contact is not considered to be a crash event due to its intra-unit characteristics. Therefore, no CDC could be assigned to the damage pattern, and no WinSMASH calculations could be performed.

Figure 7. Back plane view of the 2007 Honda CR-V and intra-unit damage from the utility trailer.

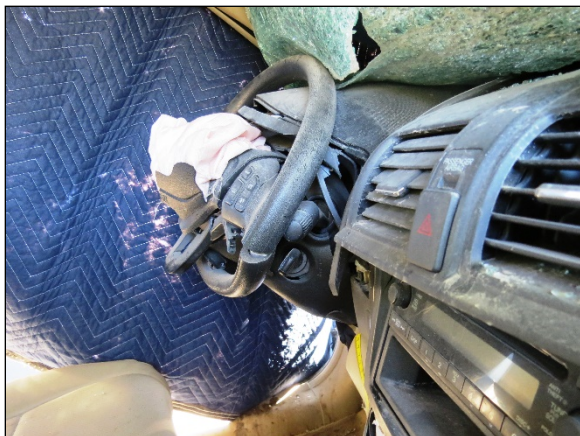
Occupant contact identified in the Honda was attributable to the driver's forward kinematic response and displacement that resulted from his lack of manual restraint usage. This included significant deformation/collapse of the steering wheel rim from loading by the driver's chest (**Figure 8**), scuffing to the left lower instrument panel by the driver's knees, and a distinct fracture pattern to the windshield glazing from contact by the driver's head/face (**Figure 9**). The driver likely experienced induced loading and indirect contact with the Mack's dump body through the windshield glazing of the Honda during the vehicles' maximum engagement. The driver's head also contacted the visor and windshield header in the Honda.

Figure 8. Steering wheel rim/column deformation in the Honda from driver loading.

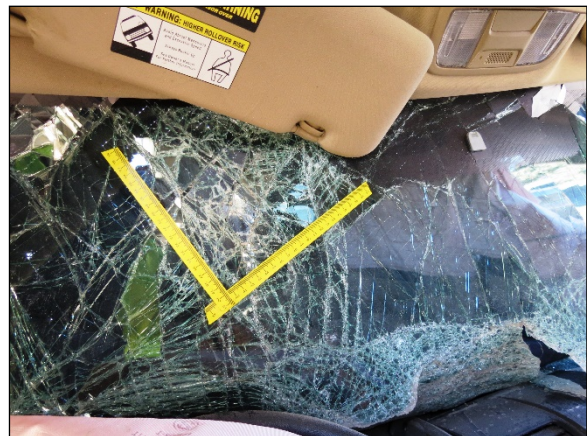
Figure 9. Contact to the windshield glazing from the Honda driver's head.

The sustained forward momentum of the driver caused his head to flex forward as his torso's movement was restricted by its engagement with the steering column. The driver's head contacted the windshield of the Honda, which fractured the glazing above the steering column. Simultaneously, the maximum engagement of the vehicles caused the lower edge of the Mack's dump body to engage the windshield and A-pillars of the Honda. This was in alignment with the location of the driver's head contact to the windshield, resulting in indirect contact of the driver's head with the back plane of the Mack's dump body. Massive head injuries to the driver were induced by this contact and loading.

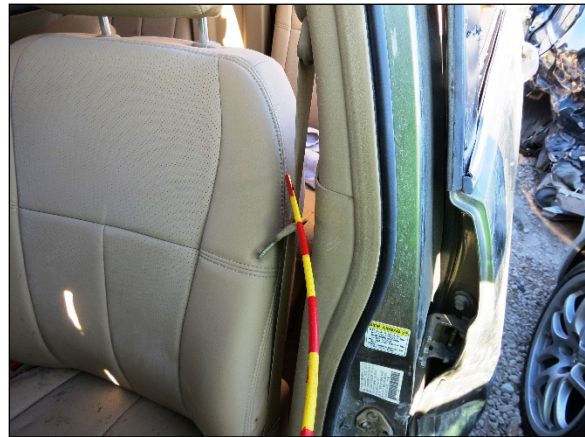
At the time of the SCI inspection, the driver's D-ring was adjusted to its fully downward position. The webbing was locked in position as a result of pretensioner actuation and taut against the B-pillar. Based on the observations of the SCI investigator and its post-crash condition, it was apparent that the seat belt system was not in use by the driver at the time of the crash. **Figure 10** depicts the driver's 3-point lap and shoulder seat belt system at the time of the SCI inspection.

Figure 10. Driver's 3-point lap and shoulder seat belt system in the 2007 Honda CR-V.

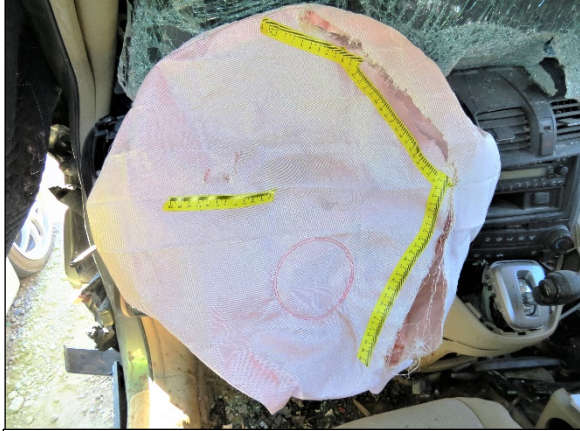
The driver's frontal air bag had deployed from the steering wheel hub-mounted module. There was no rupture of the inflator or other apparent malfunction of the system during deployment. The unbelted driver responded to the frontal crash forces with a forward trajectory and contacted the deployed air bag with his chest. Due to the severity of the crash and his unrestrained status, the driver experienced significant prolonged loading of the inflated air bag. The air bag became compressed between the steering wheel rim and the driver, which increased the internal pressure of the air bag. Despite its venting, the fabric of the air bag was unable to withstand the high internal pressure created by the compression of the bag by the driver during his kinematic response. This pressure exceeded the strength load of the air bag's fabric, which caused the fabric to separate and burst on its face, along the circumference of the steering wheel rim.

Figure 11. Deployed driver's frontal air bag with burst fabric, highlighted by yellow marking tape.

Figure 11 depicts the driver's air bag as documented by the SCI investigator. The SCI investigator and the manufacturer representative from Honda disassembled the involved air bag module for inspection. A new manufacturer replacement air bag module was provided by the Honda representative for exemplar/comparison purposes. Upon inspection, it was determined that the involved air bag module was a genuine manufacturer component. The air bag module itself was the original equipment installed in the Honda CR-V during its manufacture; however, the air bag inflator had been replaced during certified service as remedy for a manufacturer recall (see *NHTSA Recalls and Investigations*). According to the Honda representative, the modified bracket and labeling present on the involved air bag module indicated that the recall remedy had been performed in accordance with the manufacturer's specified procedure. There was no rupture of the Honda's air bag inflator (**Figure 12**).

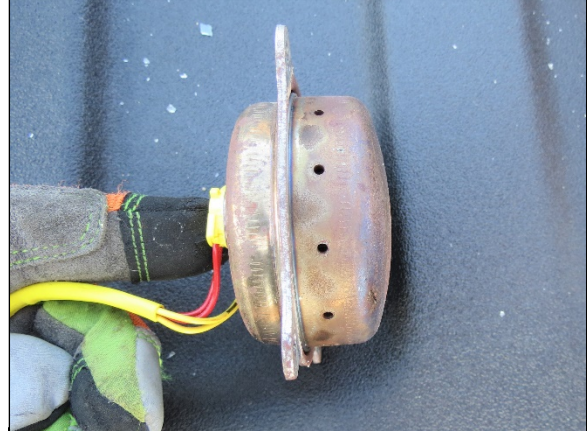
Figure 12. Lateral view of the Honda's air bag inflator, removed from the module during SCI documentation.

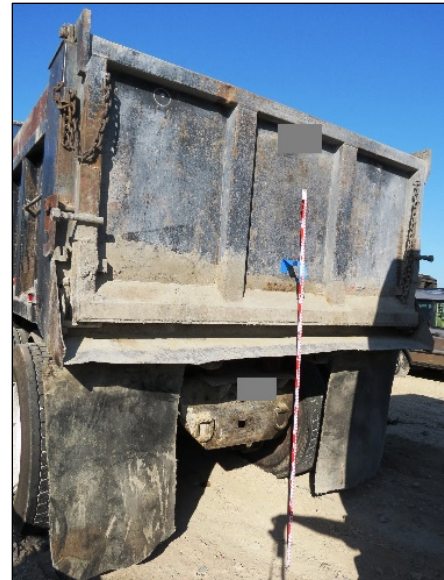
There was no discernable damage to the Mack truck, despite its involvement in the crash. The steel construction of the Mack's frame and heavy-duty dump body withstood the crash forces from the Honda's impact. **Figure 15** depicts the back plane of the Mack at the time of the SCI inspection, with a calibrated measuring tape for visual reference. The CDC assigned to the Mack was 06BDWW1. No WinSMASH calculations could be computed due to the lack of damage and vehicle type, which were beyond the scope of the model's capabilities.

Figure 15. Back plane view of the 1994 Mack dump truck.
