DOT HS 812 839

**Special Crash Investigations
On-Site Air Bag Non-Deployment
Crash Investigation
Vehicle: 2006 Mazda 6
Location: Maryland
Crash Date: March 2018**

Special Crash Investigations
On-Site Air Bag Non-Deployment Crash Investigation
Office of Defects Investigation
Case No: CR18017
Vehicle: 2006 Mazda 6
Location: Maryland
Crash Date: March 2018

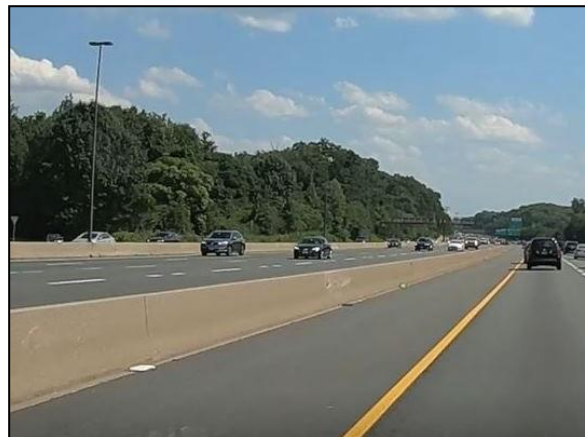
The crash (Event 1) occurred as the front plane/left aspect of the Mazda struck the face of the concrete barrier. Impact forces accentuated the vehicle's counterclockwise rotation, and the entire width of the front plane engaged the barrier. The Mazda was redirected by the barrier and rebounded toward the southwest (back toward the travel lanes). It ultimately slid to final rest straddling the travel lane second from the right, facing north. **Figure 3** depicts the concrete barrier with impact damage in the area of the crash site. However, due to the numerous impacts to the barrier, the SCI investigator was unable to determine which specific area of contact was related to the Mazda's impact.

Figure 3: Southeast-facing view of the concrete barrier in the area of the crash.

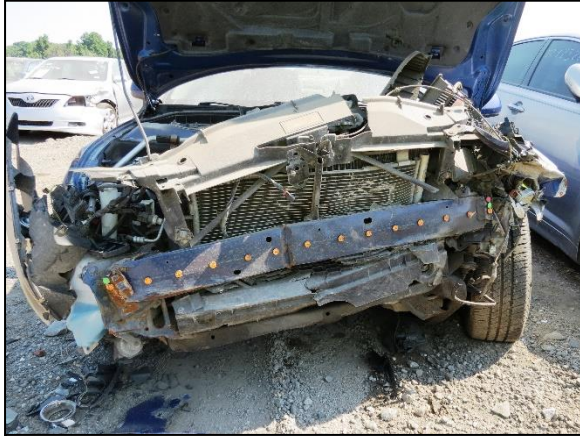
Damage to the exterior of the Mazda was located on the front plane, associative to the front plane crash event with the concrete median barrier. Direct contact spanned the entire 140 cm (55.1 in) end width of the Mazda. The bumper fascia was fractured and entirely separated from the front of the vehicle, with longitudinal crush to the exposed bumper beam. Both headlight assemblies were fractured, and the grille/fascia was missing. Deformation was observed to the hood and both front fenders, and the engine compartment components were displaced by the overall front plane deformation that was biased to the left aspect.

Figure 5: View of the front plane crush profile as documented during the SCI inspection.

A residual crush profile was documented using a Field-L width across the entire 118 cm (46.5 in) front bumper beam of the Mazda (**Figure 5**). This profile produced the following resultant measurements: C1 = 52 cm (20.5 in), C2 = 52 cm (20.5 in), C3 = 46 cm (18.1 in), C4 = 40 cm (15.7 in), C5 = 32 cm (12.6 in), and C6 = 18 cm (7.1 in). Maximum crush in the profile was observed at the left end of the beam. The left wheelbase was reduced by 5 cm (2.0 in). Based on the observed damage to the Mazda, the CDC assigned for the Event 1 impact was 11FDEW3. **Figure 6** depicts the damage profile to the front of the Mazda from an overhead perspective.

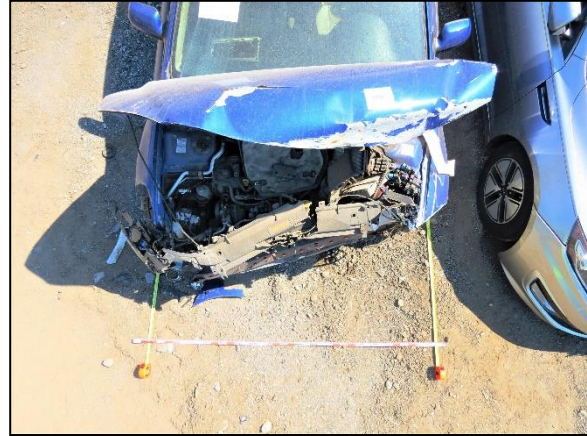
Figure 6: Overhead view of the front crush profile to the Mazda.

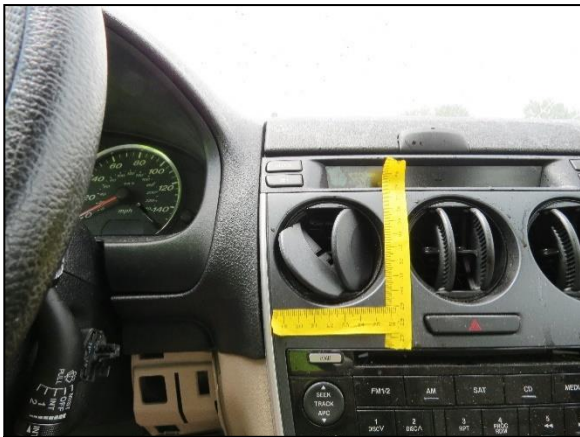
Figure 7: Fractured vent louvre in the Mazda.

The driver's right hand separated from the steering wheel rim, causing her right wrist to contact and fracture the signal/wiper stalk from the steering column and her right hand to engage the vent louvre in the left aspect of the center instrument panel. This contact resulted in a right wrist avulsion, abrasion, and sprain.

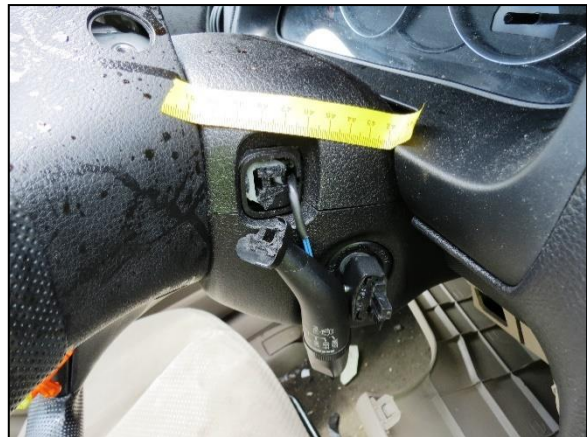
Figure 8: Fractured signal/wiper stalk in the Mazda.

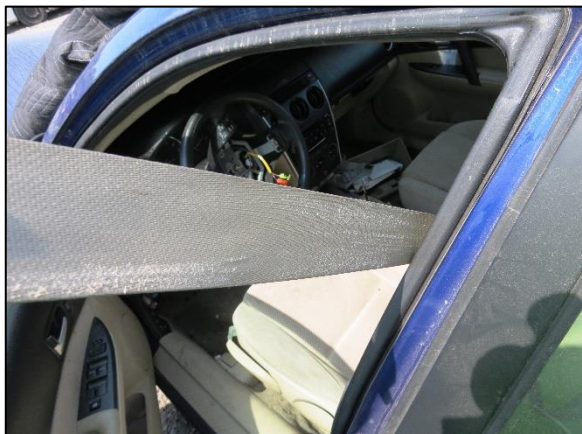
At the time of the SCI inspection, the driver's D-ring was adjusted fully upward. Webbing spooled freely and retracted upon release. A polymer transfer was observed on the webbing from the D-ring (**Figure 9**), and there were subtle loading abrasions observed to the polymer surface of the latch plate in the belt path (**Figure 10**). It was apparent that the Mazda's driver was using the system for manual restraint when the crash occurred.

Figure 9: Webbing of the driver seat belt system in the Mazda with polymer transfer from the D-ring.

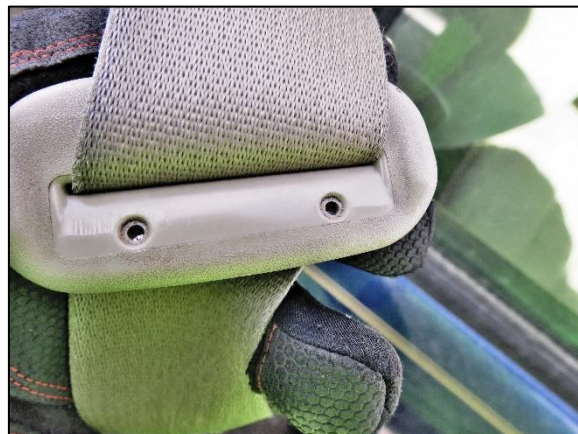
Figure 10: Latch plate of the Mazda's driver seat belt system with visible loading abrasions in the belt path.

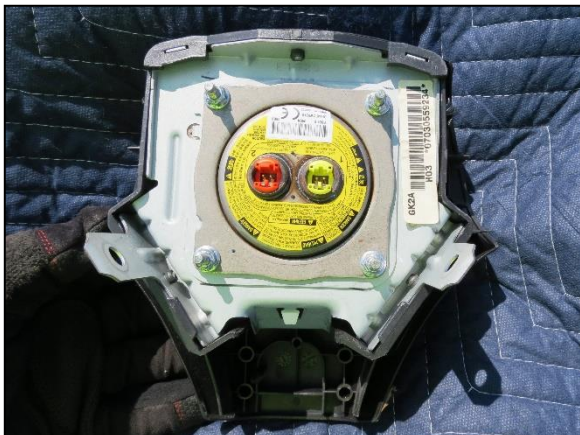
The SCI investigator examined both frontal air bag modules, which had been deposited loose in the Mazda’s second row by the unknown prior inspectors. The driver’s air bag module (**Figure 11**) and the front right passenger’s module (**Figure 12**) both appeared to be genuine original manufacturer components. Proper manufacturer markings and serialization codes were observed on the module and inflator components. There was no damage or abnormal wear to either module, with no evidence to suggest that either module would not operate as designed.

Figure 11: Driver’s frontal air bag module from the Mazda as found in the vehicle during the SCI inspection.

2. As observed during the SCI inspection, the Mazda's driver's and passenger's frontal air bag modules were original manufacturer components. They were not damaged or altered, and showed no evidence of malfunction or other adverse condition.

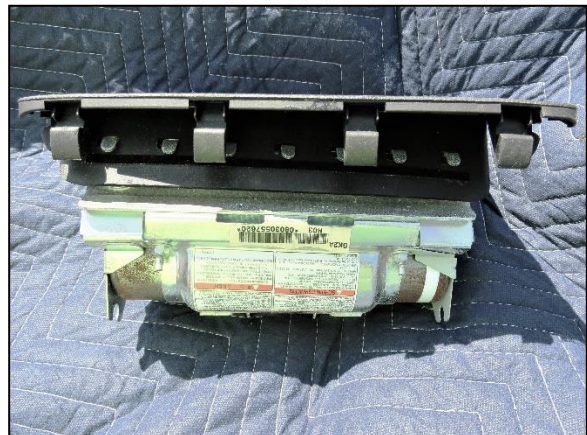
Figure 12: View of the Mazda’s passenger’s frontal air bag module at the time of the SCI inspection.
