**National Highway
Traffic Safety
Administration**

DOT HS 812 843

**Special Crash Investigations
On-Site Air Bag
Non-Deployment Crash
Investigation
Vehicle: 2016 Nissan Versa
Location: Virginia
Crash Date: June 2017**

**SPECIAL CRASH INVESTIGATIONS
ON-SITE AIR BAG NON-DEPLOYMENT CRASH INVESTIGATION
CASE NO.: CR17023
OFFICE OF DEFECTS INVESTIGATION
VEHICLE: 2016 NISSAN VERSA
LOCATION: VIRGINIA
CRASH DATE: JUNE 2017**

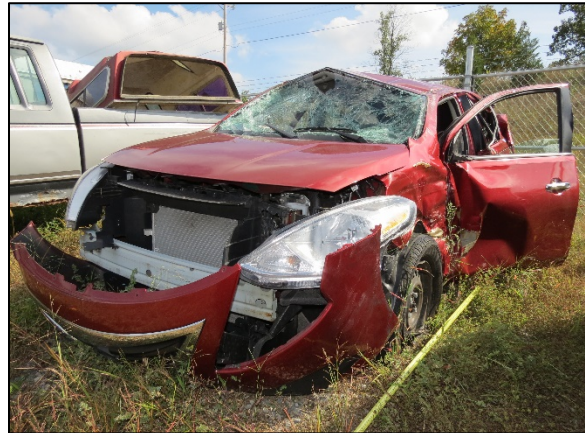
This report documents the on-site investigation of the non-deployment of the air bag systems in a 2016 Nissan Versa (**Figure 1**) during a multiple event crash. The Nissan was traveling at slow speed in heavy traffic on a limited-access roadway when it was rear-ended by a 2002 Buick Rendezvous traveling at a higher speed. The impact displaced the Nissan forward and into the rear of a 2015 Honda CR-V, after which the Nissan overturned. Although it was equipped with certified advanced 208-compliant (CAC) frontal air bags, front seat-mounted side impact air bags, side impact-sensing inflatable curtain (IC) air bags, and front seat belt retractor pretensioners, none of the supplemental devices actuated/deployed in the crash. The Nissan was occupied by a belted 57-year-old female driver, a belted 41-year-old female front right occupant, and a belted 13-year-old female second row right occupant. Both front row occupants were airlifted from the crash site by helicopters and flown to a regional trauma center for treatment of reported incapacitating (A-level) injuries. The 13-year-old female's injury status was unknown.

Figure 1: Front left oblique view of the 2016 Nissan Versa at the time of the SCI vehicle inspection.

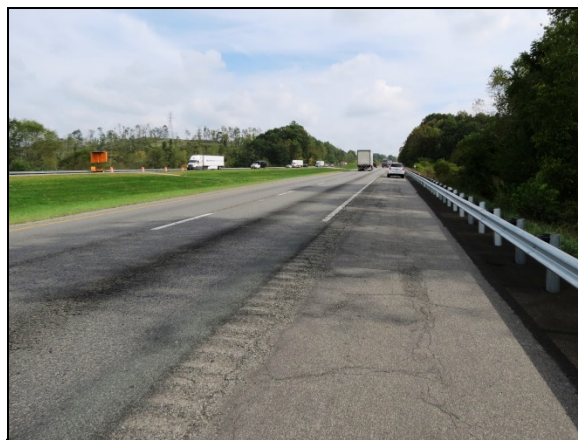
Figure 2: Southeast-facing trajectory view of the roadway in the vicinity of the crash.

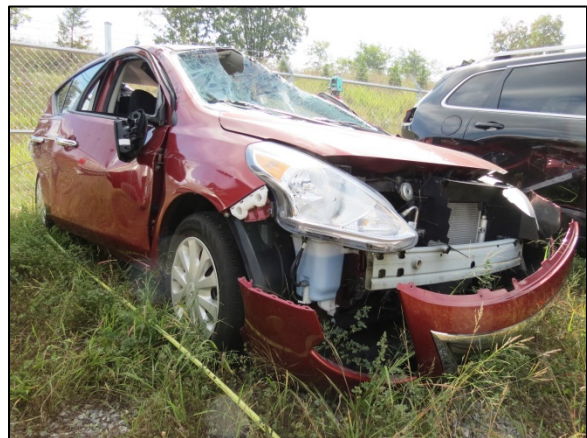
The 2016 Nissan Versa (**Figure 3**) was manufactured in March 2016 and identified by the Vehicle Identification Number (VIN) 3N1CN7AP6GLxxxxxx. It was a 4-door sedan equipped with the SL-level trim package, and was built on a 260 cm (102.4 in) wheelbase. A placard declared that the Nissan's gross vehicle weight rating (GVWR) was 1,554 kg (3,426 lb). Front and rear axle ratings (GAWR) were 794 kg (1,750 lb) and 775 kg (1,708 lb), respectively. The curb weight was 1,129 kg (2,490 lb). A 1.6 liter, inline 4-cylinder, gasoline engine powered the Nissan, linked to a continuously variable transmission (CVT) with front-wheel drive. The vehicle manufacturer's recommended tire size and cold tire pressure for all four axle positions were P185/65R15 at 230 kPa (33 PSI). All four equipped tires were Continental ContiPro Contact tires of the recommended size, with matching Tire Identification Numbers (TINs) of P5FP 3YP 1016. All had ample tread at the time of the SCI vehicle inspection.

Figure 3: Front right oblique view of the 2016 Nissan Versa at the time of the SCI vehicle inspection.

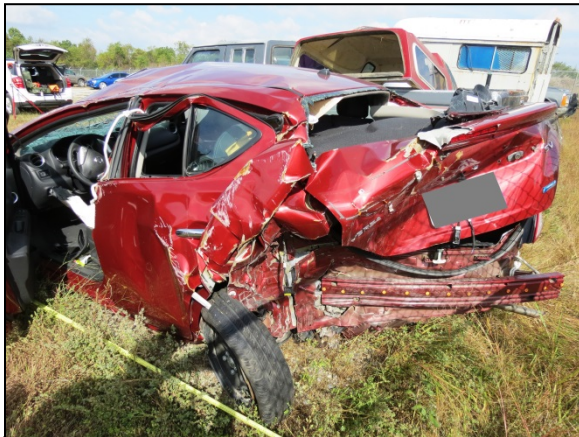
Damage to the exterior of the Nissan was located on all planes. There was rear plane damage associative to the first impact with the Buick, front and left plane damage from the second impact with the Honda, and right, top, and left plane damage associative to the rollover event. Rear plane damage was severe. The direct contact began on the Nissan's centerline and extended 66 cm (26.0 in) left to the left rear corner. Combined direct and induced damage spanned the entire rear end width of the Nissan. In the damage pattern was significant longitudinal deformation, inclusive of collapse of the entire trunk/cargo area and deformation to the trunk lid, bumper beam, left quarter panel, and surrounding components (**Figures 4 and 5**). The rear bumper fascia was completely separated from the vehicle.

Figure 4: Rear plane damage to the 2009 Nissan Versa.

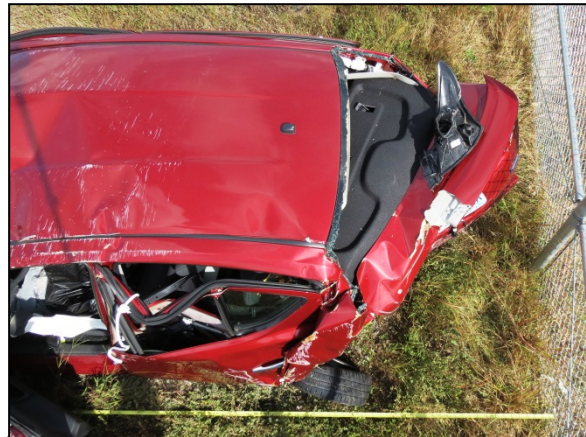
Figure 5: Overhead view of the Nissan's rear profile.

Using a combined damage width (Field-L) of 122 cm (48.0 in) across the entire rear bumper beam, a crush profile was documented using the Nikon Nivo 5+M total station. The residual crush measurements included: C1 = 99 cm (39.0 in), C2 = 70 cm (27.6 in), C3 = 48 cm (18.9 in), C4 = 29 cm (11.4 in), C5 = 13 cm (5.1 in), C6 = 0 cm (0.0 in). Maximum crush was located at

the C1 position. Based on the visible damage pattern, the Collision Deformation Classification (CDC) assigned to the Nissan for the Event 1 impact with the Buick was 06BZEW7.

The Missing Vehicle Algorithm of the WinSMASH model was used to calculate the delta-V of the rear plane impact for the Nissan. The total calculated delta-V was 49 km/h (30 mph). The longitudinal component of the calculated delta-V was 49 km/h (30 mph), with a lateral component of 0 km/h (0 mph). These results appeared reasonable.

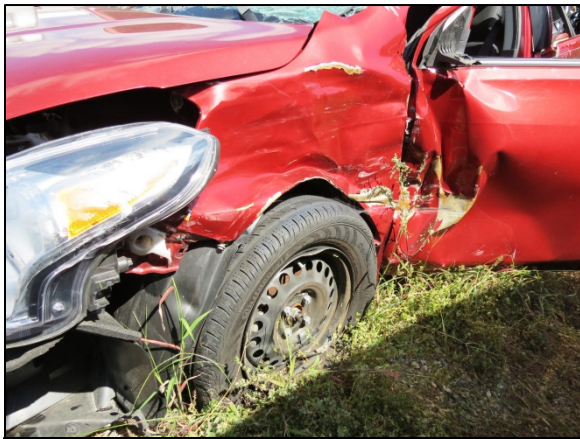
Damage from the second impact event with the Honda was located on the left front corner aspect of the Nissan. The damage was present on the extreme left corner of the front bumper fascia, as well as the left headlight assembly, left front fender, and left front door (**Figure 6**). From a frontal perspective, the damage began at the left front bumper corner and extended approximately 8 cm (3.1 in) to the right. However, it extended a total of 128 cm (50.4 in) along the left plane to 60 cm (23.6 in) rearward of the left front axle position. In the damage pattern were longitudinal swiping abrasions and minor lateral deformation. Due to the nature of the damage profile, representative crush measurements could not be documented. The CDC assigned to the Event 2 damage pattern was 12FLEE6. No WinSMASH delta-V calculations could be computed because the nature of the crash forces was beyond the scope of the model.

Figure 6: Event 2 impact damage to the left front corner area of the Nissan.

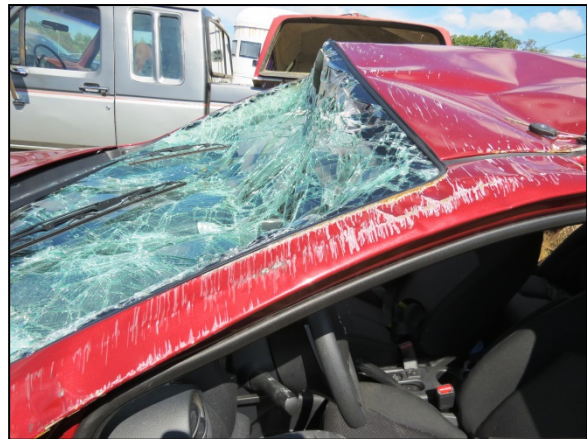
Figure 7: Vertical deformation to the Nissan's roof.

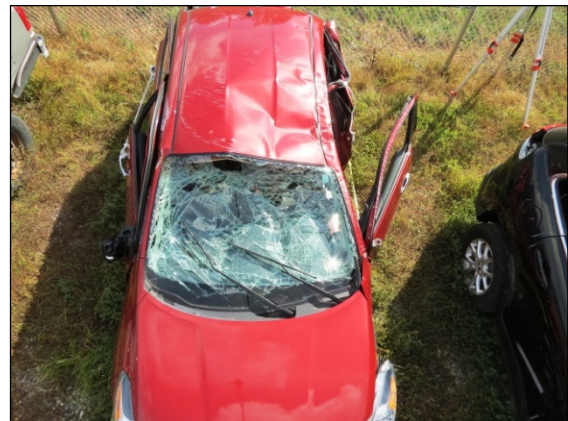
Rollover damage was visible on the right, left, and top planes of the Nissan. This primarily consisted of abrasions and scratches to the body surfaces, with minor deformation. Minor vertical deflection of the roof was visible, but accurate measurements of its magnitude could not be obtained. Downward vertical deflection of the forward left aspect of the Nissan's roof (**Figure 7**) above the driver's seat position was estimated to be less than 3 cm (1.2 in). **Figure 8** depicts an overhead view of the Nissan's top plane from a frontal perspective. The CDC assigned to the Nissan for the Event 3 rollover damage was 00TDDO2. No WinSMASH

Figure 8: Overhead view of the Nissan's top plane.

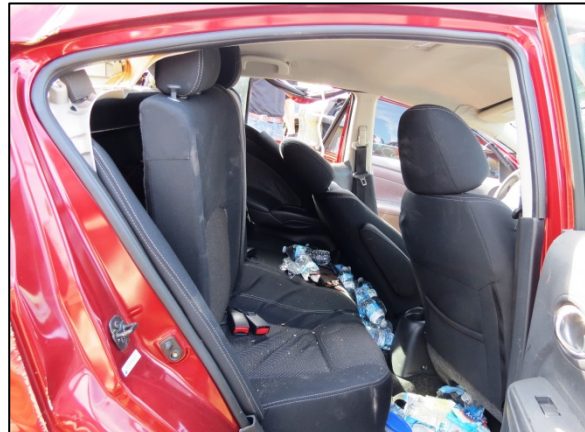
The interior of the Nissan was inspected for crash-related intrusion and occupant contact. Intrusion into the occupant compartment space included significant longitudinal intrusion of the left aspect of the Nissan's second row seat back. Deformation associated with the first impact event by the Buick's front plane resulted in the complete collapse of the Nissan's trunk space and corresponding forward displacement of the second row seat back (**Figure 9**), rear package shelf, and left C-pillar. Corresponding displacement of the seat back measured 48 cm (18.9 in) at the second row left position, 28 cm (11.0 in) at the second row center position, and 24 cm (9.4 in) at the second row right position. All measurements were obtained at the upper aspect of the seat back. Vertical intrusion associated with the rollover (Event 3) was of minor severity. The maximum vertical intrusion measured 7 cm (2.8 in), and was located to the roof above the driver's seat position.

Figure 9: Forward displacement of the Nissan's second row seatback as viewed from the second row right position.

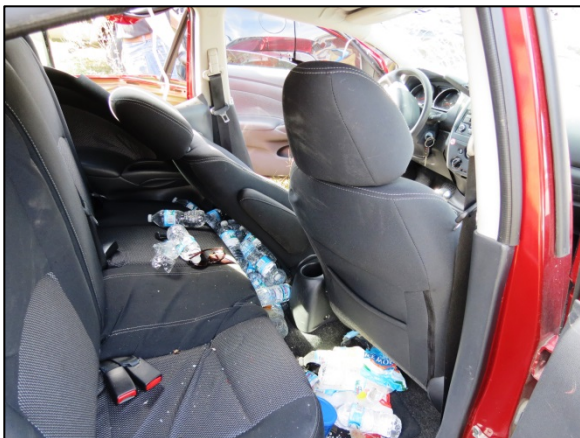
Occupant loading in the Nissan was evident to the front row seatbacks. Both the driver's and front right passenger's seatbacks were deformed rearward (**Figure 10**). Similarly, the front row's adjustable head restraints were also deformed rearward (**Figure 11**). This deformation was the result of contact and loading by the head and posterior back of both the driver and front row right occupant during the first impact event with the Buick.

Figure 10: The Nissan's deformed front row seatbacks.

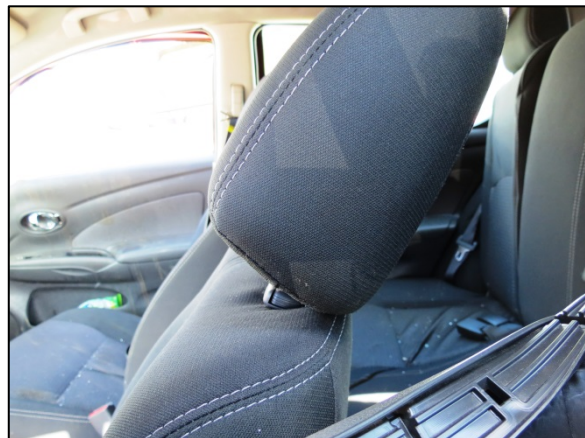
Figure 11: Nissan driver's deformed head restraint.

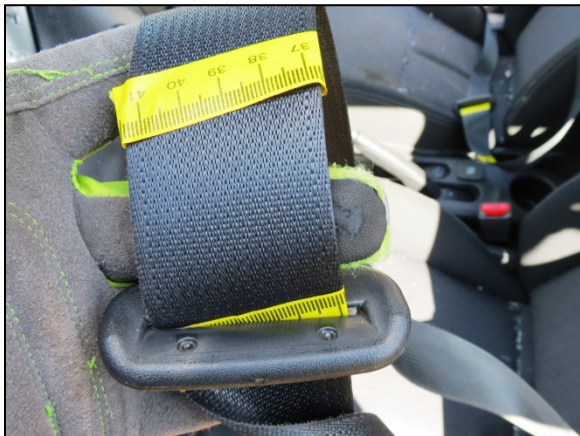
At the time of the SCI inspection, the driver's seat belt system was loosely retracted against the left B-pillar. The SCI investigator extended the webbing and observed an area of loading abrasions on the webbing from the latch plate, located from 99-105 cm (39.0-41.3 in) above the lower anchor. An area of loading abrasion from the D-ring was located 96 cm (37.8 in) above the end of the latch plate loading. Lastly, there was corresponding loading evidence in the belt path of the latch plate. It was apparent to the SCI investigator that the driver was restrained by the driver's seat belt system at the time of the crash. **Figure 12** depicts the Nissan's driver seat belt system at the time of the SCI vehicle inspection.

Figure 12: Loading evidence on the Nissan driver's 3-point lap and shoulder seat belt system.

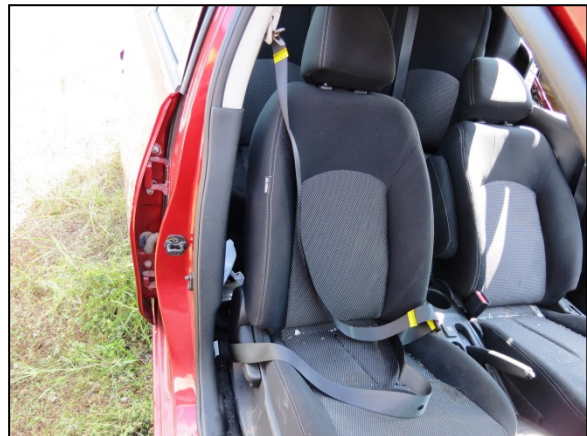
Figure 13: View of the Nissan's front right passenger's seat belt system with the occupant loading evidence identified.

The front right passenger's seat belt system was also loosely retracted at the time of the SCI inspection. The SCI investigator extended the webbing and observed an area of loading abrasions on the webbing from the latch plate, located from 117-128 cm (46.1-50.4 in) above the lower anchor. An area of loading abrasion from the D-ring was located 91 cm (35.8 in) above the end of the latch plate loading. Lastly, there was corresponding loading evidence in the belt path of the latch plate. It was apparent to the SCI investigator that the front row right occupant was restrained by the seat belt system at the time of the crash. **Figure 13** depicts the Nissan's front right passenger's seat belt system at the time of the SCI vehicle inspection.

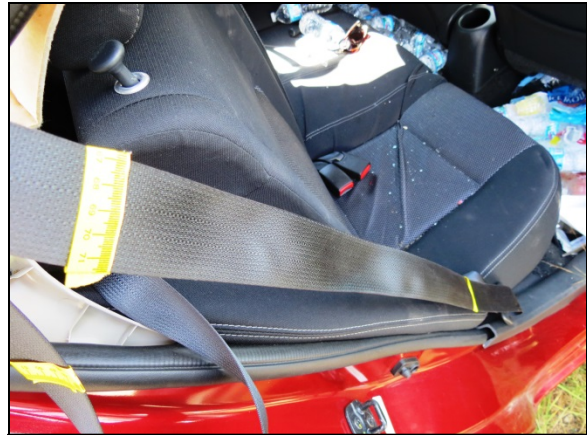
The second row right seat belt system was loosely retracted against the right C-pillar at the time of the SCI vehicle inspection. With the webbing extended, a distinct pattern of waffling to the webbing was visible (**Figure 14**). The waffled section of webbing was located from 39-92 cm (15.4-36.2 in) above the lower anchor. Although there was no loading evidence in the belt path of the latch plate, a small abrasion was found on the webbing that correlated to loading evidence from the D-ring. This was located 36 cm (14.2 in) above the end of the waffled section. It was apparent to the SCI investigator that the second row right occupant was restrained by the seat belt system at the time of the crash.

Figure 14: Loading evidence to the second row right seat belt system in the Nissan.

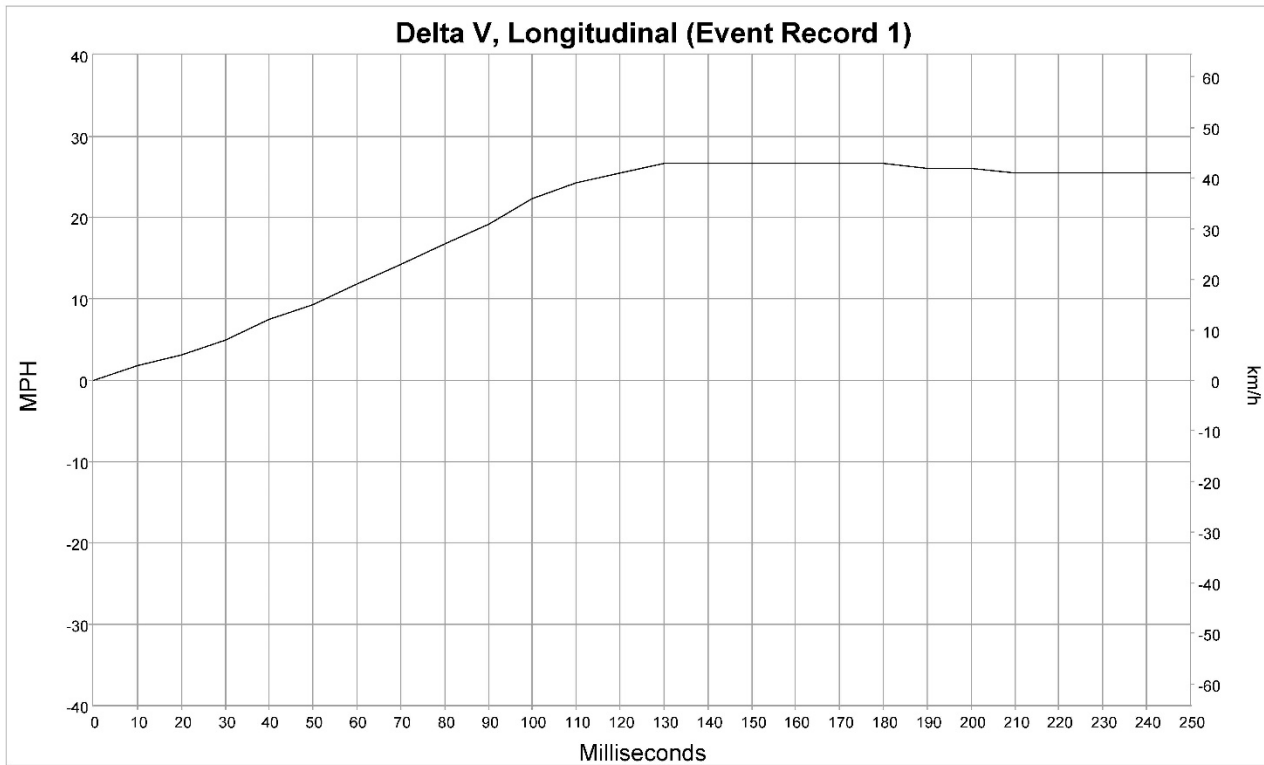
Longitudinal Delta V (Event Record 1)

The maximum longitudinal delta-V for the first event record was 43 km/h (27 mph) at 145 milliseconds after time zero. The maximum lateral delta-V was 7 km/h (4 mph) at 105 milliseconds after time zero. This was a left rear impact event, which correlated to Event 1 of the subject crash.

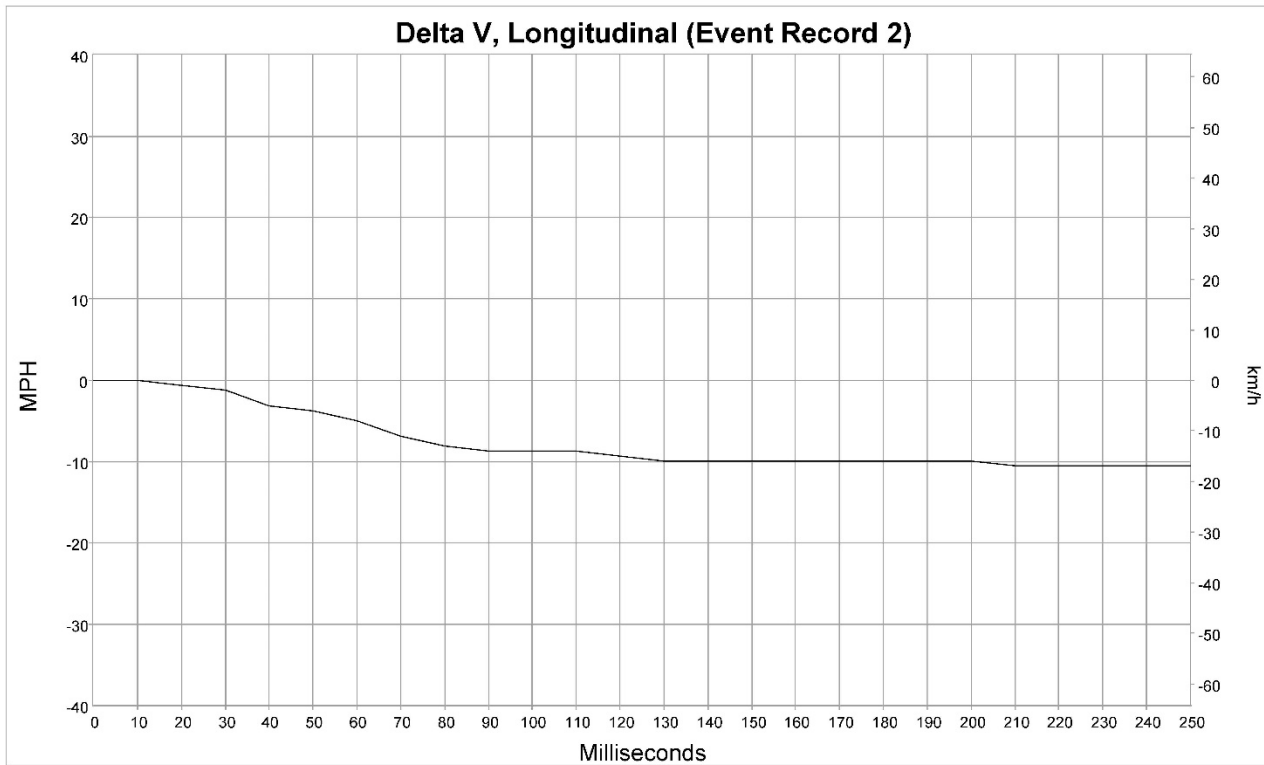
Longitudinal Delta V (Event Record 2)

The second event record reported a maximum longitudinal delta-V of -18 km/h (-11 mph) at 300 milliseconds and a maximum lateral delta-V of 7 km/h (4 mph) at 117.5 milliseconds. This was a front left impact event, which correlated to Event 2 of the subject crash. The reported time between the recorded events was 0.9-seconds.
