DOT HS 812 844

**Special Crash Investigations  
On-Site Small Overlap/Oblique  
Impact Investigation  
Vehicle: 2014 GMC Acadia  
Location: Missouri  
Crash Date: June 2016**

**Special Crash Investigations**  
**On-Site Small Overlap/Oblique Impact Investigation**  
**Case Number: IN16027**  
**Vehicle: 2014 GMC Acadia**  
**Location: Missouri**  
**Crash Date: June 2016**

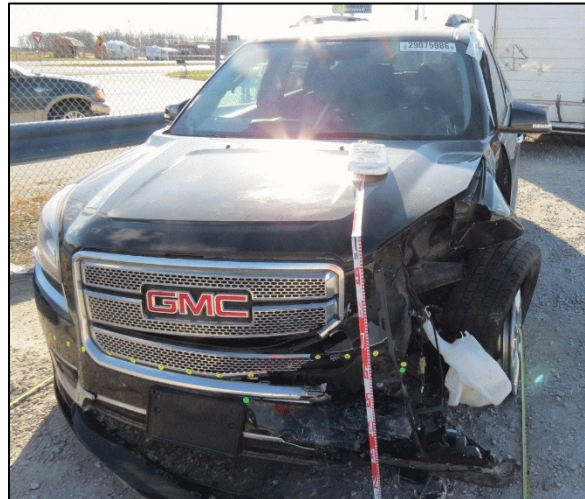
This report documents the on-site investigation of a small overlap/oblique impact to a 2014 GMC Acadia (**Figure 1**). This crash investigation was undertaken by the National Highway Traffic Safety Administration in November 2016, after the crash was identified by the Special Crash Investigation (SCI) team at the Indiana University Transportation Research Center through an online search of Missouri crash report abstracts. This investigation was assigned in November 2016, when permission for the vehicle inspection was obtained from the insurance company. The crash occurred in June 2016 at 1200 hours in the afternoon in Missouri and was investigated by a local police agency. The crash involved the GMC and a 2011 Chevrolet Cruze. The GMC and crash scene were inspected in November 2016. The Chevrolet could not be inspected since it was sold for salvage.

**Figure 1:** The damaged 2014 GMC Acadia

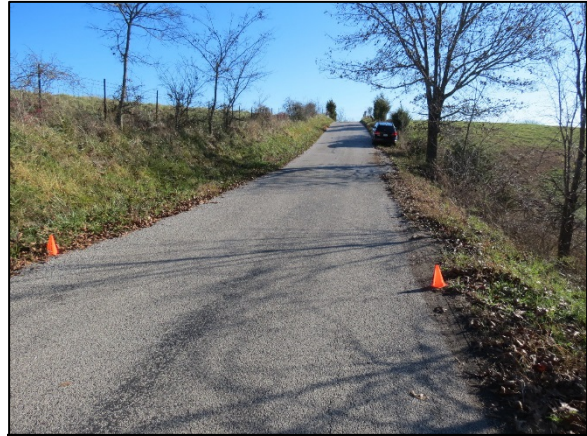
**Figure 2:** Eastbound approach of the GMC

The GMC was traveling east in the eastbound lane (**Figure 2**) and the Chevrolet was traveling west (**Figure 3**). Each vehicle was approaching a hillcrest and the Chevrolet was partially in the GMC’s travel lane. The GMC’s EDR reported the vehicle’s travel speed as 66 km/h (41 mph) at -5.0 sec prior to algorithm enable (AE) gradually decelerating to 58 km/h (36 mph) at -0.5 sec, which was the end of the pre-crash recording. The GMC crested the hill as the Chevrolet was approaching the hillcrest.

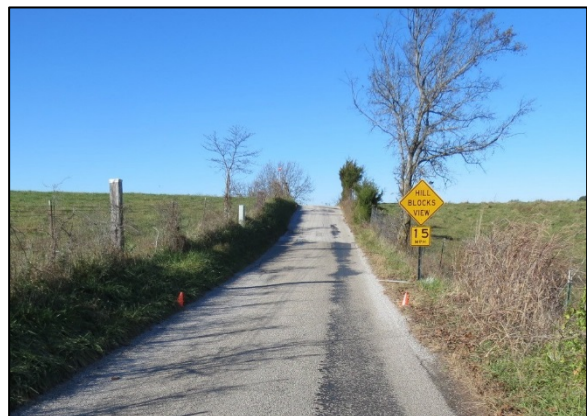
**Figure 3:** Westbound approach of the Chevrolet

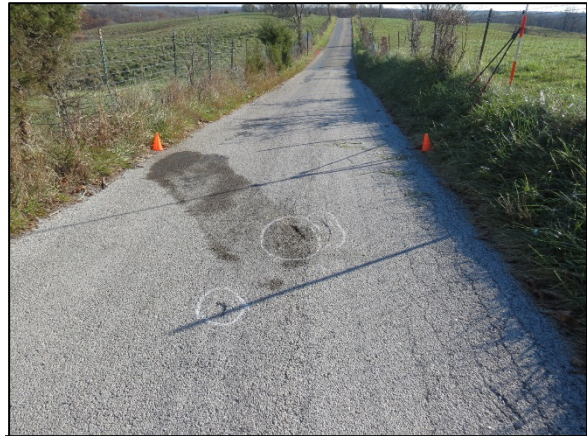
The front left corner of the Chevrolet struck the front left corner of the GMC (Event 1). The impact occurred 0.4 m (1.3 ft) into the GMC's travel lane (**Figure 4**). The impact resulted in stage 1 and 2 deployment of the GMC's driver's frontal air bag and deployment of the both IC air bags. The vehicle's EDR reported the maximum longitudinal and lateral velocity changes as -42 km/h (-26 mph) and 3 km/h (2 mph), respectively. The missing vehicle algorithm of the WinSMASH program calculated the GMC's total delta-V as 15 km/h (9 mph). The longitudinal and lateral velocity changes were -15 km/h (-9 mph) and 0 km/h (1 mph), respectively.

**Figure 4:** View east to point of impact in GMC's travel lane

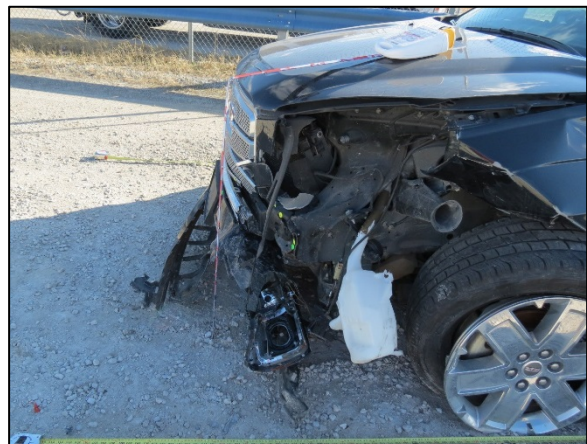
The front and left planes of the GMC were damaged during the impact with the Chevrolet. The direct damage to the front plane of the GMC involved the left corner of the front bumper, grille, and headlamp/turn signal assemblies. The direct damage was 50 cm (19.6 in) long beginning at the left corner of the bumper fascia. The Field L was 126 cm (49.6 in) long and began at the same location. The direct damage also extended onto the left fender and left front wheel. Crush measurements were taken on the bumper bar and the maximum residual crush was 8 cm (3.1 in) occurring at C<sub>1</sub>, which was located at the left stub frame rail (**Figure 5**). The crush values were: C<sub>1</sub> = 8 cm (3.1 in), C<sub>2</sub> = 3 cm (1.2 in), C<sub>3</sub> = 0 cm, C<sub>4</sub> = 0 cm, C<sub>5</sub> = 0 cm, C<sub>6</sub> = 0 cm.

**Figure 5:** Left side view of the crush to the GMC’s bumper bar

The Collision Deformation Classification (CDC) was 12FLEW1 (0 degrees). The severity of the damage was moderate.

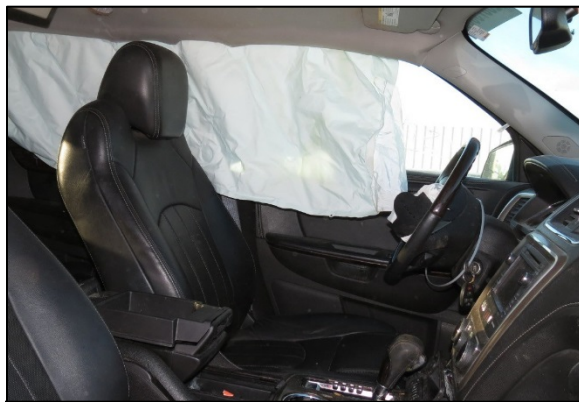
The IC air bags were located along the roof side rail inside the headliner and extended from the A-pillar to the D-pillar. The deflated left IC (**Figure 6**) was 225 cm (88.6 in) wide and 47 cm (18.5 in) high. The deflated IC extended 17 cm (6.7 in) below the beltline. There was a triangular-shaped gap between the front of the IC and the A-pillar that was 38 cm (15.0 in) wide at the beltline and 47 cm (18.5 in) high at the front of the IC. There was no discernable evidence of occupant contact to the left IC and no damage. The right IC was the same dimensions at the left. It sustained no damage during the crash.

**Figure 6:** The GMC's deflated left IC air bag

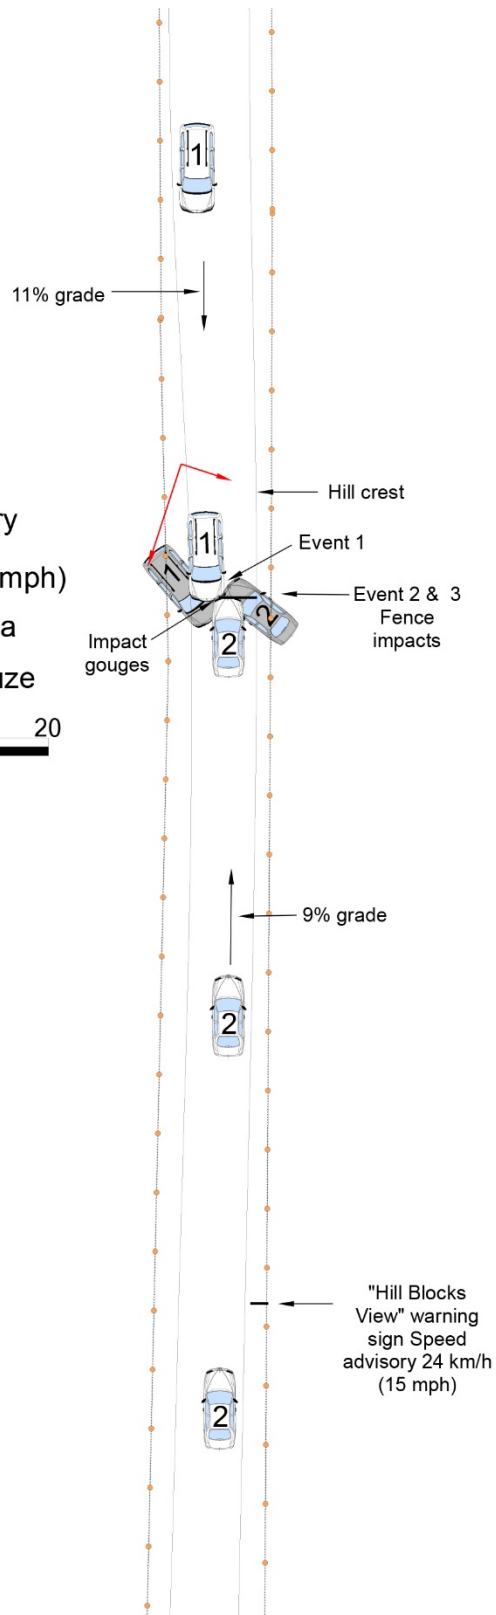
# CRASH DIAGRAM

Daylight, Clear and Dry  
 Speed Limit 32 km/h (20 mph)  
 1 = 2014 GMC Acadia  
 2 = 2011 Chevrolet Cruze

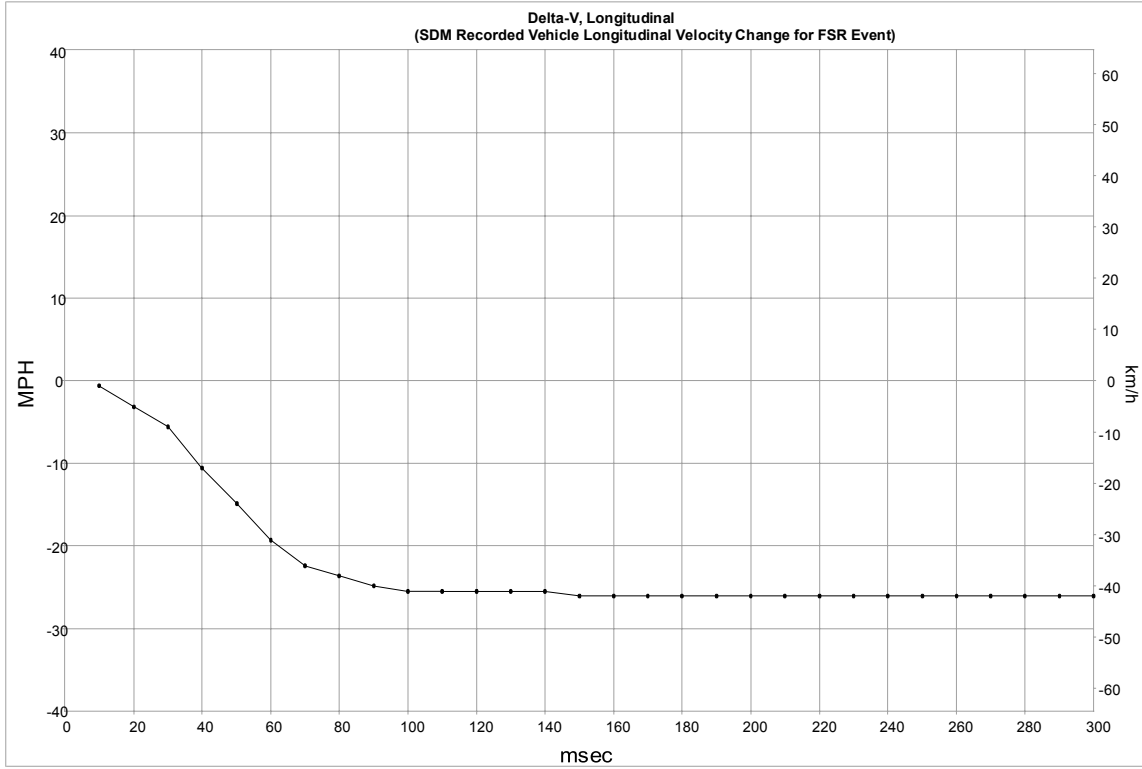
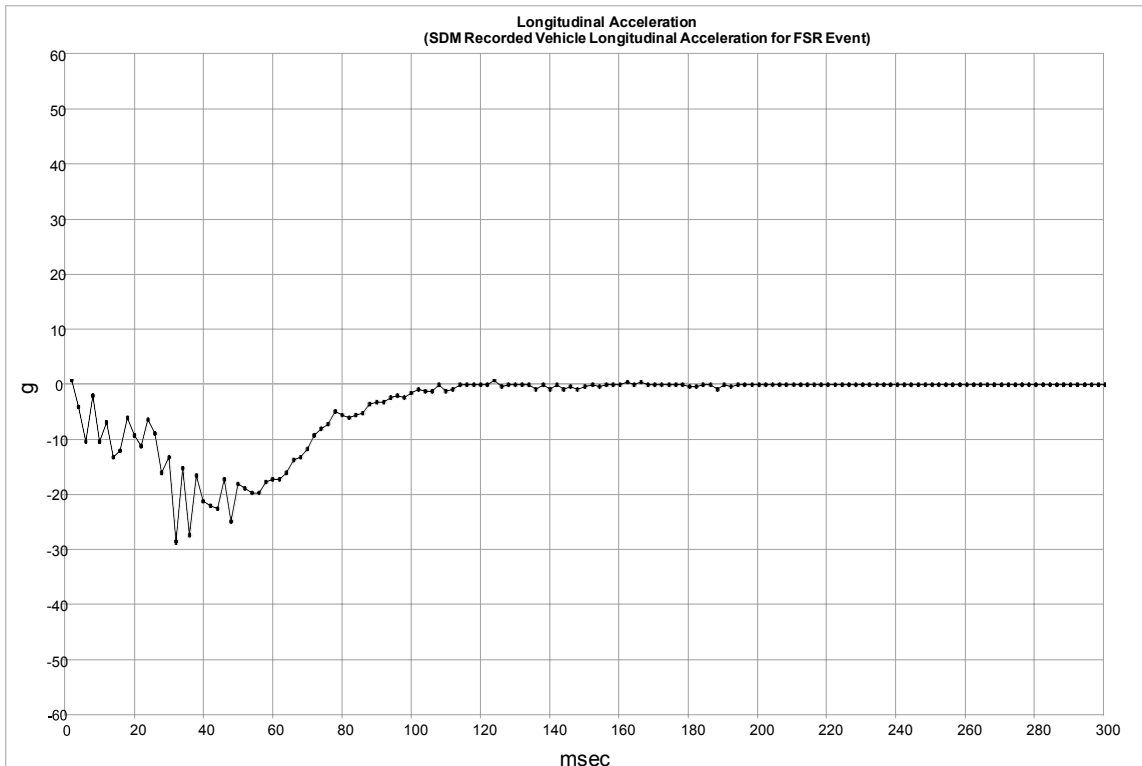
### Longitudinal Crash Pulse (Event Record 1)

Maximum Delta-V, Longitudinal (Maximum Longitudinal SDM Recorded Vehicle Velocity Change for FSR Event) MPH [km/h]	-26 [-42]
Time, Maximum Delta-V (Time From FSR Time Zero to Maximum Longitudinal SDM Recorded Vehicle Velocity Change)(msec)	196
Maximum Delta-V, Lateral (Maximum Lateral SDM Recorded Vehicle Velocity Change for FSR Event) MPH [km/h]	2 [ 3]
Time Maximum Delta-V, Lateral (Time From FSR Time Zero to Maximum Lateral SDM Recorded Vehicle Velocity Change)(msec)	146
