DOT HS 812 848

# **Special Crash Investigations On-Site Ambulance Crash Investigation**

**Vehicle: 2016 Ford F-450 Type I  
Ambulance**

**Crash Date: February 2018**

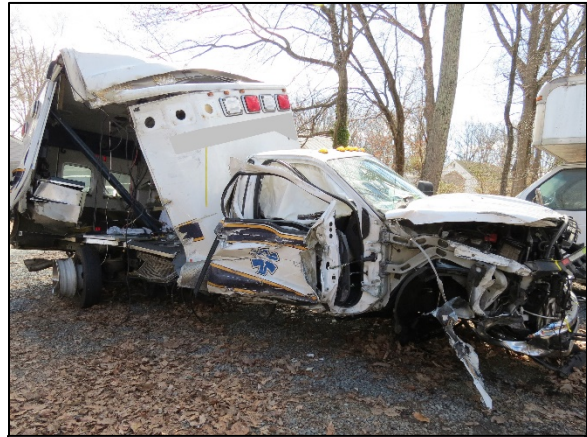
This report documents the on-site investigation of a 2016 Ford F-450 Type I ambulance (**Figure 1**) that crashed into the rear of a tanker semi-trailer that was stopped at a controlled intersection. The ambulance was staffed by a crew of three career emergency medical services (EMS) professionals who were in the process of transporting a patient in a non-emergency mode (without the use of emergency warning lights or siren) for mental health treatment. The 29-year-old belted male driver and 24-year-old belted female front right passenger sustained B-level (non-incapacitating) injuries, the belted 26-year-old male EMS

**Figure 1:** Right front oblique view of the 2016 Ford F-450 Type I ambulance at the time of the SCI inspection.

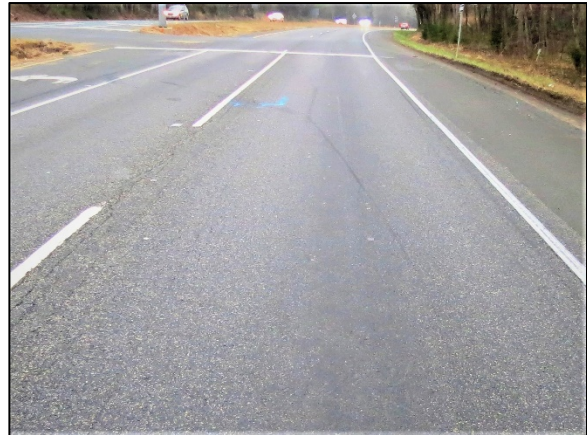
The ambulance's right front tire mark and area of initial impact (highlighted on the roadway by blue marking paint) is depicted in **Figure 4**. The ambulance's front plane, right aspect struck the tanker's back plane, left aspect. Due to the abrupt steering input by the ambulance's driver immediately prior to impact, the associated forces were in the 1 o'clock sector for the Ford ambulance and the 6 o'clock sector for the tanker trailer. The right corner of the Ford's cab engaged the outer left rear wheel/tire of the trailer, while the leading right corner aspect of the patient compartment module engaged the rear plane of the cylindrical tank. Associated forces produced significant deformation to the patient compartment module of the ambulance, and the engagement of the vehicles induced a clockwise rotation to the Ford ambulance.

**Figure 4:** East-facing view of the ambulance's right front tire mark across the right (outboard) travel lane.

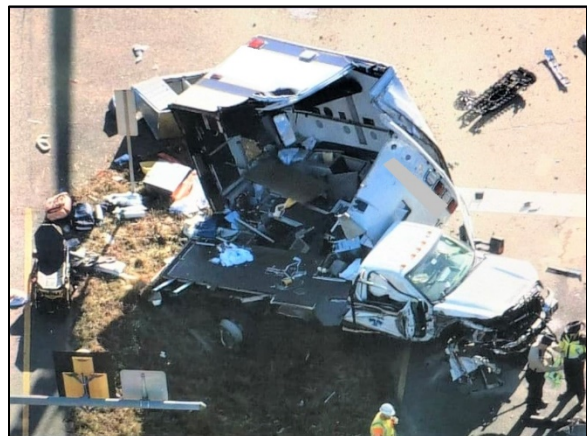
**Figure 5:** View of the ambulance at final rest (*on-scene image obtained from an online news source*).

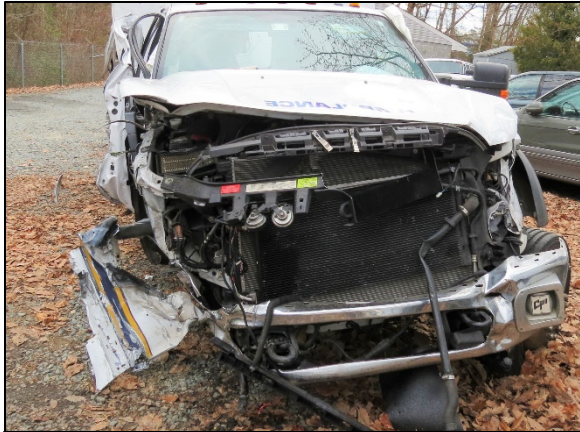
A residual crush profile of the front plane was obtained using a direct and induced damage length (Field-L) across the entire 176 cm (69.3 in) width of the damaged bumper beam. The center of the Field-L was the vehicle's centerline, while the direct damage center was located 68 cm (26.8 in) right of center. Accounting for free space due to the contour of the bumper beam, the profile produced the following resultant measurements for the Event 1 damage pattern: C1 – C4 = 0 cm

(0 in), C5 = 4 cm (1.6 in), and C6 = 33 cm (13.0 in). The direct damage extended down the right plane of the ambulance.

**Figure 7:** Front plane view of the 2016 Ford F-450 and its front plane damage profile.

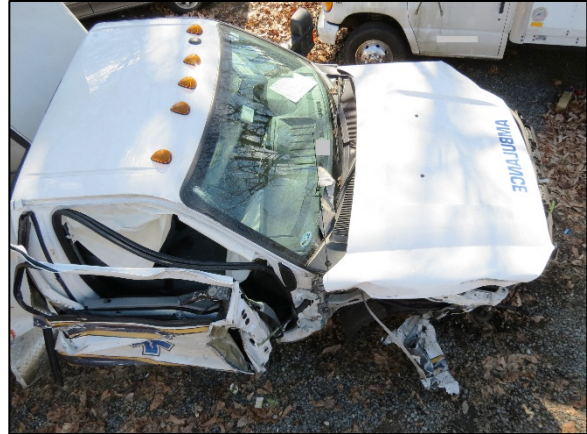
SCI reconstruction of the crash determined that the right front tire/wheel of the Ford ambulance engaged the left rear dual tires/wheels of the tanker semi-trailer, which sheared the right front tire/wheel from the Ford. The irregular shape of the damage pattern to the Ford's front plane (Figure 7) matched the profile of the semi-trailer's rear plane. The damage extended longitudinally down the right plane of the Ford (Figure 8).

**Figure 8:** Right overhead perspective view of the ambulance cab and the magnitude of the damage extent.

The Truck Deformation Classification (TDC) assigned to the Ford for the impact with the rear plane of the tanker semi-trailer was 01FRAE9. No WinSMASH calculations could be performed because the corner impact type and vehicle model were beyond the scope of the model.

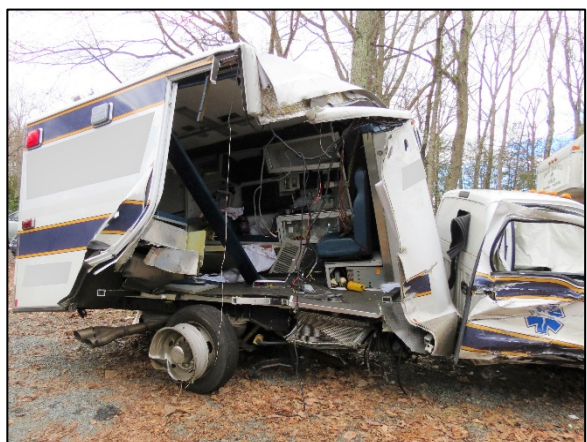
The front right aspect of the patient compartment also engaged the rear plane of the semi-trailer. This contact sheared the entire front half of the right wall off of the patient compartment, and produced extensive damage to the patient compartment module. The right rear dual tires/wheels of the ambulance also engaged the left rear dual tires/wheels of the semi-trailer, which contributed to the ambulance's clockwise rotation, sheared the outer right rear tire from the ambulance, and deformed the Ford's wheelbase dimensions. Figure 9 depicts the right plane of the ambulance at the time of the SCI inspection.

**Figure 9:** Right plane view of the Ford ambulance and the damage to the patient compartment.

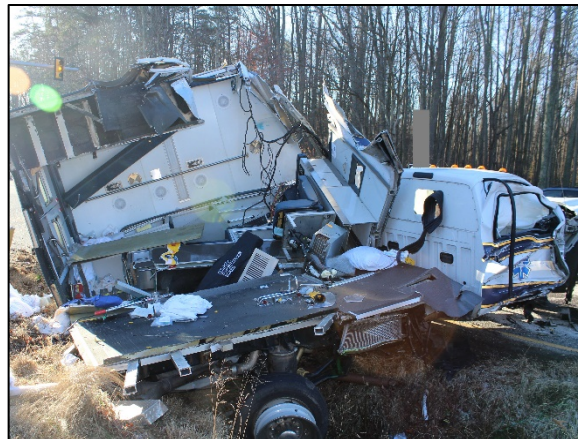
The first impact event with the tanker semi-trailer compromised the integrity of the patient compartment module by separating the walls from the floor structure on the right, front, and rear planes of the patient compartment. During the later stages of the crash, the entire top and sides of the patient compartment module rolled to the left off of the frame, exposing the entire interior to the outside environment. This damage was evident in the on-scene images provided by the investigating law enforcement agency (**Figure 10**).

**Figure 10:** Right plane view of the Ford and patient compartment remnants (*on-scene law enforcement image*).

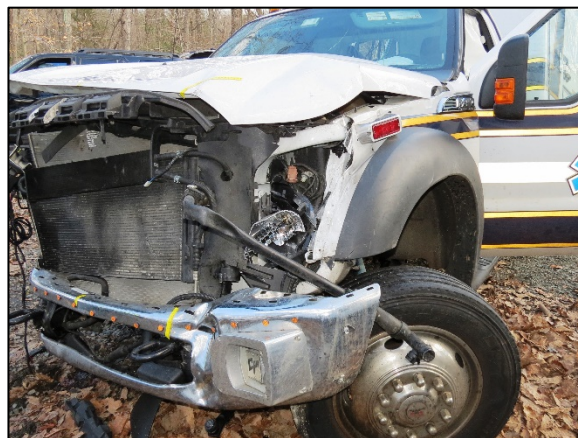
The second impact event with the Dodge produced minor damage to the left aspect of the Ford's front plane. Direct contact began 43 cm (16.9 in) left of center on the bumper beam and extended 45 cm (17.7 in) to the left front bumper corner. On the hood, the damage began 50 cm (19.7 in) left of center and extended to the left corner. A small area of red paint transfer was observed on the left front corner of the hood. The left front headlight assembly was disintegrated, and there was minor deformation to the hood and bumper beam (**Figure 11**) which evidenced the Ford's engagement with the Dodge.

**Figure 11:** Left front damage to the Ford associative to the impact with the Dodge.

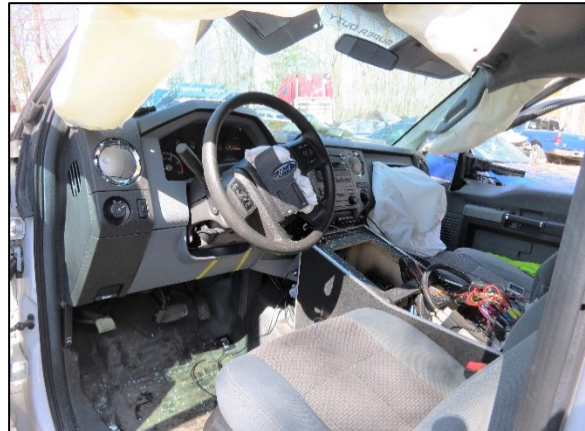
There was minor damage to the interior of the Ford's cab; however, there was extensive damage to the interior of the patient compartment. The focal damage in the cab was related to intrusion/integrity loss of the right front door, occupant contact, and supplemental restraint (air bag) deployment. There was also a small scuff to the left lower instrument panel associative to contact from the driver's right knee (**Figure 12**). The first impact event with the tanker semi-trailer included longitudinal forces that captured the forward aspect of the right front door and displaced it rearward. This separated the hinges from the right lower A-pillar. Subsequent rearward displacement of the door crushed its rear aspect, which collapsed the latch around the striker.

**Figure 12:** Crossing view of the ambulance cab interior, with the driver knee contact to the left lower instrument panel identified by yellow marking tape.

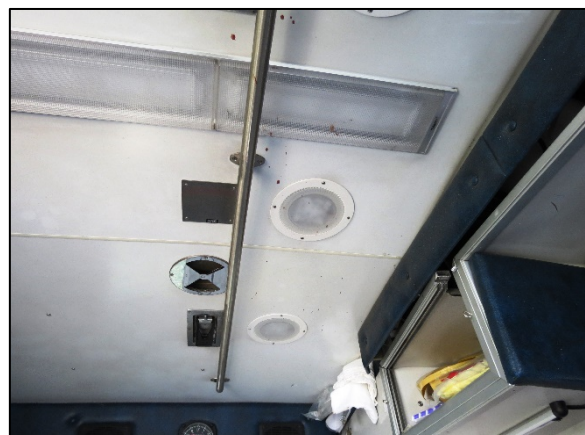
Significant damage to the patient compartment module of the ambulance was related to the engagement with the tanker semi-trailer during the first impact event, and included the complete separation of the forward, right, and rear planes from the floor. The entire stack of cabinetry original located at the forward right corner of the interior was missing. Further integrity loss included the separation of the right entry door and its frame. It was apparent to the SCI investigator, based on the impact dynamics and the observed damage that the cot and patient were likely contacted and displaced by front cabinetry and patient compartment walls as the separation of the patient compartment module occurred during the crash. With the separated cabinetry missing, the SCI investigator was unable to document any contact evidence on the cabinets to support such dynamics. However, blood splatter observed on the ceiling of the interior support the SCI investigator's conclusion (**Figure 13**).

**Figure 13:** Rear-facing view of directional blood splatter on the ceiling of the patient compartment.

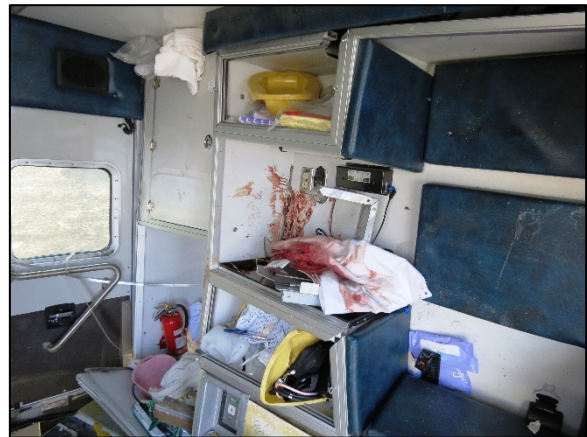
The only other evidence related to the occupants and their kinematics was an area of pooled blood on the left wall, aft of the CPR seat position (**Figure 14**). This evidenced the final rest position of the patient. She was found post-crash lying face down, still buckled by the lateral restraint straps of the cot and with the cot on top of her.

**Figure 14:** View of the left wall and pooled blood that evidenced the patient occupant's final rest position.

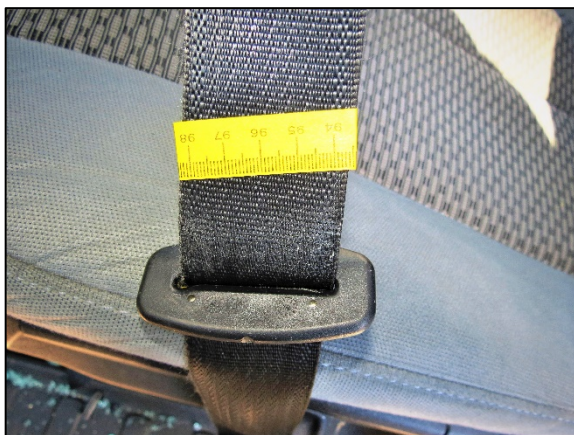
The driver's seat belt webbing was extended from the retractor, with the webbing hanging loosely against the seatback. Definitive abrasions in the polymer surface in the belt path of the latch plate evidenced driver loading during the crash, and corresponded to polymer transfer on the webbing (**Figure 15**). The front right seat belt system was also found hanging loosely and extended from the retractor, with similar loading abrasions on the latch plate. The webbing between the latch plate loading and the D-ring was waffled (**Figure 16**), and evidenced occupant loading from the crash. Based on the SCI investigator's observations, it was evident that the driver and front right passenger were both restrained by the manual seat belt systems at the time of the crash. This determination was supported by the data imaged from the Ford's EDR.

**Figure 15:** Latch plate loading transfer on the webbing of the Ford's driver safety belt system.

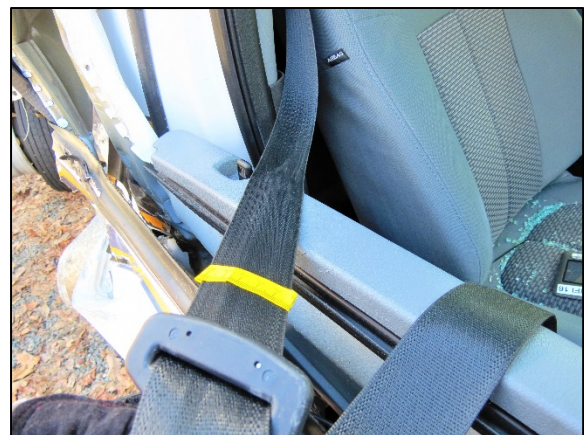
**Figure 16:** View of the front right passenger's safety belt system and loading evidence.

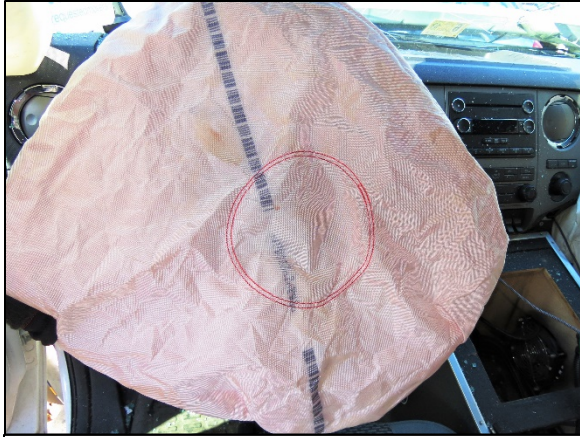
The driver's frontal air bag deployed from the module without damage. It was internally tethered, with a pair of 2 cm (0.8 in) diameter vents on the back side of the bag. A discolored scuff, attributed to driver face contact, was located at the 12 o'clock position immediately above the outer circumference of the center stitch pattern (**Figure 18**).

**Figure 18:** Deployed driver's frontal air bag in the Ford ambulance.

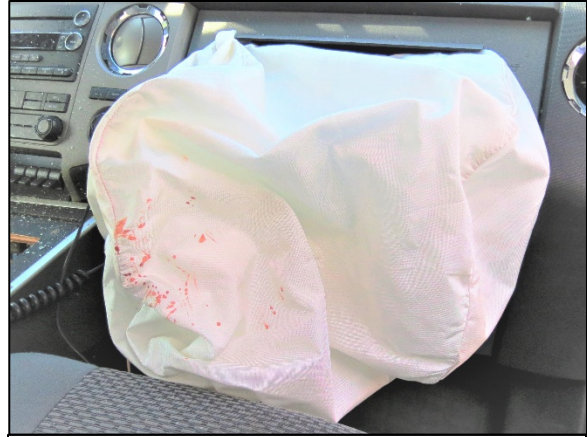
**Figure 19:** View of the deployed passenger's frontal air bag at the time of the SCI inspection.

The passenger's frontal air bag also deployed without damage during the crash. Although there was no discernable loading evidence on the air bag, an area of splattered red liquid was observed on the left half of the air bag's face (**Figure 19**). The SCI investigator was unable to determine either the specific type of substance splattered on the air bag or its source.

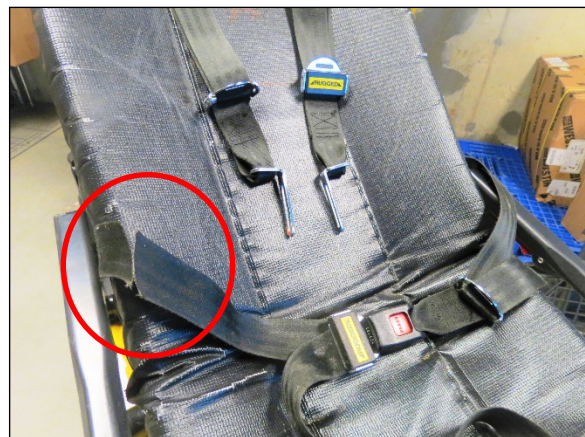
At the time of the SCI inspection, the three lateral straps had all been cut adjacent to the right side of the cot, and their latch plates remained engaged in their respective buckles. The shoulder harness straps hung loosely, were not damaged, and were not buckled in the lateral chest strap. This indicated to the SCI investigator that the shoulder straps were not in use at the time of the crash. Only the lateral harness strap was used in the partial restraint of the cot occupant. **Figure 23** depicts the shoulder straps and lateral chest strap, with the cut location to the lateral strap visible on the right edge of the mattress platform.

**Figure 23:** Lateral chest strap buckled without the shoulder straps (cut location highlighted by the red circle).

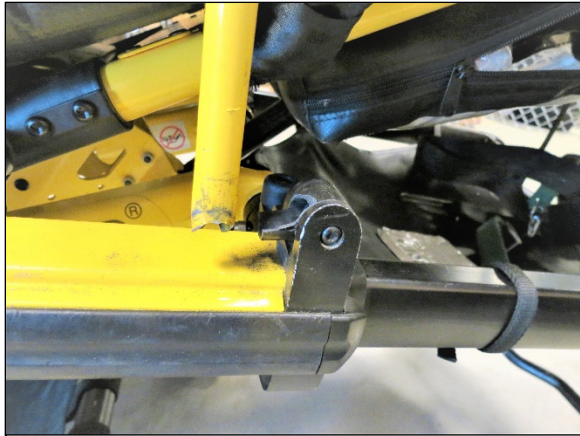
The patient cot sustained minor damage attributable to occupant loading and contact with displaced cabinets in relation to the crash event. The locking pin was slightly rotated on the right lower frame rail, evidentiary of the loading force exerted on it by the combined mass of the cot and patient during the crash. The forward support of the left arm rail was fractured (**Figure 24**), likely associative to contact with cabinetry while being displaced during the crash. There was also a few small gouges/tears in the fabric of the mattress at the top of the backrest, with a small area of blood transfer from the patient occupant (**Figure 25**).

**Figure 24:** View of the fractured left arm rail support.

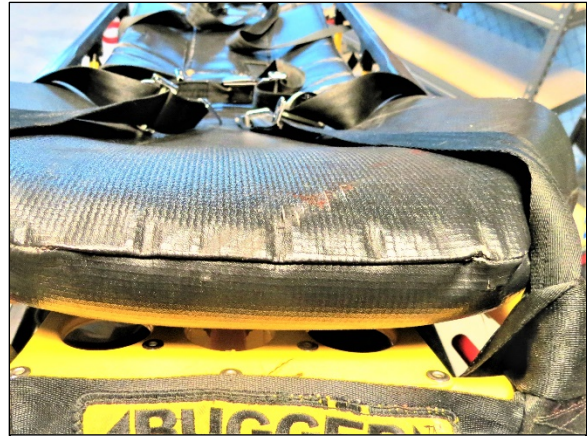
**Figure 25:** Blood transfer on top edge of cot mattress.

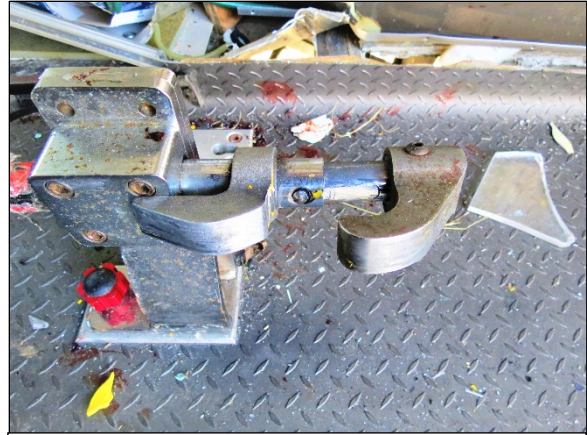
**Figure 27:** Disengaged locking clamp mechanism in the patient compartment.

The SCI investigator observed that the bolts of the antler bracket remained intact and the bracket was in place. However, it was crooked with respect to the alignment of the securement points, and the right aspect was deformed diagonally to the front and right (toward the direction of the primary impact forces). The rail clamp mounting bracket, bolts, and clamp mechanism also remained intact, with the clamp in the unlocked position. The SCI investigator concluded that the clamp had released during the crash. The occupant responded toward the frontal crash force and the back of her torso compressed against the mattress platform and inclined back support. This translated a loading force into the cot's frame. The moment of this force created a load at the locking clamp mechanism that forced the rail clamp open.

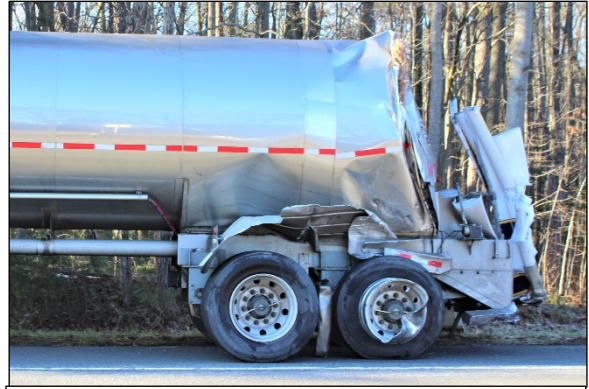
However, significant damage was sustained by the rear aspect of the tanker semi-trailer. The truck and semi-trailer were retained by their respective owners after the crash, and had returned to their out-of-State origin prior to SCI case assignment. Consequently, neither was available for SCI inspection. **Figure 28** depicts the combined unit at the crash site, while **Figure 29** depicts the damage pattern to the back of the tanker semi-trailer.

**Figure 29:** Left lateral view of the damage tanker semi-trailer (*on-scene law enforcement image*).
