U.S. Department  
of Transportation

**National Highway  
Traffic Safety  
Administration**

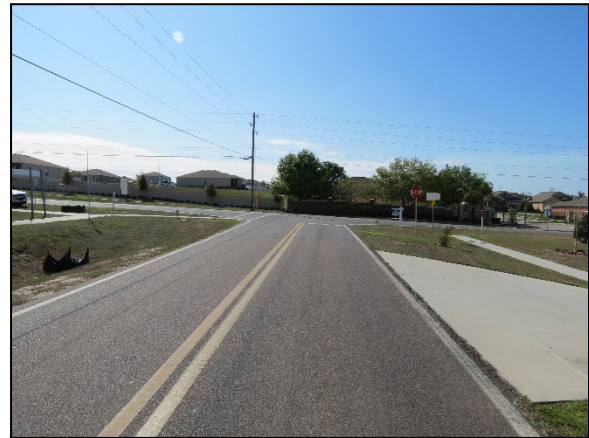
**Figure 2.** West-facing view of the Honda's pre-crash travel trajectory.

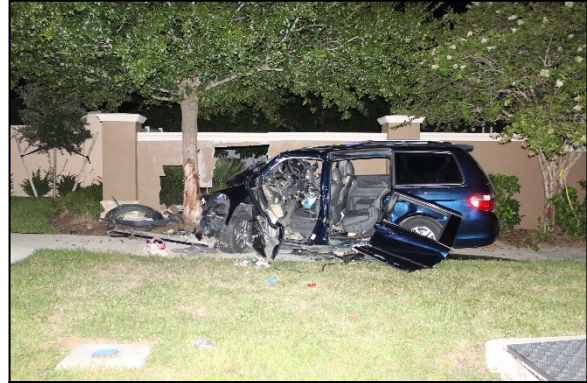
**Figure 4.** West-facing view toward the impacted wall and tree with the Honda at final rest (on-scene image provided by the investigating law enforcement agency).

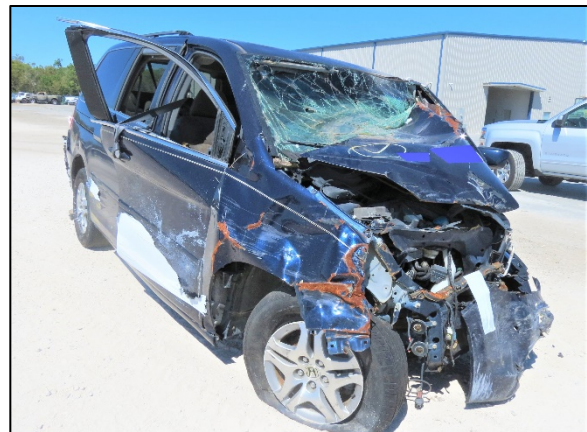
**Figure 5.** Front right oblique view of the Honda.

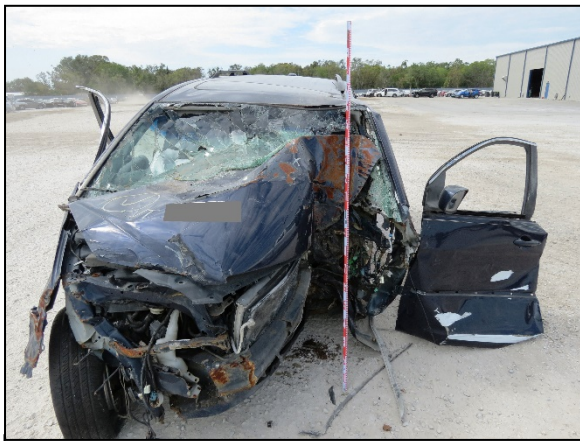
**Figure 6.** View of the front plane damage profile to the 2006 Honda Odyssey.

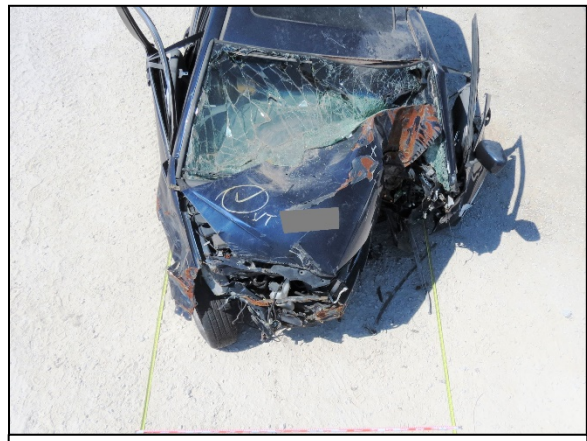
**Figure 7.** Deformation to the front plane of the Honda from an overhead perspective.

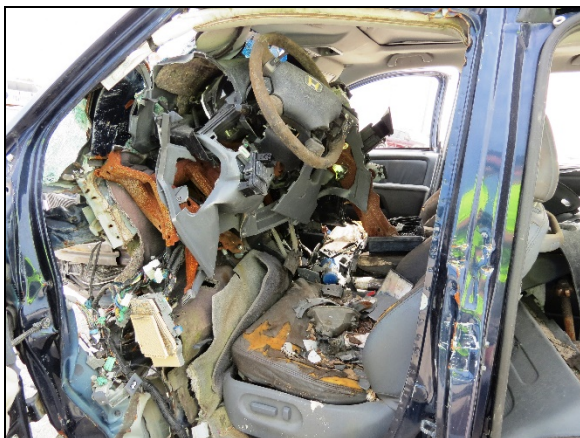
**Figure 8.** Crossing view of the Honda's driver position and surrounding intrusion from the left.

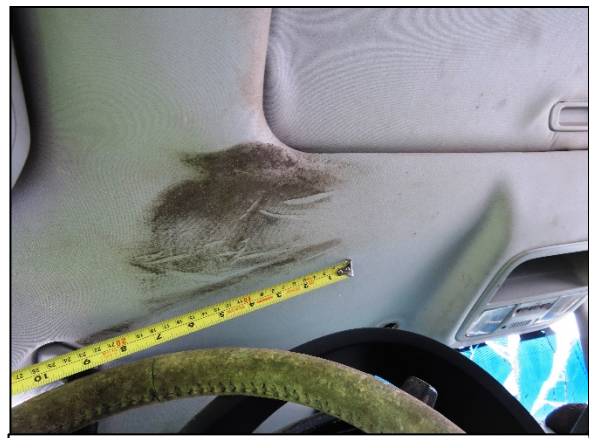
**Figure 9.** Area above the driver's seat position in the Honda, possibly from contact by the driver's head.

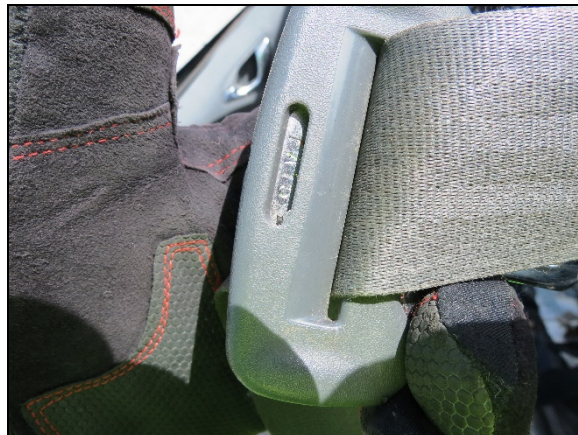
**Figure 10.** Latch plate of the Honda driver's seat belt system with minor loading abrasion evidence.

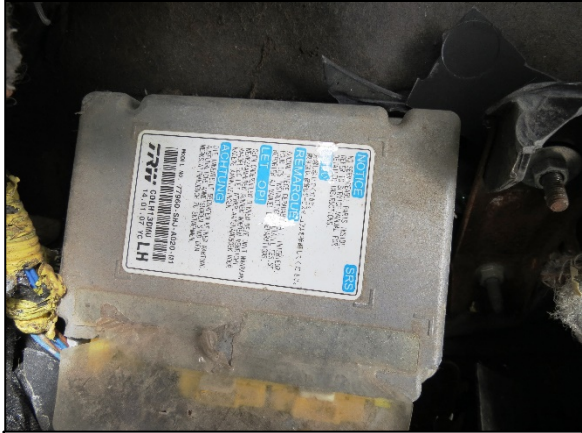
**Figure 11.** View of the Honda's exposed ACU beneath the center instrument stack during the SCI inspection.
