DOT HS 812 868

Special Crash Investigations: Alleged Inadvertent Air Bag Deployment Investigation; Vehicle: 2010 Nissan Versa; Location: California; Crash Date: July 2017

**Special Crash Investigations
Alleged Inadvertent Air Bag Deployment Investigation
Office of Defects Investigation
Case Number: DS17014
Vehicle: 2010 Nissan Versa
Location: California
Crash Date: July 2017**

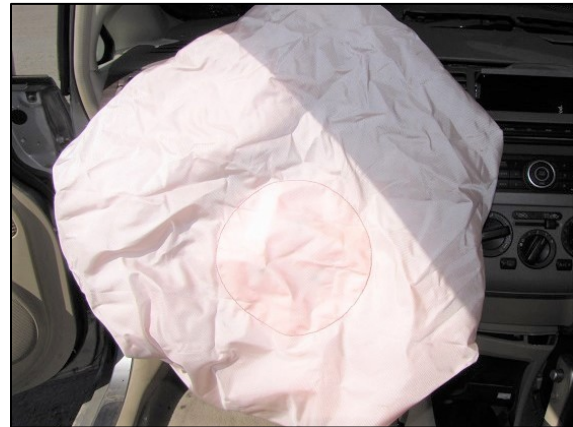
Figure 1. Deployed driver's frontal air bag, 2010 Nissan Versa.

The driver's frontal air bag deployed from the steering wheel hub. The air bag measured 56 cm (22.0 in) in diameter and was configured with two vent ports and two tethers. The cover flaps opened at their tear points and neither the air bag or cover flaps were damaged. The driver notification stated this air bag deployed inadvertently without warning or impact. The vehicle manufacturer initiated an investigation including an imaging of the EDR data and a vehicle inspection. The vehicle manufacturer concluded their analysis determined that the air bag deployed as a direct result of the frontal collision, as was evident in the EDR data, as large accelerations were recorded within 100 ms of T-0 for the frontal air bag deployment system. The Nissan was subject to an NHTSA recall for the air bag system in which a potential existed for inflator rupture. During the inspection, the inflator canister for the deployed frontal air bag was examined and photographed and it exhibited no such damage. The recall is examined further in the NHTSA Recalls and Investigations discussion of this report.

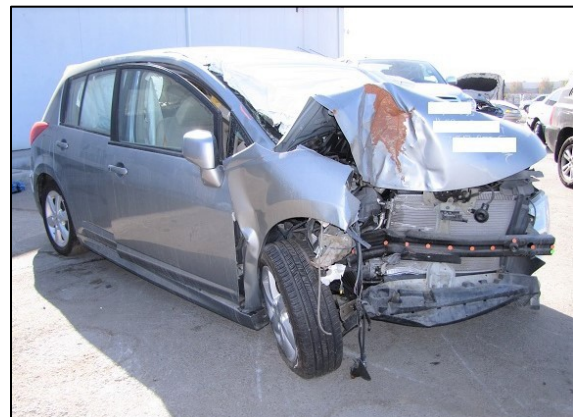
Figure 2. Front plane damage, 2010 Nissan Versa.

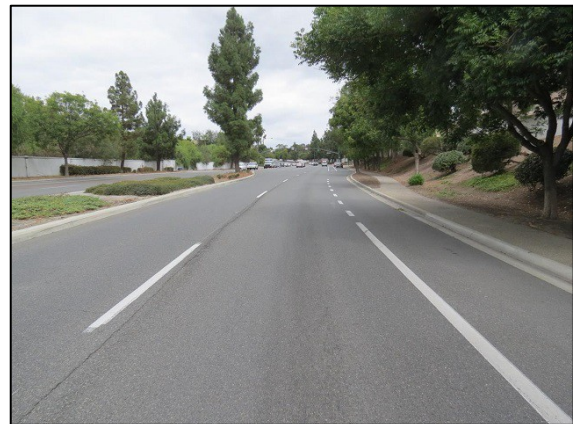
The crash site was the northbound lanes of a divided north/south asphalt surface street in California (**Figure 3**). The roadway configuration was initially two northbound lanes separated by a dashed white painted stripe. This section of roadway curved right at a radius of 400 m (1,312 ft). The curved section was followed by a straight section heading due north and the lanes expanded from two to five. From right to left, the configuration was a right turn lane, bike lane, two through lanes and two left turn lanes. The slope in the pre-crash section of roadway measured positive 1 percent. The right turn lane measured 3.3 m (10.8 ft) wide and was bordered by a raised concrete curb measuring 16 cm (6.3 in) high, a paved concrete sidewalk measuring 1.7 m (5.6 ft) wide on the right and a solid white painted stripe on the left. Mature trees lined the right roadside. The posted speed limit was 80 km/h (50 mph). Conditions were daylight, clear and dry. A crash diagram is included at the end of this report.

Figure 3. Crash site, pre-crash approach looking north.

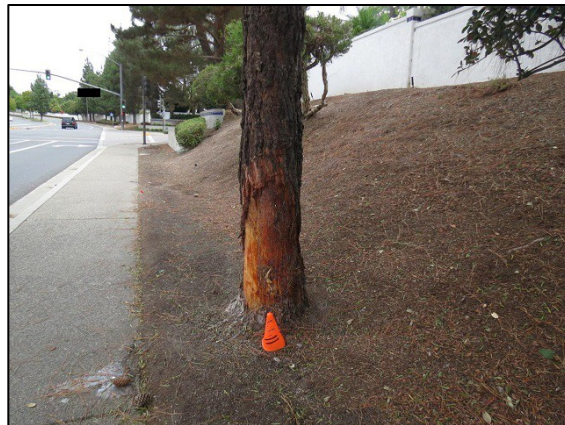
The Nissan departed the roadway on the right edge, traveled over the raised curb and across the paved sidewalk and its front plane struck a tree in a head-on configuration. The departure angle was calculated at approximately 10 degrees using the location of two marks on the curb deposited by the vehicle's right-side tires and the location of the struck tree. Distance traveled from roadway departure to impact was 10 m (33 ft). The Nissan initiated a post-impact, clockwise rotation of 60 degrees and came to rest against the tree and facing northeast. The tree measured 43 cm (17.0 in) in diameter. Damage caused by the impact measured to 90 cm (35.0 in) above ground on the trunk (**Figure 4**). This damage included displacement of bark but no fracturing or movement of the tree was documented.

Figure 4. Point of impact, looking north.

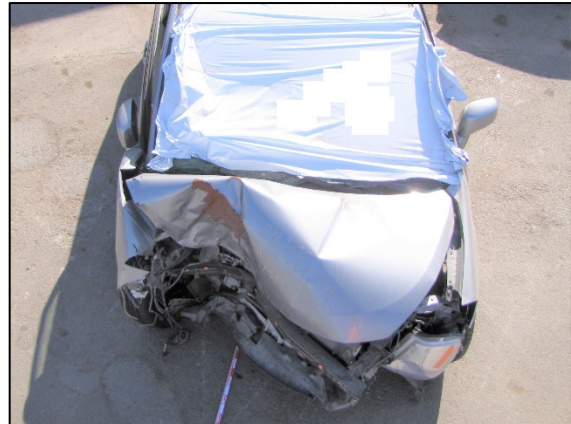
The Nissan sustained severe damage to the front plane damage caused by the impact with the tree (**Figure 5**). The front bumper fascia was displaced from the vehicle and the backing bar was used to measure direct damage and crush. The direct damage began at the front right bumper corner and extended 57 cm (22.5 in) to the left. The Field L extended from bumper corner to bumper corner and measured 107 cm (42.1 in). Thirteen measurements were taken at bumper level by the Nikon Total Station and the Faro Blitz program computed crush measurement in six increments as follows: $C_1 = 0$ cm, $C_2 = 25$ cm (9.8 in), $C_3 = 51$ cm (20.1 in), $C_4 = 78$ cm (30.7 in), $C_5 = 77$ cm (30.3 in), and $C_6 = 64$ cm (25.2 in). The calculated

Figure 5. Front plane damage, 2010 Nissan Versa.

PDOF was rounded to 0 degrees. Both frame rails were shifted 15 cm (5.9 in) to the right. The collision deformation classification for the Chevrolet in Event 1 was 12FZEW5.

The Nissan sustained additional front plane damage including displacement of the grille and right headlamp assembly. It sustained top plane damage including crumpling of the hood and right plane damage including crumpling of the right front fender and restriction of the right front tire. The engine and transmission were shifted rearward. The vehicle sustained undercarriage damage including the underbody and suspension. The damage was located on the right aspect between the front and rear axles. The fuel tank was not damaged. Direct damage to the undercarriage began 18 cm (7.1 in) aft of the right front wheel well extending longitudinally 80 cm rearward; it began 22 cm (8.7 in) left of the right sill extending laterally 30 cm (11.8 in) to the left. The direct damage consisted primarily of bent sheet metal, scuffs and scrape marks.
