U.S. Department  
of Transportation

**National Highway  
Traffic Safety  
Administration**

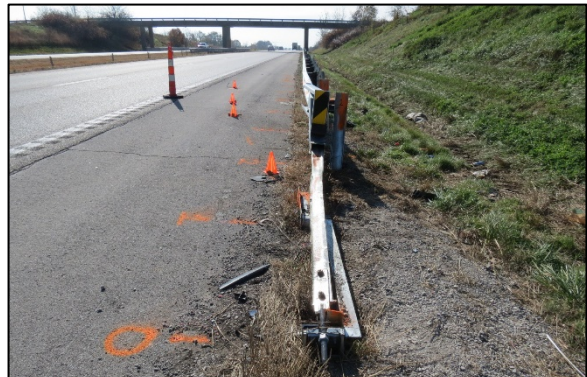
**Figure 1.** The damaged end terminal and guardrail, view south.

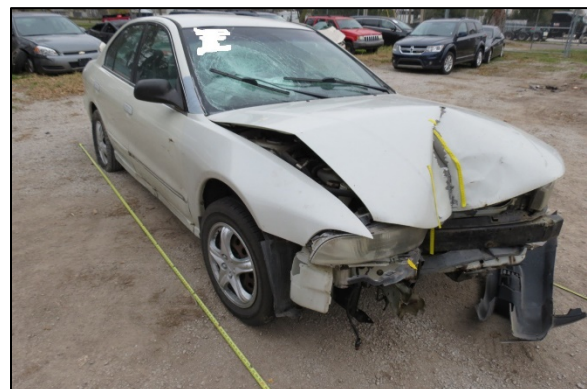
**Figure 2.** The damaged 2003 Mitsubishi Galant.

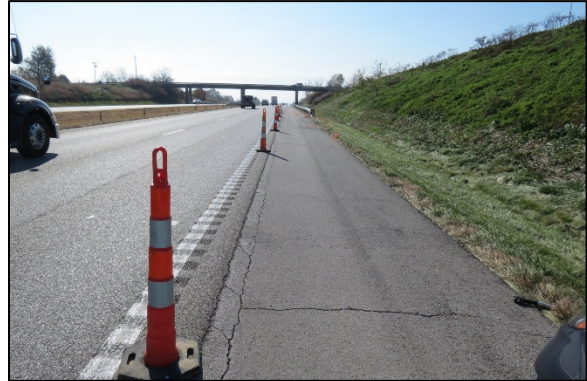
**Figure 3.** Approach of Mitsubishi to end terminal, view south.

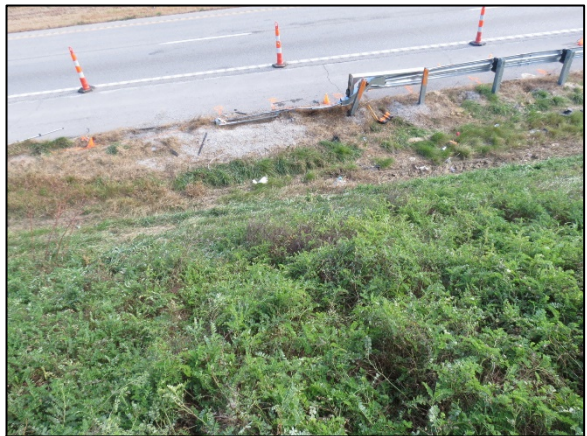
**Figure 4.** View east to damaged guardrail and final rest position of Mitsubishi.

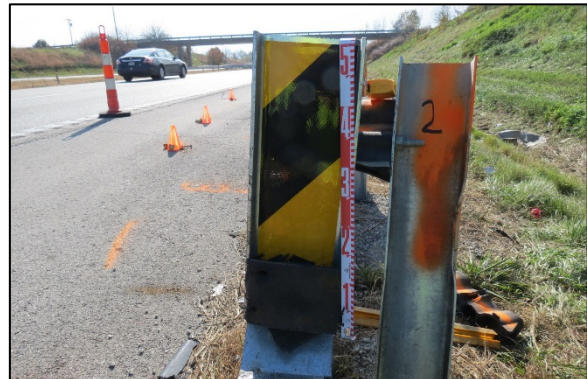
**Figure 5.** Face of end terminal.

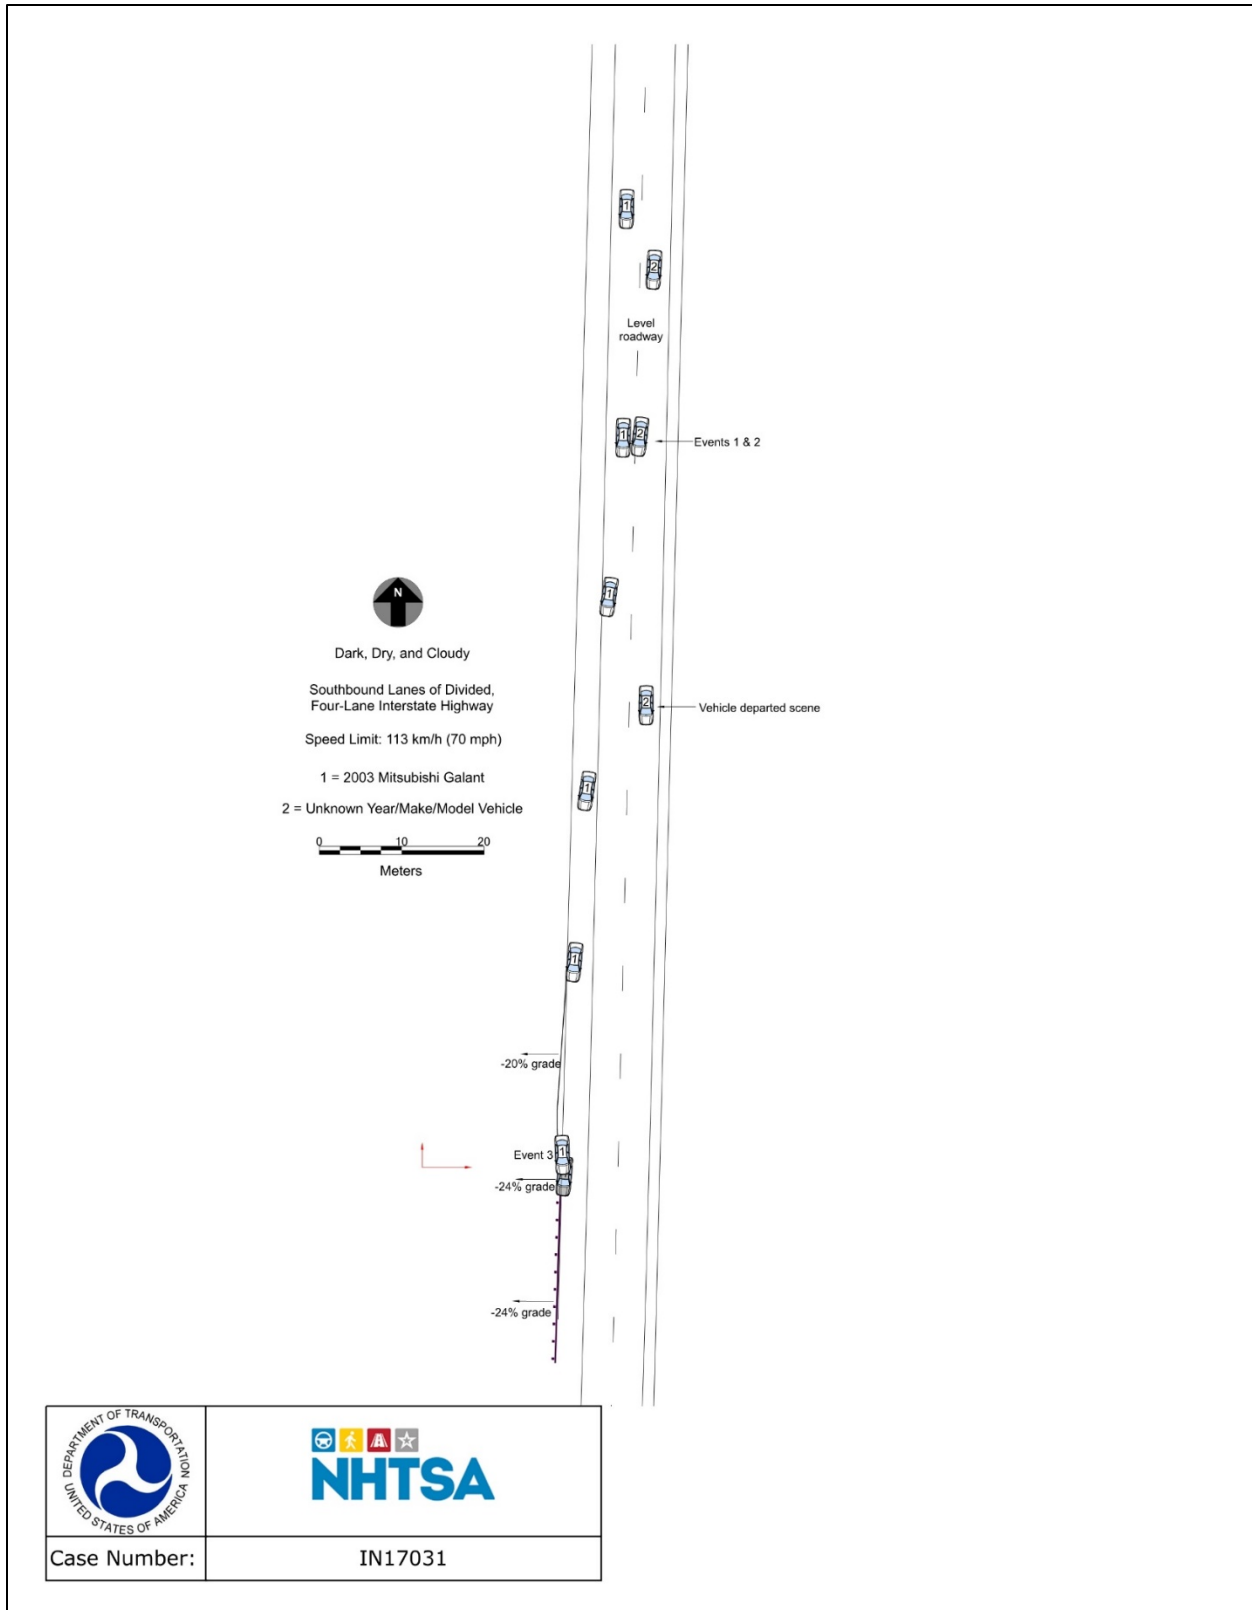
**APPENDIX A: FHWA Guardrail Form**
