DOT HS 812 896

**Special Crash Investigations
On-Site Guardrail End
Terminal Investigation;
Vehicle: 2011
Chevrolet Impala;
Location: Missouri;
Crash Date: January 2018**

SPECIAL CRASH INVESTIGATIONS
ON-SITE GUARDRAIL END TREATMENT INVESTIGATION
CASE NUMBER - IN18001
VEHICLE - 2011 CHEVROLET IMPALA
LOCATION - MISSOURI
CRASH DATE - JANUARY 2018

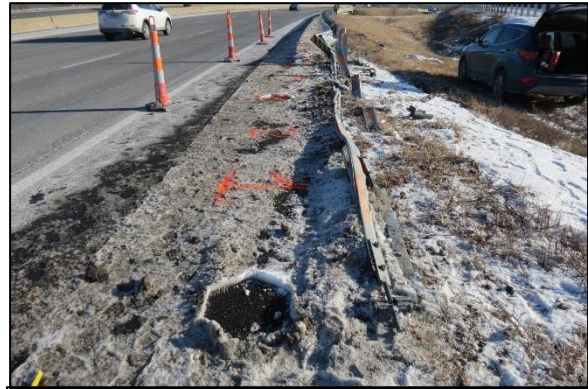
Figure 1: The damaged guardrail and end terminal, view northeast

The face of the end terminal was 18 cm (7 in) wide and 51 cm (20 in) high. It sustained minor damage (**Figure 6**). Posts 1 and 2 collapsed downstream to the ground and detached from the damaged guardrail. Posts 3, 4, 5, and 6 were all bent downstream and were detached from the damaged guardrail. Posts 7-12 were not damaged and remained attached to the guardrail.

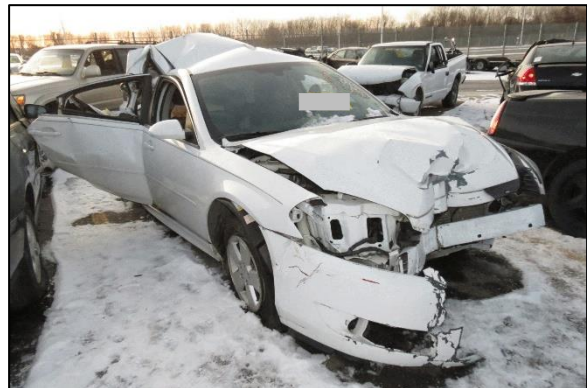
Figure 2: The damaged 2011 Chevrolet Impala

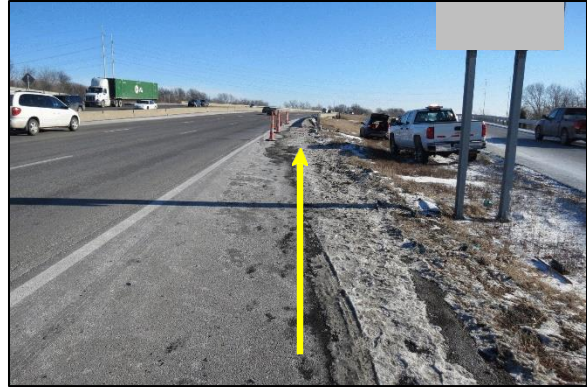
For unknown reasons, the Chevrolet traveled off the south road side (**Figure 3**) and the front plane (**Figure 4**) struck the end terminal. The force direction on the vehicle was in the 12 o'clock sector and the impact resulted in a stage one and two deployment of the driver's frontal air bag. The WinSMASH program could not be used to calculate delta V since a yielding object impact is out of scope for the program. However, WinSMASH was used to calculate a barrier equivalent speed (BES) of 38 km/h (24 mph) based on the damage to the front bumper. The vehicle's EDR reported the maximum longitudinal and lateral delta Vs as -34.40 km/h (-21.38 mph) and -1.14

Figure 3: Northeast approach to end terminal

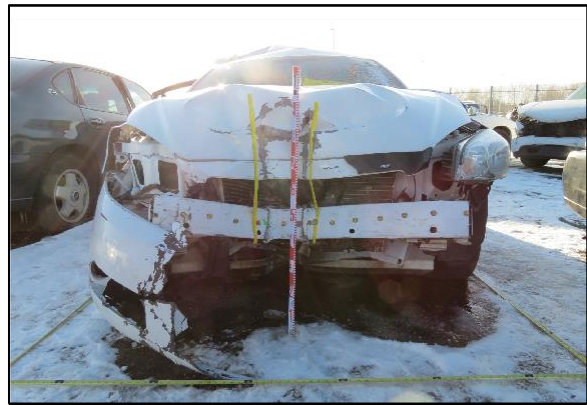
Figure 4: Damage to front plane of the Chevrolet from end terminal impact

The Chevrolet sustained damage to the front plane during the impact with the end terminal. The bumper fascia, bumper bar, hood, grille, and right head lamp/turn signal assembly were directly damaged. The direct damage began 59 cm (23.2 in) right of the left front bumper corner and extended 18 cm (7.1 in) to the right. The field L was 107 cm (42.1 in). The maximum residual crush was 40 cm (15.7 in) occurring 67 cm (26.3 in) right of the front left bumper corner. The crush values were: C1 = 9 cm, (3.5 in), C2 = 19 cm (7.4 in), C3 = 32 cm (12.6 in), C4 = 40 cm (15.7 in), C5 = 26 cm (10.2 in), C6 = 11 cm (4.3 in).

The collision deformation classifications (CDC) was 12FCEN2 (0 degrees). The severity of the damage was moderate.

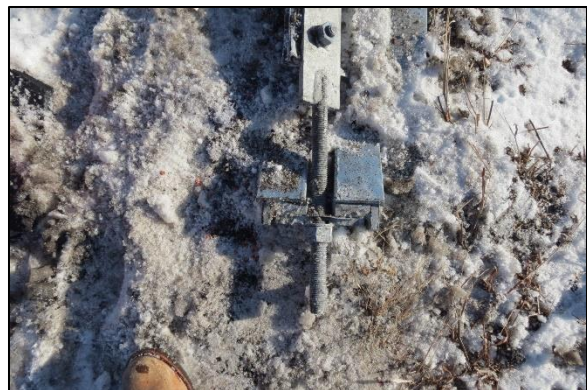
The front plane of the Chevrolet struck the guardrail head, which was mounted on top of an angular guide chute. The end of one section of guardrail 3.8 m (12.5 ft) long was routed through the guide chute and attached by a bolt to the ground anchor (Post 0, **Figure 5**). During an end terminal impact, these guardrail sections are designed to enter the upstream end of the terminal and pass through the chute, which is angled downward and rearward. The rail is extruded underneath the vehicle toward the ground and dissipated crash energy through compaction. During this crash, 8.0 m (26.4 ft) of

Figure 5: Anchor bolt secured to end of guardrail tab

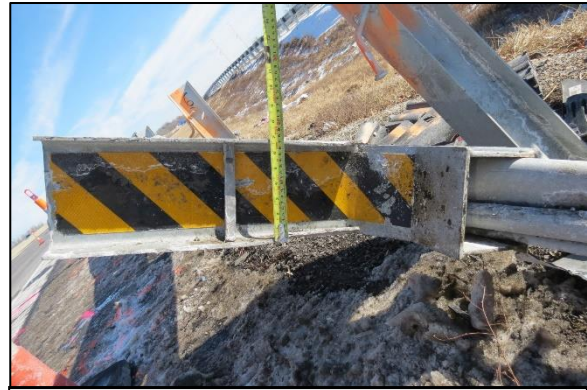
Figure 6: Soft Stop guardrail head
