DOT HS 812 903

# **Special Crash Investigations On-Site Guardrail End Terminal Investigation Vehicle: 2001 Buick LeSabre Location: Missouri Crash Date: March 2017**

**Special Crash Investigations**  
**On-Site Guardrail End Terminal Investigation**  
**Case Number - IN17014**  
**Vehicle - 2001 Buick Lesabre**  
**Location – Missouri**  
**Crash Date - March 2017**

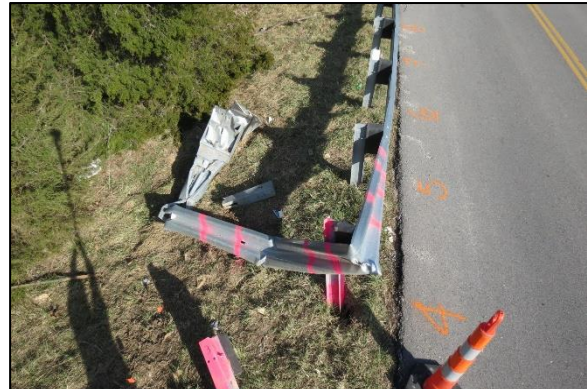
This on-site investigation documents a passenger vehicle impact to a Sequential Kinking Terminal (SKT) guardrail end terminal (**Figure 1**) that is of interest to the Federal Highway Administration (FHWA). This crash was identified by an engineer with the Missouri Department of Transportation (MoDOT), who submitted photographs of the damaged guardrail end terminal to the FHWA. The FHWA determined that the guardrail end terminal and crash type were of interest for further research. This crash investigation was then initiated by the National Highway Traffic Safety Administration in March 2017 and assigned to the Special Crash Investigations team at the Indiana University Transportation Research Center. This single-vehicle crash involved a 2001 Buick LeSabre (**Figure 2**). The crash occurred in Missouri in March 2017 in the evening and the crash scene, guardrail, and vehicle were inspected in the same month.

**Figure 1:** Overhead view of the damaged end terminal and guardrail

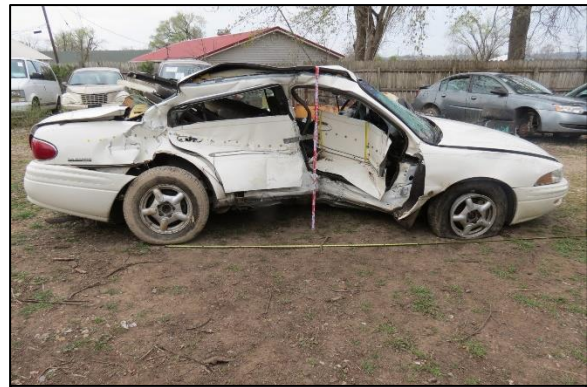
**Figure 2:** The damaged 2001 Buick LeSabre

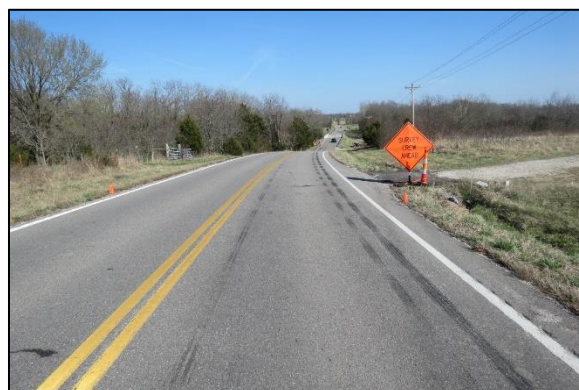
**Figure 3:** Eastbound approach of the Buick to the area of lane departure

The driver of the Buick was traveling eastbound and was negotiating a right curve. The vehicle drifted left and crossed the centerline into the westbound lane (**Figure 3**). The driver initiated a right steering maneuver and crossed back into the eastbound lane. The police reported the onset of tire marks from the left side tires in the westbound lane that were located 132.0 m (433.0 ft) from the impact with the guardrail end terminal. The driver initiated a left steering maneuver as the vehicle reentered the eastbound lane and the Buick began to yaw counterclockwise. The vehicle traveled 32.3 m (105.9 ft) in a northeast direction across the roadway (**Figure 4**) as it continued to yaw counterclockwise and departed the left (north) side of the road. The vehicle continued for an additional 4.8 m (15.7 ft) to impact with the guardrail end terminal with the front portion of the vehicle off-road.

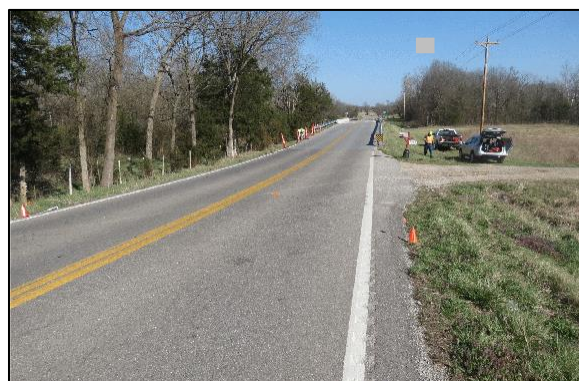
**Figure 4:** View northeast to area of onset of yaw marks and approach to end terminal impact

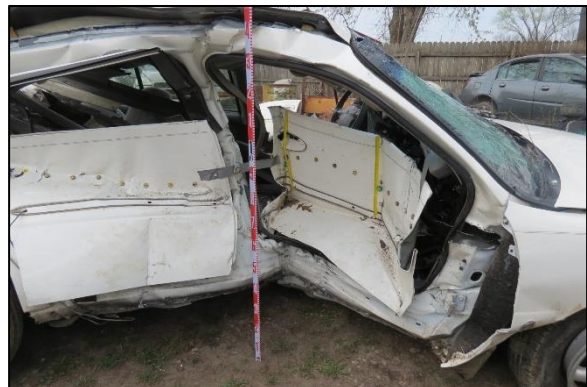
The right plane of the Buick (**Figure 5**) struck the end terminal (**Figure 6**, event 1). The vehicle was rotated counterclockwise 105 degrees relative to the end terminal at the moment of the impact. The impact speed is not known. The impact was centered on the right front door and the force direction on the vehicle was in the 3 o'clock sector. The crash damaged and kinked a total of 7.6 m (25.0 ft) of guardrail and damaged six posts. The impact resulted in deployment of the front row passenger's seat-mounted side impact air bag. Due to stress overload, the striker post pulled through the B-pillar and the upper hinge tore free of the A-pillar while the lower hinge separated at the pivot. The deformed door intruded an estimated 65 cm (26 in) into the front row right position.

**Figure 5:** Yellow tape outlines the end terminal contact to the Buick's right front door

**Exterior Damage Event 1:** The Buick sustained direct and induced damage to the right plane during the impact with the end terminal. The right front and rear doors, B- and C-pillars, sill, and quarter panel were directly damaged. The direct damage began 86 cm (33.9 in) rear of the right front axle and extended 223 cm (87.8 in) rearward on the right plane. The Field L was 238 cm (93.7 in). Integrity of the passenger compartment was lost by separation of the striker from the B-pillar and the right front door hinges. The door skin, which separated during the crash, was repositioned on the vehicle in the approximate crushed location and crush measurements were

documented at the mid-door and sill level. The maximum residual crush at the mid-door level was 73 cm (28.7 in) occurring at C<sub>5</sub>. The maximum residual crush to the sill was 65 cm (26.6 in) occurring at C<sub>4</sub>. The crush at each level was averaged as required by the crush measurement protocol and the crush values were: C<sub>1</sub> = 12 cm (4.7 in), C<sub>2</sub> = 46 cm (18.1 in), C<sub>3</sub> = 51 cm (20.0 in), C<sub>4</sub> = 62 cm (24.4 in), C<sub>5</sub> = 58 cm (22.8 in), C<sub>6</sub> = 30 cm (11.8 in).

*Damage Classification Event 1:* The collision deformation classification was 03RZAW4 (80 degrees). The severity of the damage was severe.

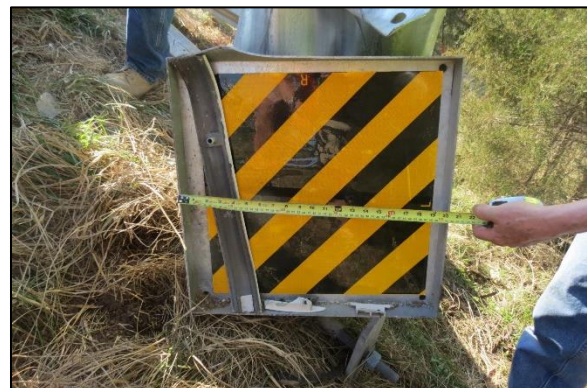
**Figure 6:** Damaged terminal

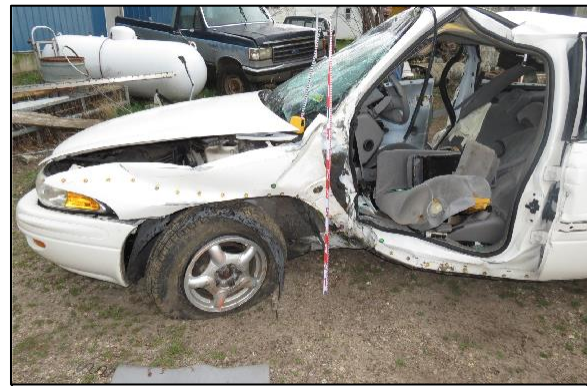
**Figure 7:** Damage to the left plane from the impact with 28 cm (11.5 in) diameter cedar tree

*Exterior Damage Event 2:* The left plane of the vehicle struck a 28 cm (11.0 in) diameter cedar tree fracturing and displacing the tree. Branches from the tree knocked down a barbed wire fence during this impact. The vehicle did not impact the fence since no direct damage consistent with a barbed wire fence impact was present on the vehicle. The direct damage from the trunk of the cedar tree began 20 cm (7.9 in) rear of the left front axle and extended 58 cm (22.8 in) rearward on the left plane. The Field L was 230 cm (90.6 in). The crush measurements were taken at the mid door level on the fender and at the sill since the left front door had been removed from the vehicle. The maximum residual crush was 27 cm (10.6 in) occurring at C<sub>3</sub>. The crush values were: C<sub>1</sub> = 0 cm, C<sub>2</sub> = 0 cm, C<sub>3</sub> = 27 cm (10.6 in), C<sub>4</sub> = 6 cm (2.4 in), C<sub>5</sub> = 3 cm (1.2 in), C<sub>6</sub> = 0 cm.

*Damage Classification Event 2:* The collision deformation classification was 10LYAW2 (300 degrees). The severity of the damage was moderate.

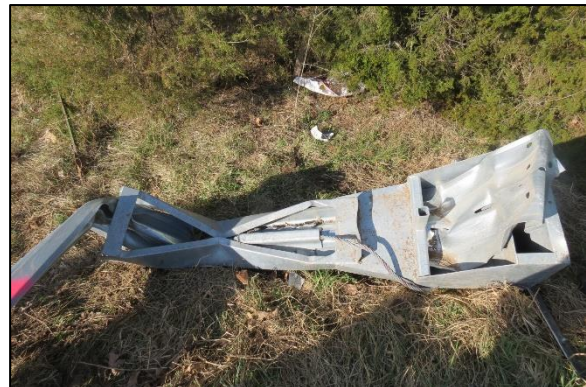
The right plane of the Buick struck the SKT end terminal and extruded 0.9 m (3.0 ft) of guardrail to the field side (**Figure 8**), damaged six posts (**Figure 9**) and deformed 7.6 m (25.0 ft) of guardrail. The full height and width [51 cm (20.1 in) and 51 cm (20.1 in)] of the face of the end terminal was directly contacted. The guardrail was displaced from posts 1 to 3. Post 1 was separated from its base at the bolt hinge. The base was pulled partially out of the ground and was bent approximately 50 degrees from vertical in the downstream direction. Post 2 was rotated to the ground in the downstream direction about its hinge bolt. Post 3 was bent downstream approximately 50 degrees from vertical and away from the roadway approximately 45 degrees. The composite offset block was slightly damaged but remained attached to the post. Post 4 was bent downstream approximately 10 degrees off vertical and was twisted in the ground toward the field side. The composite offset block remained attached to the post but was slightly damaged and displaced. The bolt was pulled through the guardrail. Posts 5 and 6 remained attached to the guardrail and were slightly displaced in the

**Figure 8:** Extruded guardrail and field side of the end terminal

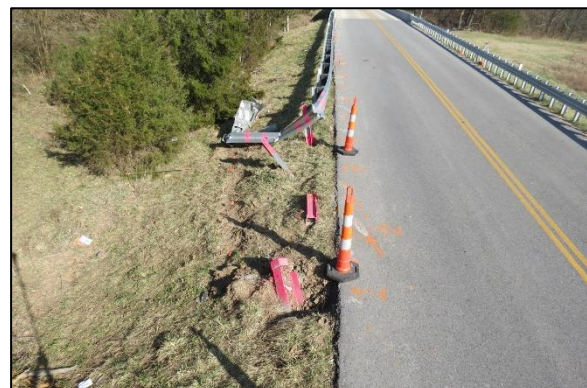
**Figure 9:** View east to the damaged and displaced posts and guardrail

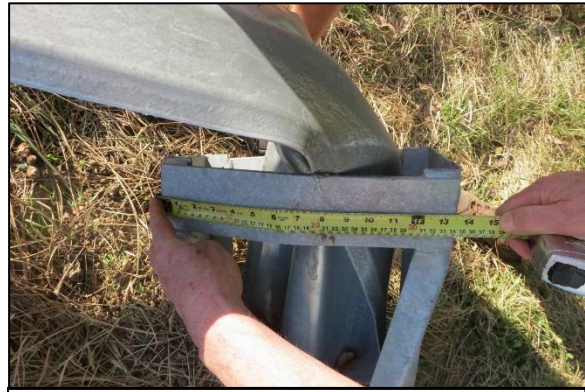
ground. The guardrail was kinked in four locations. One kink was located in the feeder channel. The guardrail was also twisted and kinked at the entrance to the feeder channel (**Figure 10**), which locked the guardrail in the feeder channel probably causing the feeder channel to bend and kink. A third kink was located at post 4 with the fourth kink located between the feeder channel and post 4. The width of the feeder channel was 10.2 cm (4.0 in) and the guide chute exit height was 34.3 cm (13.5 in). The connection of the feeder channel to the end terminal was not damaged and there were no fractured welds. The anchor cable was present and remained connected to the guardrail and was located in the feeder channel. The FHWA In-Service End Terminal Evaluation Data Collection Form is attached to the end of this report as **Appendix A**.

**Figure 10:** Twisted guardrail at the entrance to the feeder channel

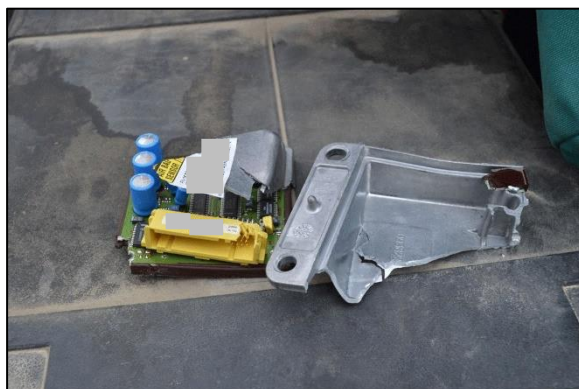
The Buick was equipped with an EDR. The air bag control module (ACM), which contains the EDR, had been removed by the police from its original location in the center tunnel and was not available at the SCI vehicle inspection. The police report stated that the ACM was damaged during the crash to the extent that they were unable to image the data. It appears that the ACM was damaged due to the intrusion. The police reported that the crash data retrieval (CDR) tool could not communicate with the EDR. The police photographs confirmed the extent of the damage sustained by the ACM (**Figure 11**).

**Figure 11:** Police photographs of the Buick's damaged ACM
