DOT HS 812 911

**Special Crash Investigations
On-Site Guardrail End Terminal
Investigation
Vehicle: 2005 Chevrolet Uplander
Location: Missouri
Crash Date: December 2017**

Special Crash Investigations
On-Site Guardrail End Terminal Investigation
Case Number: IN17036
Vehicle: 2005 Chevrolet Uplander
Location: Missouri
Crash Date: December 2017

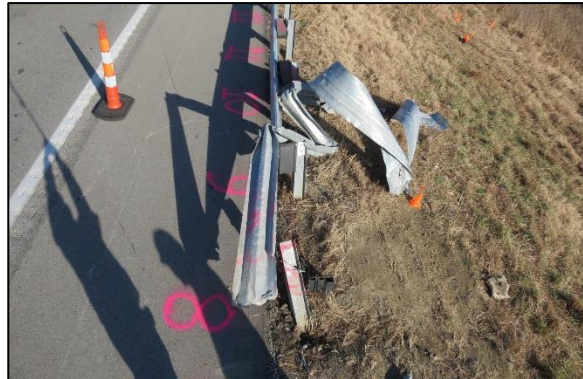
This report documents the on-site investigation of a minivan impact to an ET-Plus [10.2 cm (4.0 in. model)] guardrail end treatment (**Figure 1**) that is of interest to the Federal Highway Administration (FHWA). This crash was identified by an engineer with the Missouri Department of Transportation (MoDOT), who submitted photographs of the damaged guardrail end treatment and vehicle to the FHWA. The FHWA determined that the guardrail end treatment and crash type were of interest. This crash investigation was then initiated by the National Highway Traffic Safety Administration in December 2017 and assigned to the Special Crash Investigation team at the Indiana University Transportation Research Center. This single vehicle crash involved a 2005 Chevrolet Uplander (**Figure 2**). The crash occurred in Missouri in December 2017 during dark, morning hours and was investigated by a local police agency. The crash site, guardrail, and vehicle were inspected in December 2017.

Figure 1. The damaged ET-Plus and guardrail.

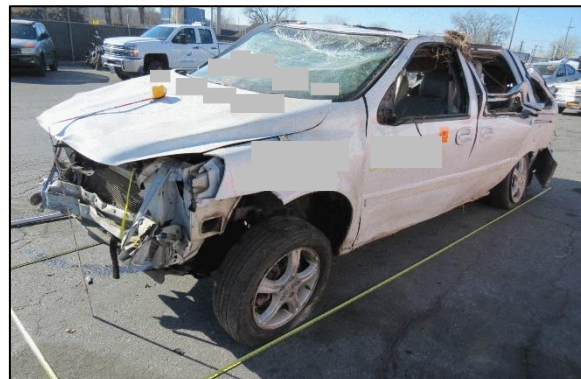
Figure 2. The damaged 2005 Chevrolet Uplander.

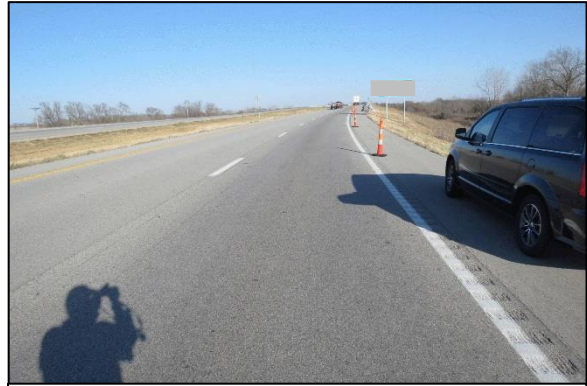
Figure 3. Northeast-bound approach of the Chevrolet.

The Chevrolet was traveling northeast in the right lane (**Figure 3**) at an EDR-reported speed of 137 km/h (85 mph) from -5.0 to -2.0 sec prior to algorithm enable (AE) slowing slightly to 134 km/h (83 mph) at -1.0 sec, which was the end of the pre-crash reporting. The brake switch circuit was reported as “Off” for the entire 5 sec of pre-crash reporting. The vehicle departed the right side of the lane onto the shoulder approximately 72 m (236 ft) prior to impact with the end terminal. The police crash report provided no information regarding the reason for the roadway departure.

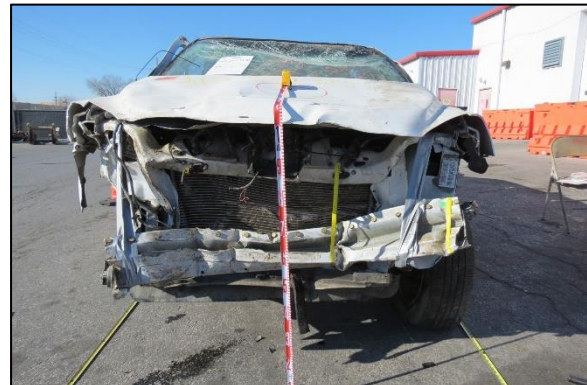
Figure 4. Damage to the front plane of the Chevrolet.

The left portion of the vehicle’s front plane (**Figure 4**) struck the end terminal (**Figure 5**, event 1) extruding 7.4 m (24.3 ft) of guardrail to the field side. The impact speed of the vehicle was estimated to be 129 km/h (80 mph).¹ The force direction on the Chevrolet was in the 12 o’clock

The Chevrolet sustained damage to the front plane during the impact with the end terminal and guardrail. The direct damage from the end terminal began 5 cm right of the left end of the bumper reinforcement and extended 39 cm (15.4 in) to the right. As the guardrail was deformed by the impact, it contacted the remaining portion of the front bumper resulting in a total length of the direct damage of 154 cm (60.6 in). The direct damage also involved both headlamp/turn signal assemblies, grille, and hood. The Field L was 120 cm (47.2 in). Crush measurements were taken at the bumper level and the maximum residual crush was 25 cm (9.8 in) occurring 15 cm (5.9 in) left of the vehicle's centerline. The bumper bar was displaced from the vehicle during the crash and was taped back in place on the ends of frame members the crush measurements. The crush values were $C_1 = 19$ cm, (7.5 in), $C_2 = 21$ cm (8.3 in), $C_3 = 25$ cm (9.8 in), $C_4 = 21$ cm (8.3 in), $C_5 = 15$ cm (5.9 in), and $C_6 = 0$ cm.

The Collision Deformation Classifications (CDC) was 12FDEW2 (0 degree). The severity of the damage was moderate.

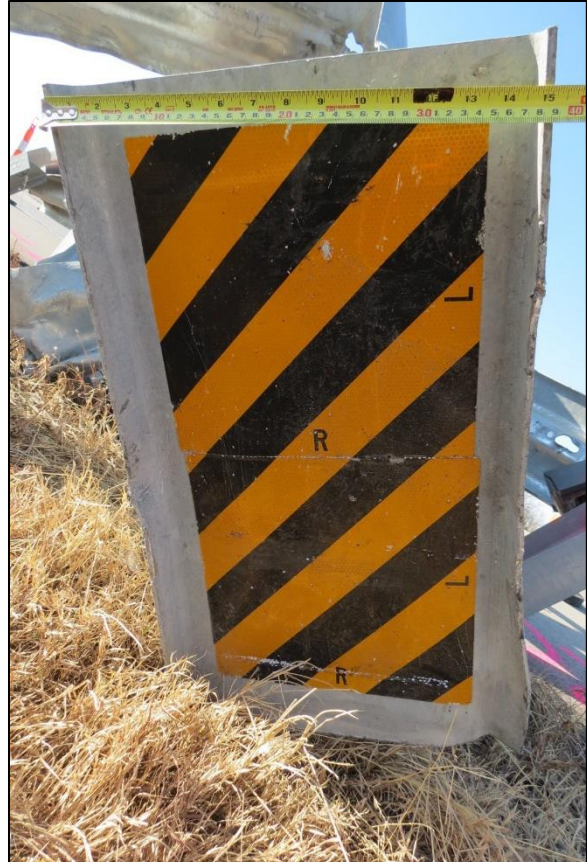
The front plane impact of the Chevrolet to the end terminal extruded 7.4 m (24.3 ft) of guardrail to the field side and damaged 21.0 m (68.9.0 ft) of guardrail and 10 posts. The direct damage involved the full height and width [71 cm (28.0 in) and 38 cm (15.0 in)] of the face of the end terminal. All the posts were constructed of steel. Posts 1 and 2 were not equipped with offset blocks. The remaining posts had composite offset blocks. Post 1 was rotated about the pivot bolt downstream to the ground. Posts 2, 3, 4, and 6 were bent downstream to the ground. Posts 5, 7, and 9 were bent downstream approximately 85, 75, and 40 degrees off vertical, respectively. Posts 9 and 10 were bent downstream approximately 10 and 25 degrees off vertical, respectively. The offset blocks were separated from posts 3 - 5 and 8. The guardrail was separated from posts 1 - 8. The guardrail was kinked

Figure 5. The face of damaged ET-Plus.

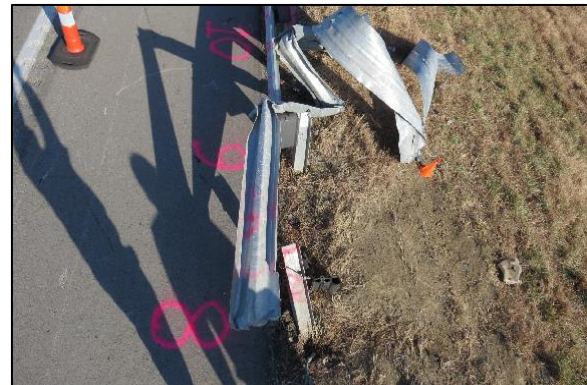
Figure 6. Kinks in the damaged guardrail.

in four locations (**Figures 6**) with one kink located at the entrance to the feeder channel. The width of the feeder channel was 10.2 cm (4.0 in) and the guide chute exit height was 38.1 cm (15.0 in). The connection of the feeder channel to the head was not damaged and no welds were broken. The anchor cable was present but was disconnected from its anchor. The height of the undamaged guardrail was 44.5 cm (17.5 in). The FHWA guardrail form is attached to the end of this report as **Appendix A**.

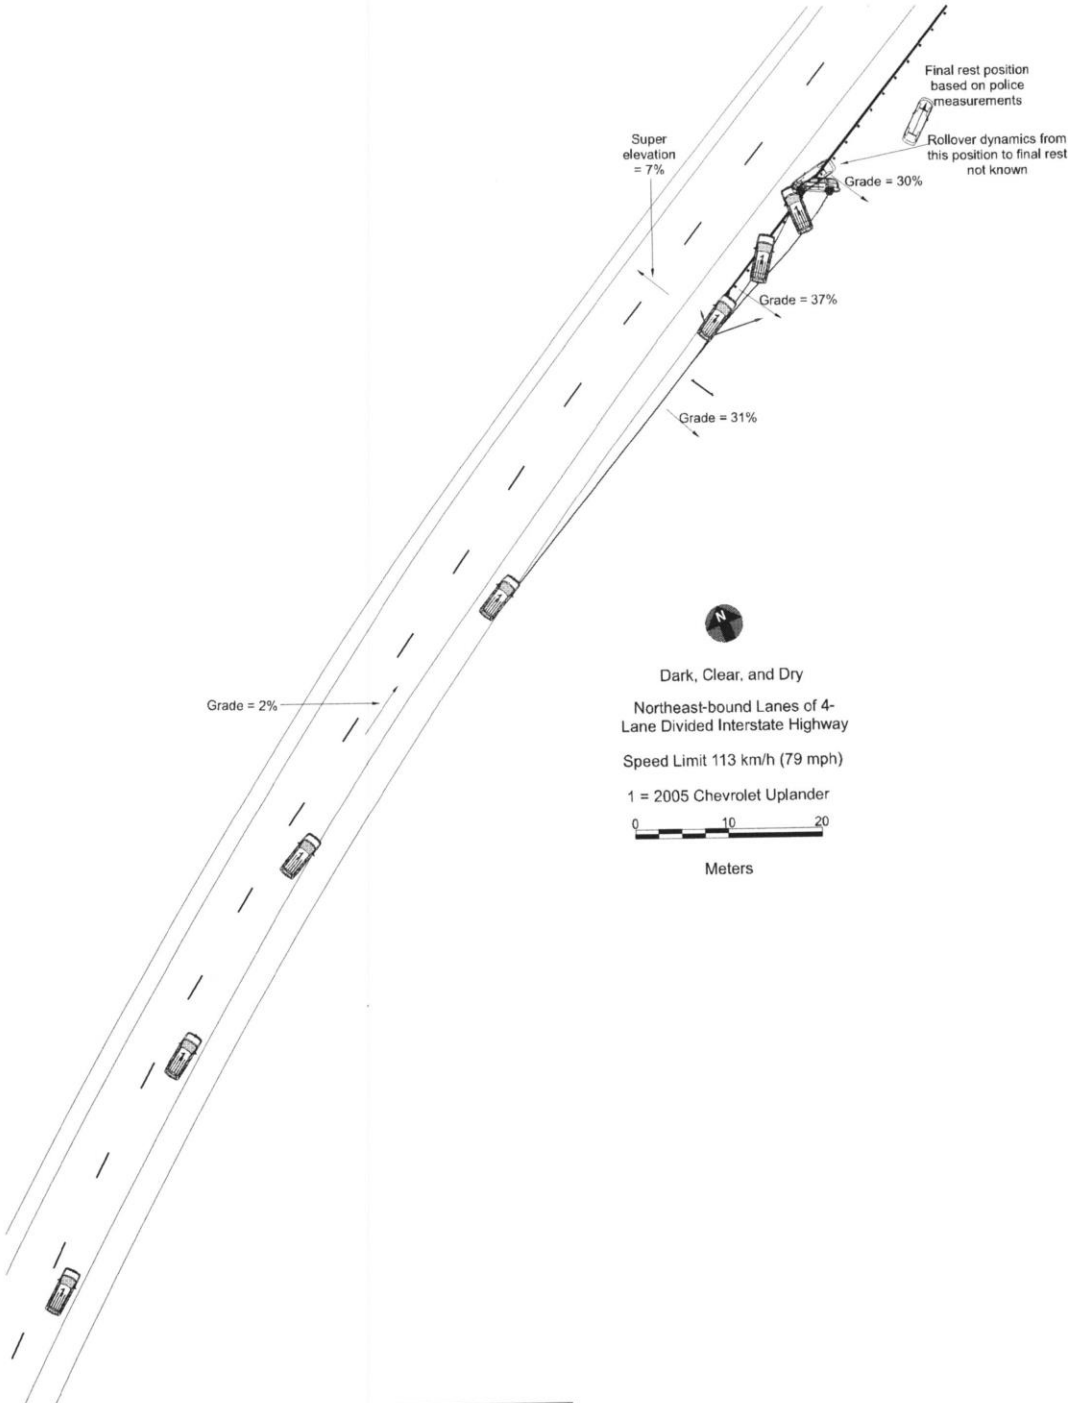
CRASH DIAGRAM

This crash occurred during dark morning hours on the east side of the northeast-bound lanes of a four-lane, divided interstate highway. The weather conditions were clear, calm wind, a temperature of 2.8 °C (37 °F), and a dew point of -4.4 °C (24 °F), according to local weather reports. The interstate traversed in a northeast/southwest direction and had two bituminous through lanes in each direction that were divided by a grass median. The roadway was curved to the right for northeast-bound traffic and the calculated radius of curvature was 367.2 m (1,204.4 ft). The northeast-bound roadway was bordered by a 1.5 m (4.9 ft) wide bituminous median shoulder with a rumble strip and a 2.6 m (8.5 ft) wide concrete right shoulder with a rumble strip. The right northeast-bound lane was 3.8 m (12.5 ft) wide and the left northeast-bound lane was 3.7 m (12.1 ft) wide. A blocked-out W-beam guardrail equipped with an ET-Plus (4 in. model) end terminal was located on the right side of the road adjacent to the shoulder. The roadway pavement markings consisted of a solid white edge line, broken white center line and solid yellow median line. The speed limit was 113 km/h (70 mph). The crash diagram is included at the end of this report.
